## Leak on a truck after filling in an LPG depot.

March 29, 2002

Arleux [Nord]

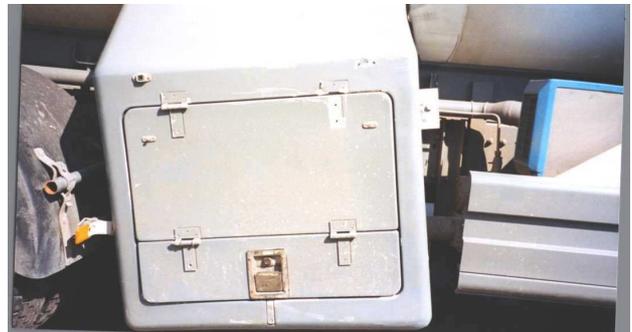
At 6.40 am, a tanker truck containing 7,5 t of liquefied propane hangs portal of a filling centre. A leak occurred on the tank on the downstream purge valve of the distribution pump (dia. 12 mm) enclosed in the vehicle's side compartment. The tearing away of the compartment caused the purge to rupture. This element is located between the bottom valve and the shut-off valve. In addition, the bottom valve was not hermetic. The depot manager actuated the site's emergency stop and initiated the internal contingency plan. Three individuals present at the site begin using fire nozzles (3) connected to the fire hydrants to limit the cloud of gas and form an ice plug. The firemen took over upon their arrive and used the equipment +set up by the centre's personnel. At 9.27 am, operations began to drain the truck to a flare stack in order to burn the gases released. The latter, placed 50 m from the truck, was ignited to lower the pressure in the tank. At 11.00 am, the pressure had dropped considerably and the ice plug stopped the leak.

Tests to close the bottom valve were performed although, due to the pressure, the ice plug ruptured and the leak continued. After several attempts, the bottom valve was loosened and closed. The tank was rendered hermetic once again. A mechanical plug was placed on the pipe. The operations were completed around 12.30 pm. The tank was then drained and rendered inert.

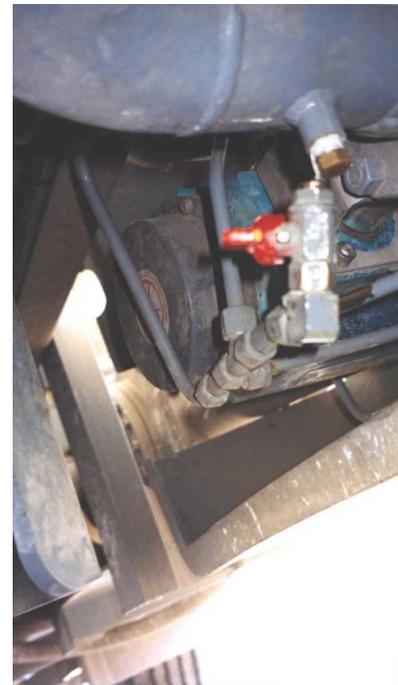
Owing to the impact, the movement of the compartment caused the purge connection to be ripped away: for info, this device was installed in the last few years to test the bottom valves for leaks and is indicated in the CFBP specifications.

The resulting leak clearly indicated that the bottom valve had not been closed completely (existing prior to the accident): This is due to the deformation of the plate supporting the bottom valve's actuating cylinder. In the case of the truck involved, the actuator consists of a pneumatically-controlled ¼-turn pneumatic valve.

*Following the event in question, a series of bottom valve leak tests were performed at the profession's initiative.*

*Since that time, periodic verifications have been integrated within site programs.*
