Emission of dangerous substances in a surface treatment facility

March 20th, 2002

Issoire [Puy-de-Dôme]

Gaseous release
Metallurgy
Pickling
Fluoronitric acid
Aluminium
Exothermic reaction
Equipment breakdown
Periodic control
Evacuation

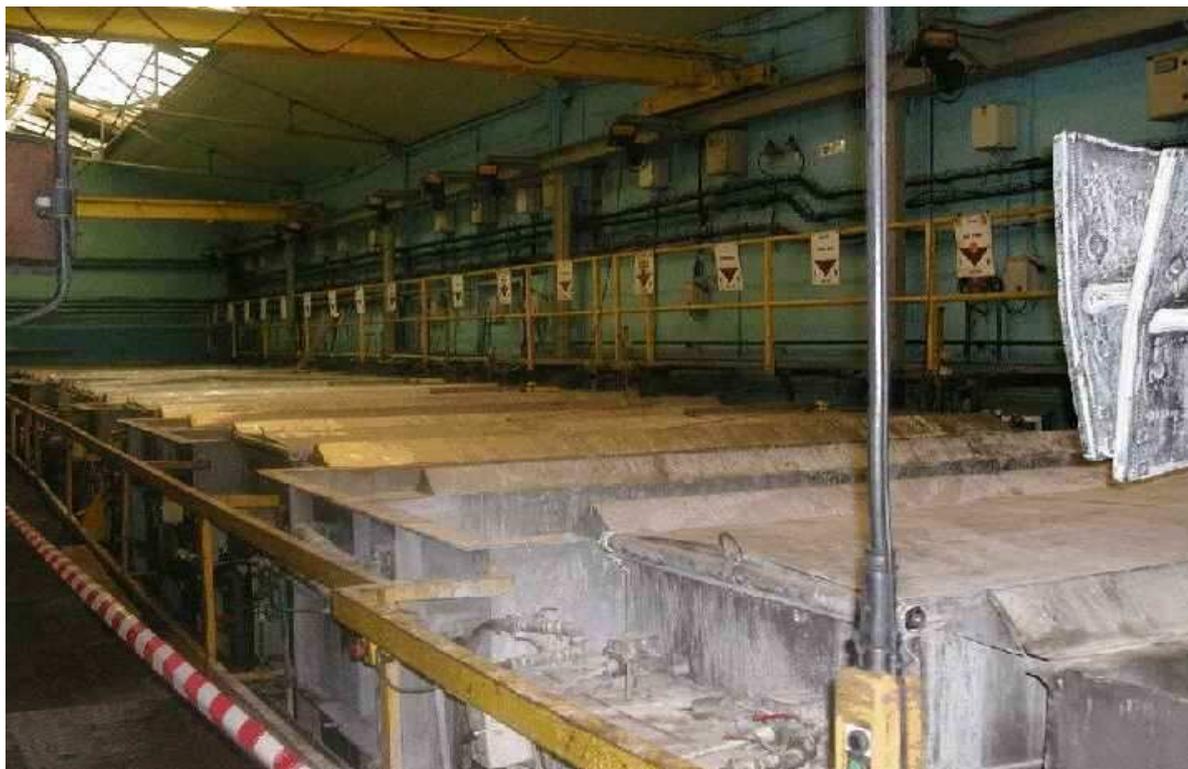
Photo DRIRE Auvergne

The accident took place on one of the two surface treatment lines, and more precisely on the control pickling line which is made up of 21 tanks made of stainless steel or composite material, each having a capacity of 6 m³ with a useful volume of 4.6 m³.

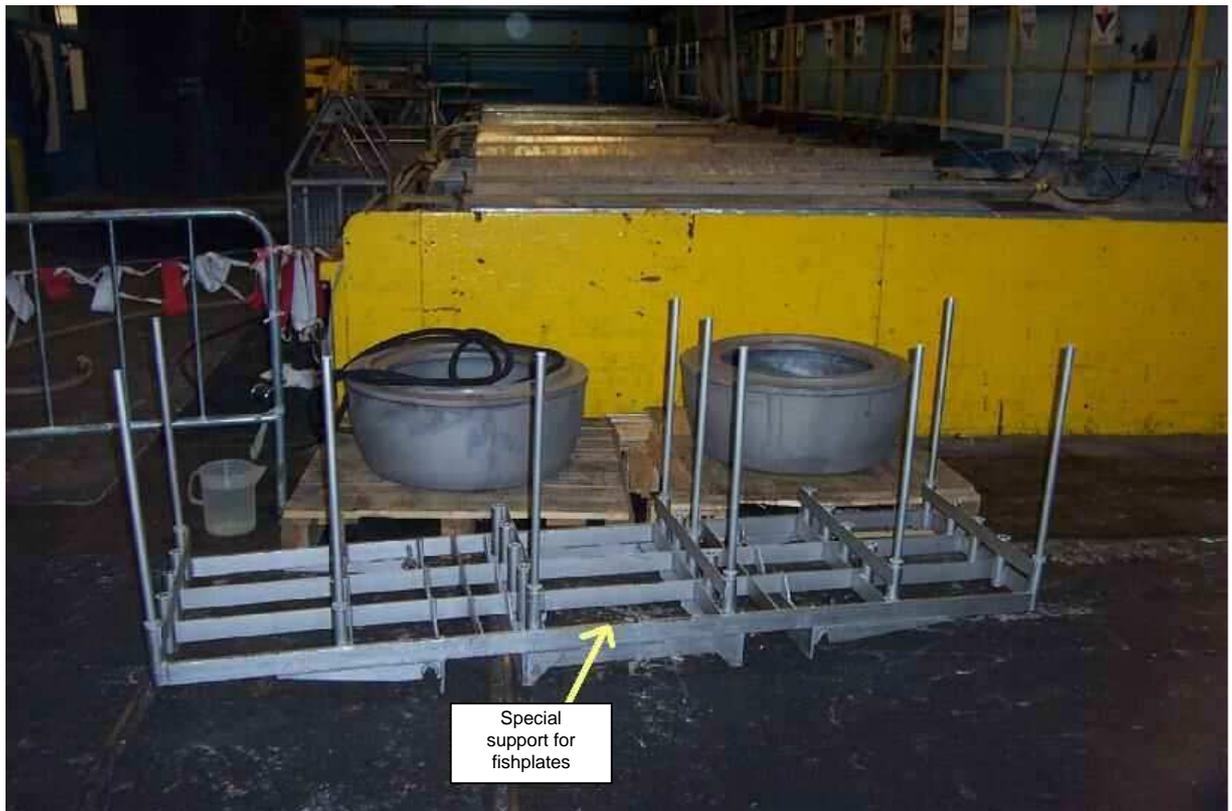
Photo DRIRE Auvergne

On March 20th, around 10:30 am, an operator was stripping aluminium aircraft fishplates (parts designed to connect the wing to the fuselage) in a cold aqueous solution of 15% pure nitric acid and 5% fluorohydric acid (by volume)¹. The 4 parts, weighing 200kg each and measuring 2.50 m long, were placed on their special support and immersed into the treatment bath using the travelling crane. Upon attempting to remove the parts from the bath 10 minutes later, the operator noted that one of the two hoists did not operate. A maintenance technician intervened using a platform on the traveling crane's electrical control cabinet, located above. His action on the synchronization of the hoists did not repair the faulty equipment. The part support structure became unbalanced and the 4 fishplates became blocked in the bottom of the tank preventing the partly immersed load from being lifted out of the fluoronitric acid solution.

At the request of the labour inspectorate, a verification of the travelling crane was conducted by an recognized organism, different from the one that habitually performs the operation. A brake failure on hoist No. 2 was diagnosed. This malfunction, followed by the blocking of the load of aluminium pieces in the acid treatment bath during intervention by the maintenance department, caused the subsequent exothermic reaction and gaseous emissions.

The operator modified the specific load supports of the same type that were used when the incident occurred, by equipping them with axial stops preventing parts from shifting should the load become unbalanced.

The surface treatment line was authorised to continue operations on March 25th, following the repair of the travelling crane and the tank.

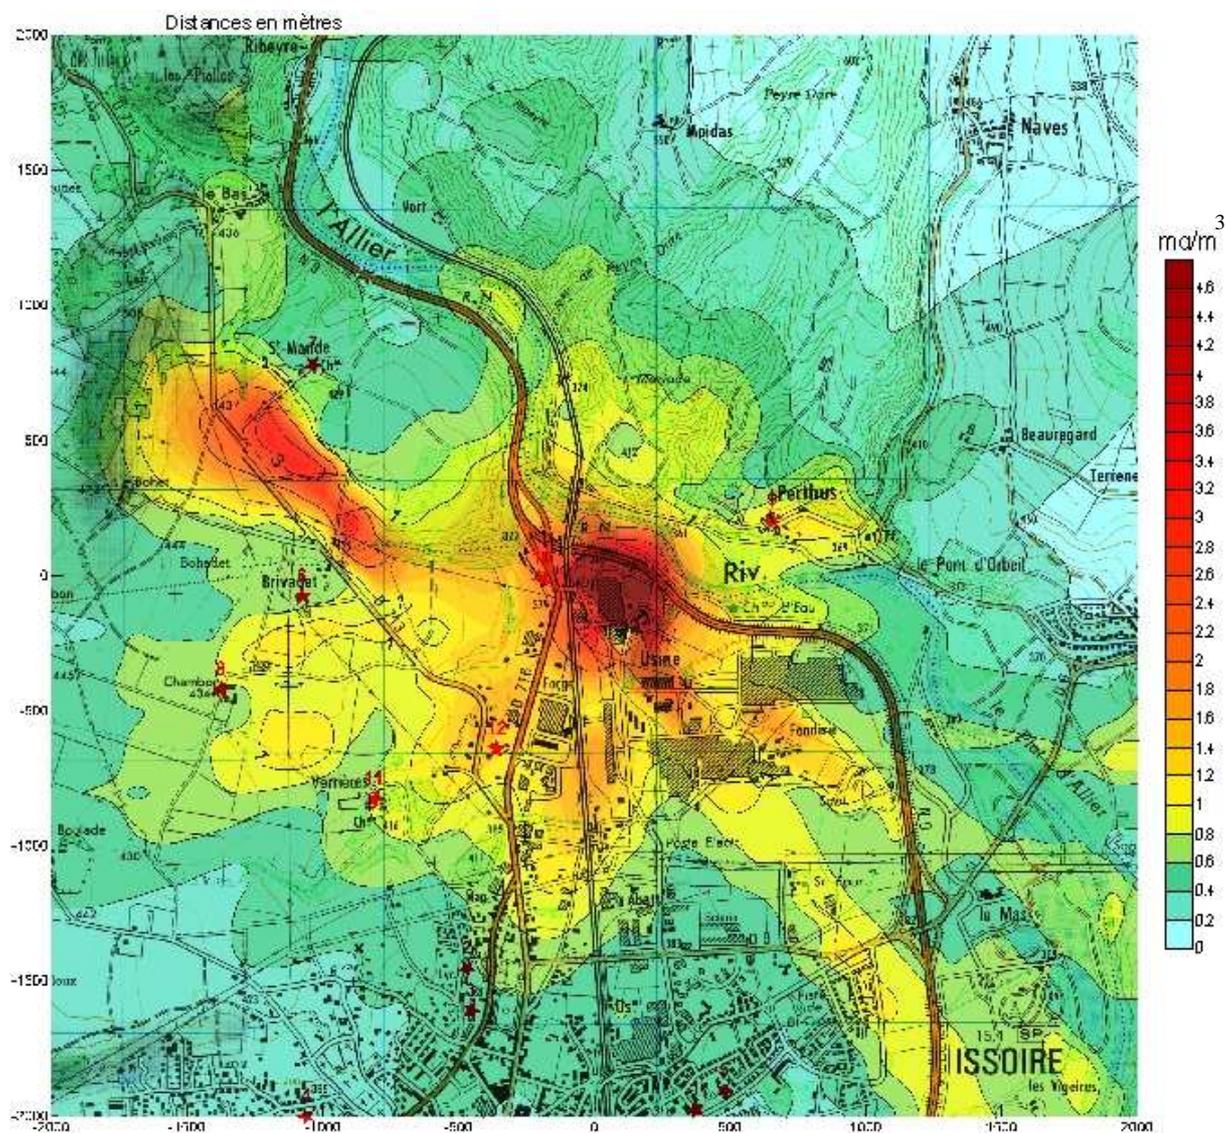
Appendix 1:

The modelling of the atmospheric dispersion of these untreated effluents, which take the topography and the nature of the ground into account as well as the meteorological conditions that may be encountered on the site, has shown that the maximum concentrations, greater than 2 mg/Nm³ for NO₂ and 1 mg/Nm³ for HF, will be within a radius of approximately 250 meters around the stacks. The homes that are the closest to the site will thus be subjected to NO₂ concentration levels between 1 and 3 mg/m³ and HF levels between 0.5 and 1 mg/m³. (See Appendices 1 and 2)

Simulation of the atmospheric dispersion of the accidental release of NO₂ vapours

Maximum NO₂ concentrations

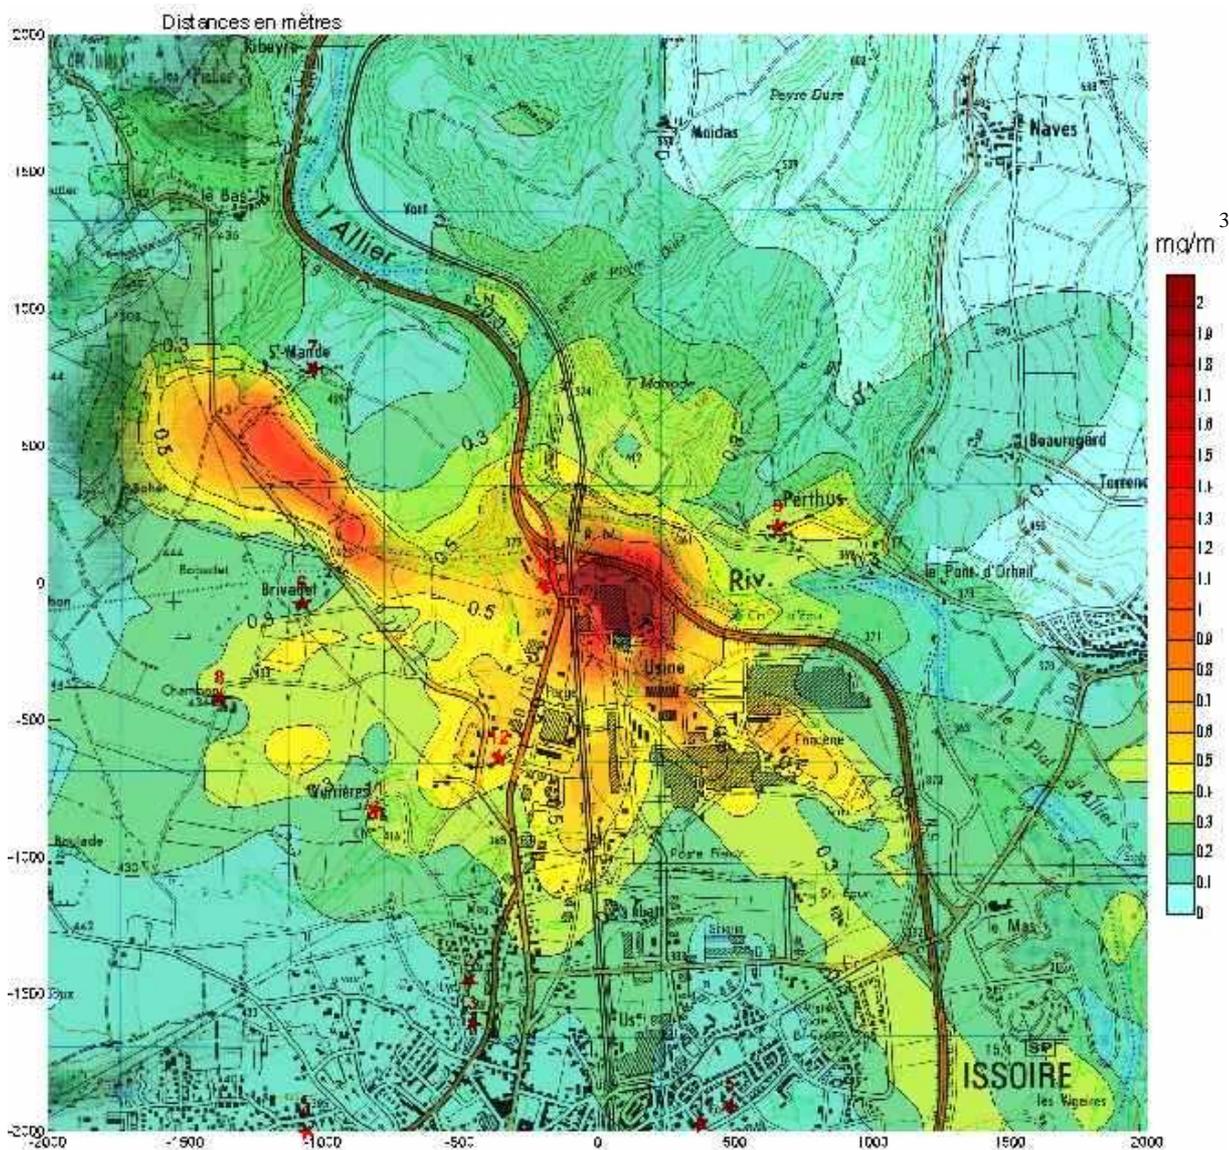
Appendix 2:
Accident in a surface treatment facility
Issoire (63 - Puy-de-Dôme), France
March 20th, 2002

Simulation of the atmospheric dispersion of the accidental release of HF vapours

Maximum HF concentrations
