Explosion of an additive tank in a oil and bitumen refinery

May 18, 2002

Dunkerque [Nord]
France

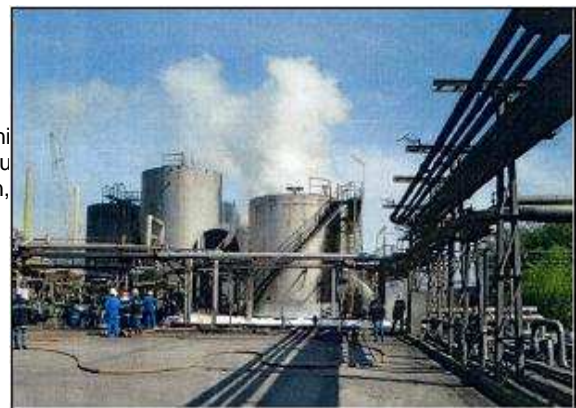
Storage zone

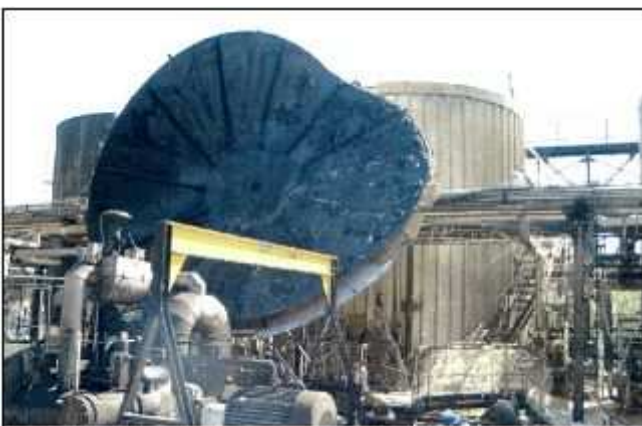
At 3.30 pm, an explosion occurred in a bitumen additive tank located in the bitumen tank zone. The roof of the recipient was blown off and landed nearby. A fire developed with flames reaching heights of up to 10 meters. The internal contingency plan was put into action. The personnel, having been alerted by the explosion, brought the fire under control in 10 minutes using 2 fire nozzles.

Roof of the tank

The frangible roof prevented the opening of the tank's shell and massive product leakage.
