# Explosion of a single-family dwelling due to underground hydrocarbon pollution

4 August, 1990

**Le Petit-Couronne [Seine-Maritime]  
France**

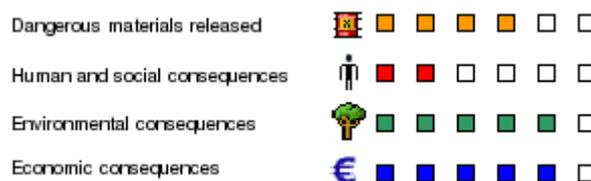
By applying the rating rules applicable to the 18 parameters of the scale officially adopted in February 1994 by the Member States' Competent Authority Committee for implementing the 'SEVESO' directive on handling hazardous substances, and in light of information available, this accident can be characterised by the four following indices:

Given the estimation of inflammable hydrocarbon quantities released into the soil (total quantity of hydrocarbons lost was estimated at between 15,000 and 20,000 m<sup>3</sup>, with this figure lying between 10,000 and 12,000 m<sup>3</sup> for the premium grade fuel alone), the "Hazardous Materials Released" parameter receives a 4 rating (parameter Q1).

A value of 2 is ascribed to the human and social consequences, corresponding to destruction of the house where the two individuals had been living (parameter H6), one of whom was slightly injured due to the blast (parameter H5).

The environmental consequences were rated at a value of 5, reflecting the pollution caused both at the soil surface and to the groundwater (parameter Env 13).

The economic consequences received a 5 rating as well as a result of the 24 MF (1991) in compensation paid out by the refinery operator plus the purchase and subsequent demolition of 2 homes (parameter € 17). The pollution clean-up works undertaken by the operator amounted to approx. 26 MF (1991), corresponding to a level 4 for parameter € 18.

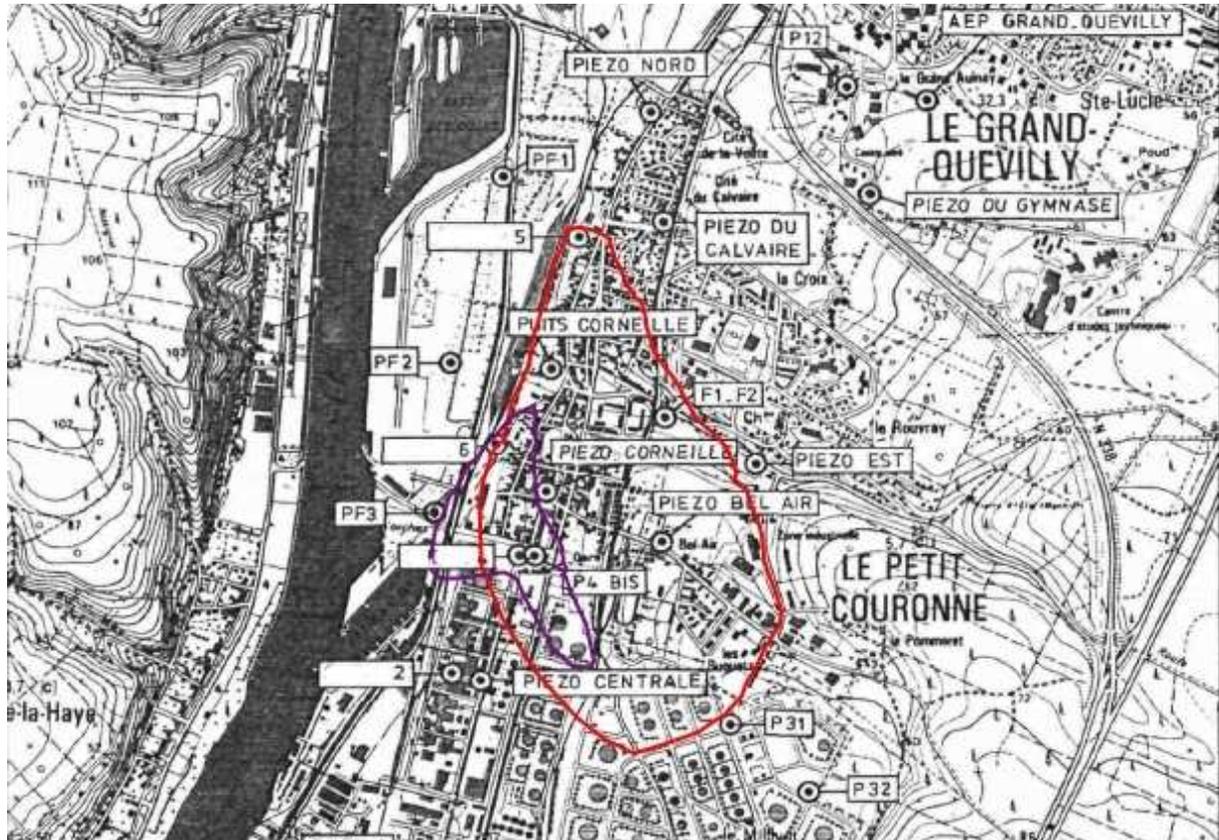
*Map 1: Evolution and localisation of the polluted zone*

- In conjunction with these investigations, a study was commissioned to a specialised expert. Four of the 15 samples extracted indicated strong contamination of the water table; moreover, an approximate mapping of the likely extension to the polluted zone was produced (see Map 1). At this stage however, the study was still not able to adequately estimate the quantity of hydrocarbons to be eliminated.

Polluted spill on the water table, as evaluated in 1989
-

Polluted spill on the water table, in 2008

Pollution mapping, performed by analysing gases in the soil, was conducted in September 1990 and indicated that the infiltrated zone extended underneath both the refinery and the centre of the Le Petit-Couronne town, over a surface area estimated at 100 ha (see Map 1).

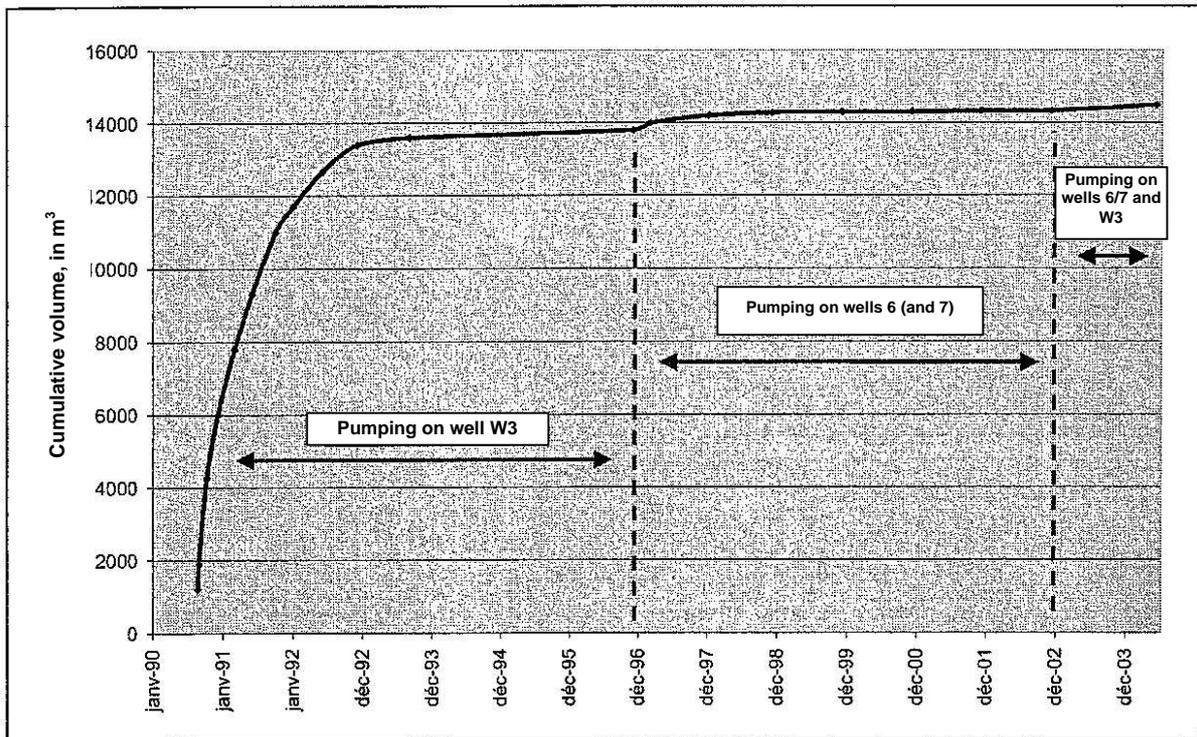
*Graph 2: Cumulative total of hydrocarbons pumped over time (Source: DRIRE Agency report)*

From 1997 to 2008, hydrocarbons were pumped into the groundwater, via the various wells located closest to the refinery, and then skimmed. As per Prefectural decree, a number of successive studies enabled determining the pumping categories and corresponding flow rates and then adapting well localisation depending on pumping efficiency and the pollution spill size / position change (Map 1). Since the heavy fraction tended to increase as of the beginning of 1994, it was decided to continue pumping until complete disappearance of the light fraction, provided pumping would remain productive on heavy residue as well. In 1998, the polluted surface area was estimated at between 40 and 55 ha. In 2005, all pumping activity as a whole allowed recovering a total hydrocarbon volume of around 14,500 m<sup>3</sup> (Graph 2).
