## Blast in a reactor on a fine chemicals site

September 3, 2002

Marans – [Charente-Maritime]

Fine chemistry  
Enamelled reactor  
Dichloromethane  
Hydrogen  
Corrosion  
Static electricity  
Blow-out disc  
Design / Dimensioning

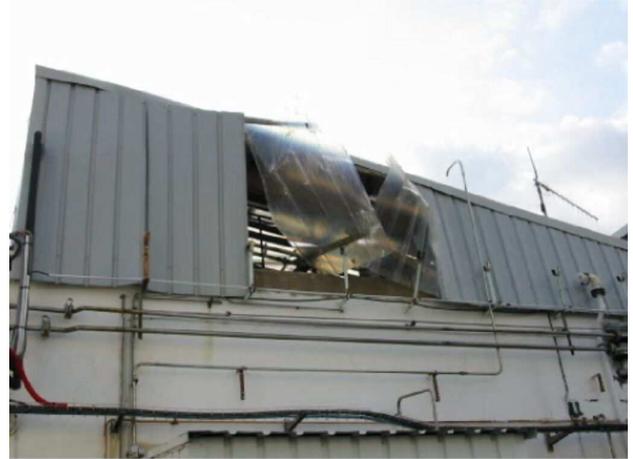
In terms of equipment damage, at the building level:

- ✓ Twenty square meters of the ceiling were blown out, mainly on the span of clear sheeting (the sheeting was folded although it remained in place),
- ✓ The siding on the upper part of the building, to the west and to the north, was blown out over 5 m with partial tearing away of the sheeting,
- ✓ Traces of product projection was visible on the northern part of the wall, up to heights of 2 m,
- ✓ Impact holes (possibly due to pieces of PVDF) were observed on the clear siding.

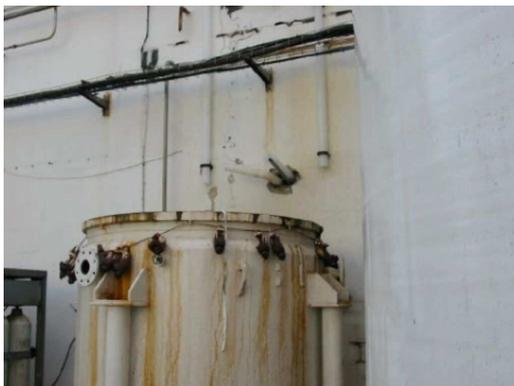
At the level of the crash tank zone, located outside the building:

- ✓ The crash tank's plastic cover was completely ripped away, as well as all of the connecting pipework,
- ✓ 30 cm of liquid is present in the tank,
- ✓ A piece of broken plastic was projected through a window in the administrative office.

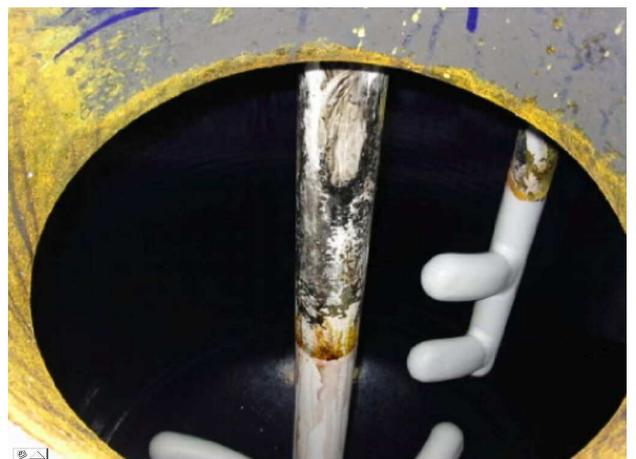
At the reactor level:

- ✓ Several gaskets exited their seats (manhole, cover and vent outlet), and their metal reinforcements were partially torn,
- ✓ Yellow traces indicate that product exited by the cover gaskets and manhole,
- ✓ A change in appearance of the PVDF piping and the valve was noted,
- ✓ Numerous enamel fragments were present on the reactor and in its immediate proximity
- ✓ The lower part of the metallic protection of the mixing shaft is caved in.

The self-detonation of an oxygen (O<sub>2</sub>) / hydrogen (H<sub>2</sub>) mixture, the hydrogen being produced by the acid corrosion of an unprotected metal surface. A corrosion spot was observed at the top of the mixing shaft. This defect on the coating of the enamelled surface of the reactor's mixing shaft happened when the mixer was being installed after inspection, an impact to which the operators did not pay any attention. As such, a gaseous mixture of dichloromethane and oxygen, sufficiently enriched with hydrogen in order to be self-detonating, may have formed in a recess of the reactor, created by the tube. The results of the tests, the extent of the damage associated with the blast and the observation of an enamel corrosion spot, backs the hypothesis of hydrogen being present in the environment.

The enamelled walls are very efficient in terms of corrosion protection, but they are also very fragile: they are sensitive to mechanical and thermal shocks. The process evaluation studies must consider the risk of damage to the protection of these walls and regular inspections must be conducted (by analysing with high voltage current, for example).
