Rupture of a grain storage cell

September 20, 2002

Vailly sur Aisne [Aisne]

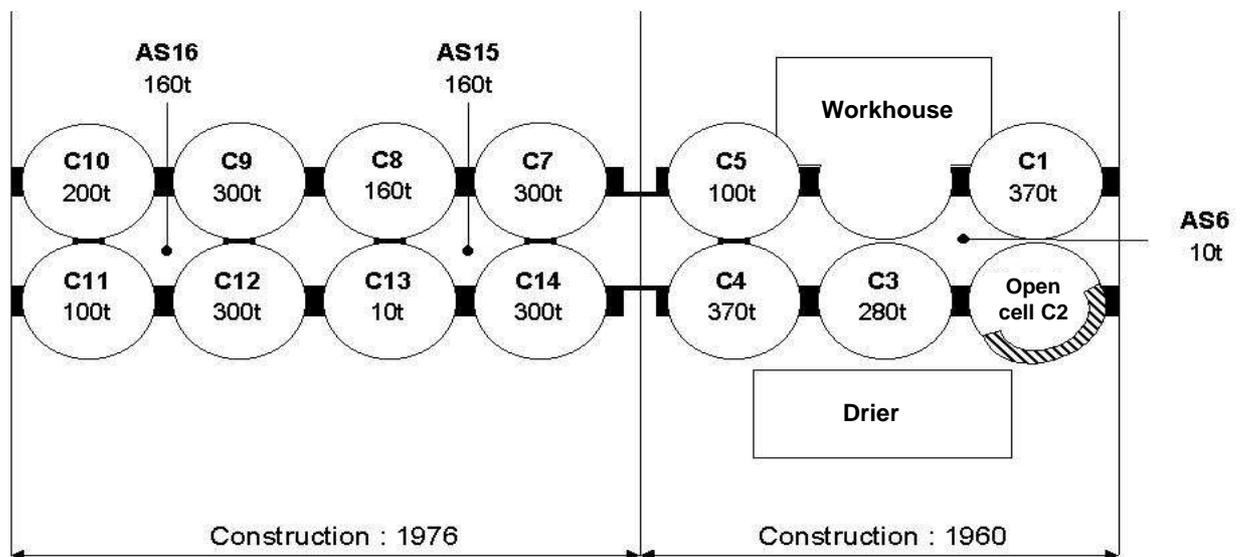
Cell identification

The silo was built in 2 phases, one in 1960 with the installation of 5 cells, the workhouse and drier, and the other in 1976 with the construction of 8 additional cells.

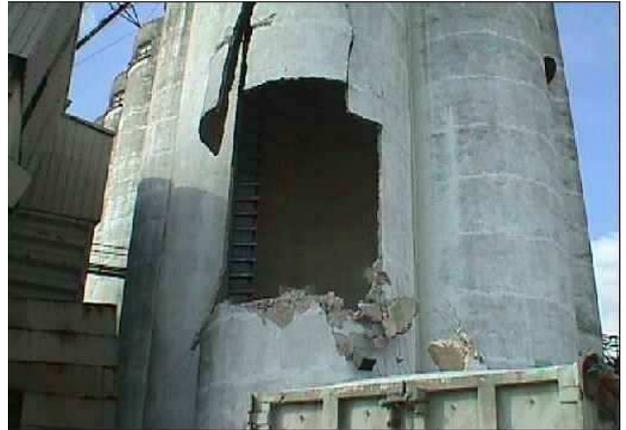
Photo DRIRE Picardie

On September 20, 2002 around 11.50 am, a driver of a truck being loaded by the side unloading system of C2 noted that pieces of concrete were falling into the trailer bed. He informed the silo operator performing the unloading operation and both employees immediately moved away from the area. A few instants later, a block weighing approximately 3 tons fell into the truck. 300 t of wheat spilled onto the ground, destabilizes the drier and is blocked by the wall separating the cooperative and the yards of the residences next door.

The ageing of the reinforced concrete compounded by corrosion of the reinforcement rods is the main cause of the rupture of the Vailly-sur-Aisne cell, built in 1960. The expert assessment conducted showed that, since 1975, the structure of the recently built cells was reinforced with two levels of steel hoops as opposed to one before. In addition, the installation of a side drainage system on the cell attributed to the weakening of the structure, thus aggravating the phenomenon and causing the structure to collapse.

Following the accident, the site was secured and a safety perimeter was set up around the installations, cracks observed in the neighbouring cell C1 were marked, the site's electrical power supply was disconnected, the grain spilled on the ground was recovered and the drier stabilized. A crisis meeting was held in the town hall's facilities in mid-afternoon in the presence
