Rupture of a grain storage cell

October 20, 2002

Jussy [Aisne]

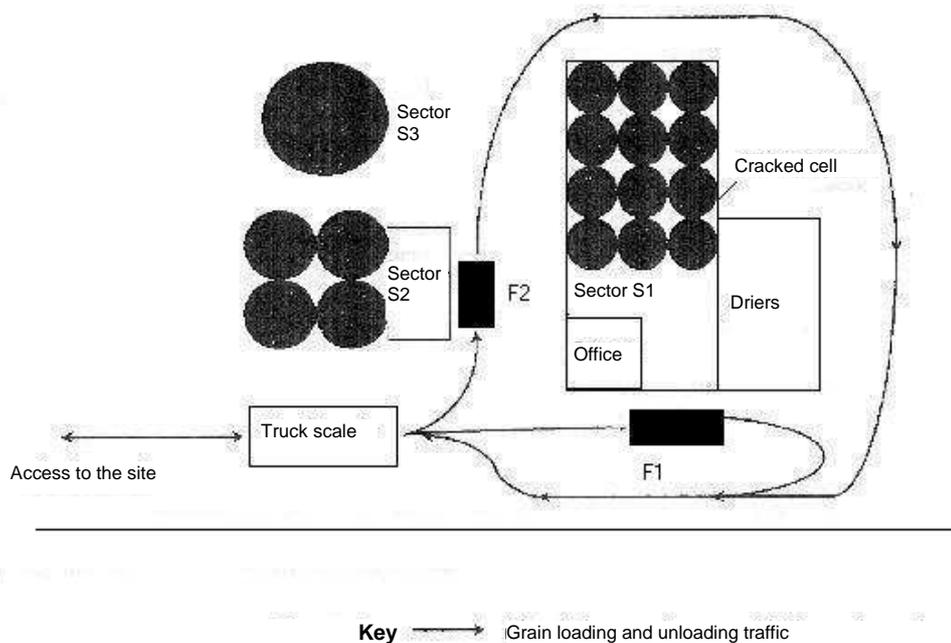
Cell identification

Located on the *commune* of Jussy since 1963, the silo, which has been enlarged over time, is divided into 3 zones of vertical storage cells interconnected by transport equipment :

- ✓ Sector S1 (1963): 12 cells with a total capacity of 5,520 m³
- ✓ Sector S2 (1971): 4 cells with a total capacity of 2,920 m³
- ✓ Sector S3 (1982): one 5,330 m³ cell

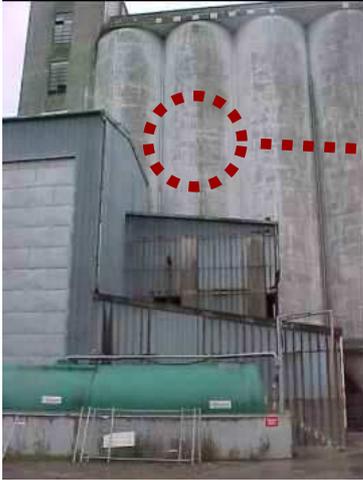
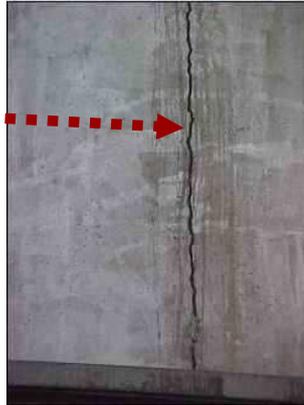
Photo DRIRE Picardie

During a round on October 20th at about 10:00 am, the silo manager is alerted by the noise of a materials fall on the drier roof. He noticed a crack all along the 25-m-high cell in the sector S1. Roughly a hundred tons of corn had spilled out, damaging a wall allowing access to the control installations located at ground level, under the outflow cones forming the base of the cells.

The ageing of the reinforced concrete compounded by corrosion of the reinforcement is at the origin of the cracking phenomenon in the Jussy cell, built in 1963. Furthermore, prior to 1975 the cell construction rules stipulated the installation of a single level of steel hoops in the cell structure as opposed to 2 since that time.

The site was secured with a safety perimeter; deliveries from farmers were suspended, the progressive unloading of the 12 cells of zone S1 and the disconnection of the drier's gas and electrical power supplies. The Classified Installations

Inspectorate proposed that the *Prefect* issue an emergency shutdown order, which was signed October 31, 2002, requiring that the installations be subject to expert evaluation. The operator decided to stop operating cells S1 and S3 and to suspend the activity of the S2 cells pending the conclusions of the evaluation.
