Blazing leak in a gasoline hydrotreatment unit of a refinery

November 17, 2002

Grandpuits Bailly Carrois [Seine et Marne] - France

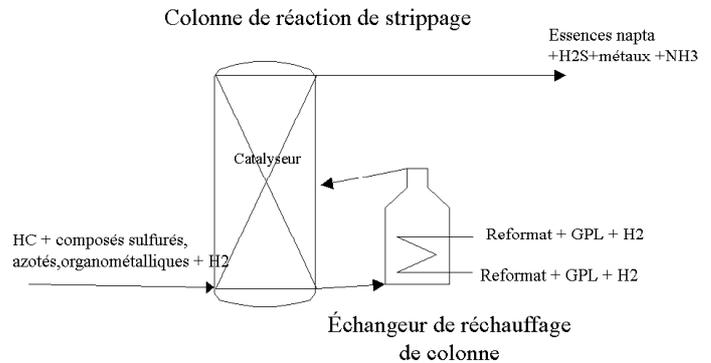
The reboiler is designed to supply the energy required for column operation, which includes the pre-treatment stripper, on which the hydrotreatment unit depends. This is a preparation phase for the reformer's load. The reboiling energy is furnished by the reformer's effluent. The complete diagram of the unit, including the loop shown opposite, is represented on the following page.

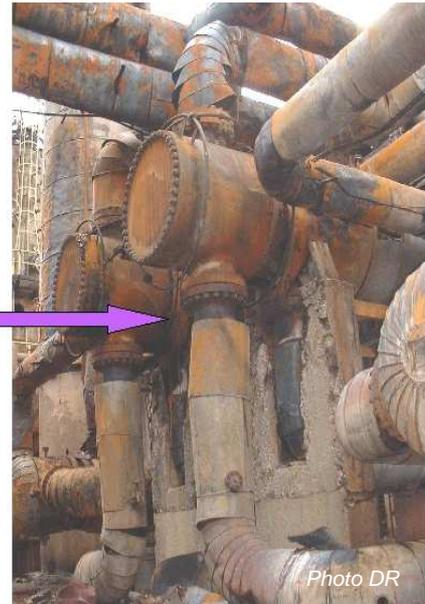
Reboiler
flange

The leak occurred on the gasket plane of the reboiler, on the hot fluid side, and immediately burst into flames producing a nearly vertical flame cone roughly ten meters in length.

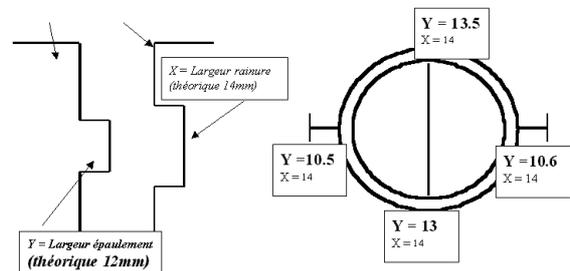
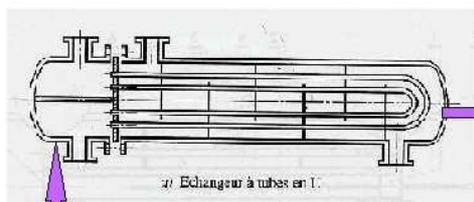
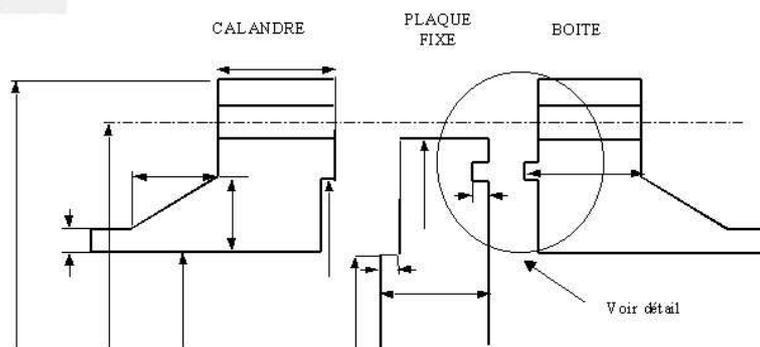
According to the findings and expert assessments, a construction defect on the exchanger is responsible for the leak. This circularity dimensional defect in the throat of the seal housing (see diagraph opposite) complicated its reassembly following the shutdown for maintenance prior to the accident.

The loss of seal coincided with the increase in the product's temperature and pressure.

Calandre : Essence
 Ps = 19 bars
 T = 210 °C

Faisceau : réformat
 Ps = 25 bars
 T = 440 °C

From the organisational standpoint, the operator has set up procedures for checking the dimensions of exchanger seal bear surfaces.

- ✓ Specific certification is now required for the personnel conducting this type of operation, together with appropriate training,
- ✓ For the external companies performing these operations, systematic dimensional inspection reports are to be compiled for the gasket bearing surfaces and shut-down points are foreseen after the upgrading, prior to installing assemblies, when reassembly operations are performed.
