Leak on effluent pipeline in a chemical plant

August 05 – 11, 2002

Le Havre – [Seine-Maritime]

Pipeline
Wastewater
Commissioning
Corrosion
Organisation / Tests

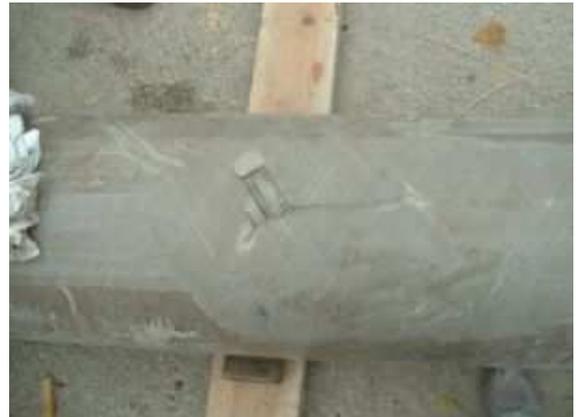
Four days later, on Sunday, August 11, 2002 at 8.05 pm, a new leak occurred and was immediately detected by the monitoring system. The rated output is 440 m³/h (diluted sulphuric acid), at a pressure of 3.9 bar (these conditions are significantly below the maximum operating conditions and much below the test conditions). The leak was located on the outside of the Le Havre plant, on an underground part of the pipeline, near a section that passes underneath some railroad tracks behind a LPG storage and filling station. The leak was evaluated at between 100 and 200 m³.

In all, between August 5 and August 11, 2002, eight problems were reported, six of which were on the first 2 kilometres of the pipeline. Two failures occurred while in service, in similar conditions, near elbows and changes in direction, while this pipeline had only been in operation roughly ten hours in service conditions where the pressure had never exceeded 5 bar in a diluted sulphuric acid environment (concentration less than 15 g/l) and at temperatures less than 35°C (temperature allowed for SVR tubes 50°C).

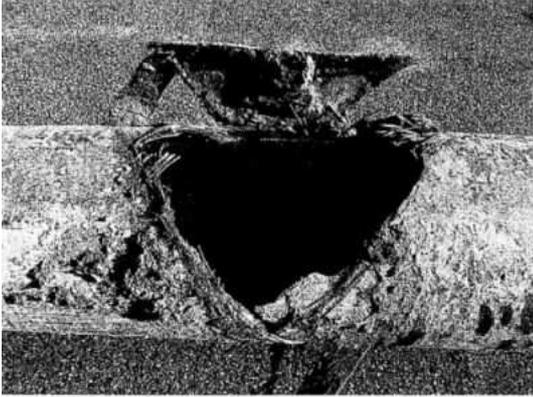
All of the faults observed on the pipes are similar in the following respects:

- ✓ the main direction of the cracking: longitudinal along the invert (lower generatrix),
- ✓ location: near a specific zone, namely a slope or angular change (45°, 30°, 22°, 11° elbows or high point).

It was clearly shown that the damage to the installation was due to a stress corrosion mechanism in an acid environment. Stress corrosion is a cracking mechanism that requires the participation of the following three elements:

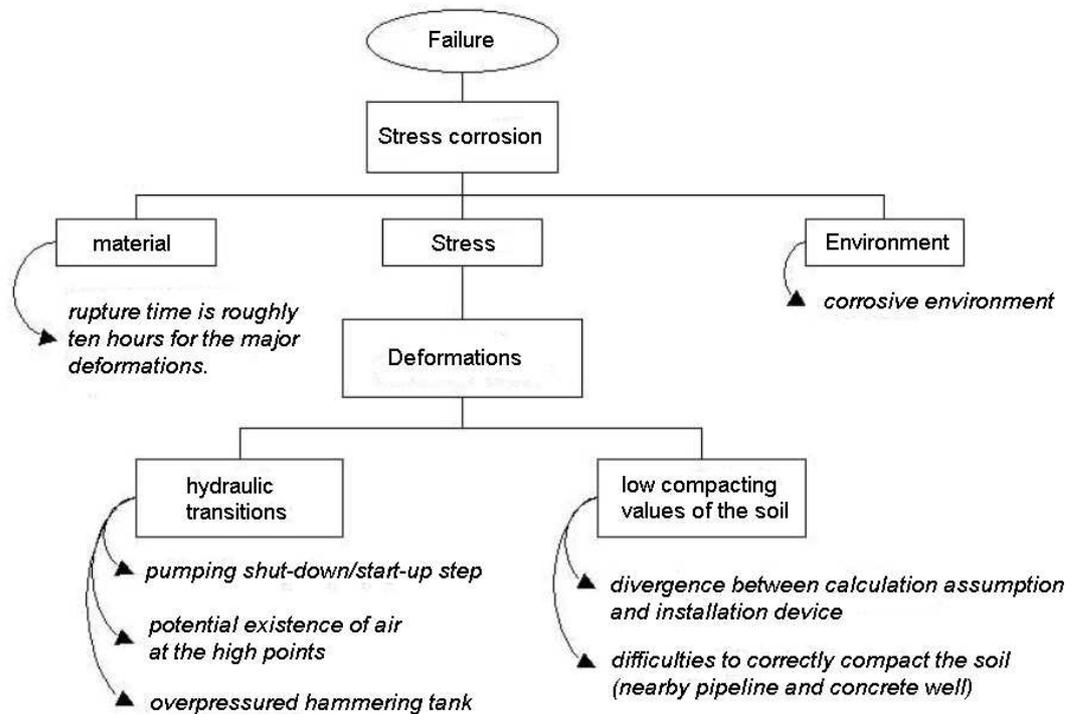
In summary, the safe-T-tree of the incidents that occurred on the pipeline in August 2002 is as follows:

The failures occurred near or at high points and near a change in direction, which confirms the role played by hydraulic transitions. Certain failures occurred in a zone where it was difficult to correctly compact the soil (nearby pipeline and concrete well). Finally, the majority of the failures (6 out of 8) occurred in the first two kilometres, i.e. in the zone where hydraulic stresses are greatest.
