Cyclohexane leak in a chemical plant

December 16, 2002

Chalampé (68 – Haut Rhin)

Chemical plant

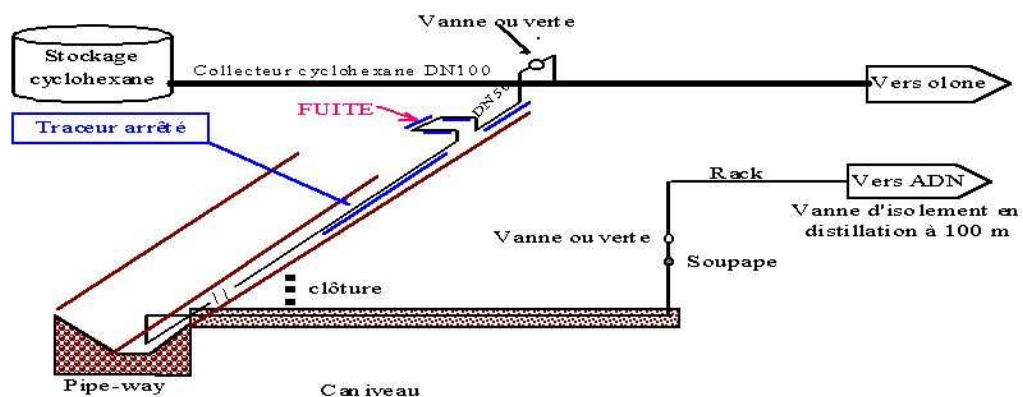
The 10,000-m³ cyclohexane storage tank (B10000) is connected to the OLONE production shop (a mixture of cyclohexanol and cyclohexanone produced from cyclohexane) via a ND100 mm pipeline. A ND50 mm manifold connected to this pipe supplies the adiponitrile (ADN) production facility. This ND50 mm manifold is routed in a pipeway (a group pipes that are half-buried in a trench dug in the ground featuring intermediate mounds of earth) and features an expansion loop located above the other pipes in the pipeway, a manual valve at each end, a valve and heat lagging equipped with steam tracing to maintain the cyclohexane in liquid form (melting point of cyclohexane = 6.47°C).

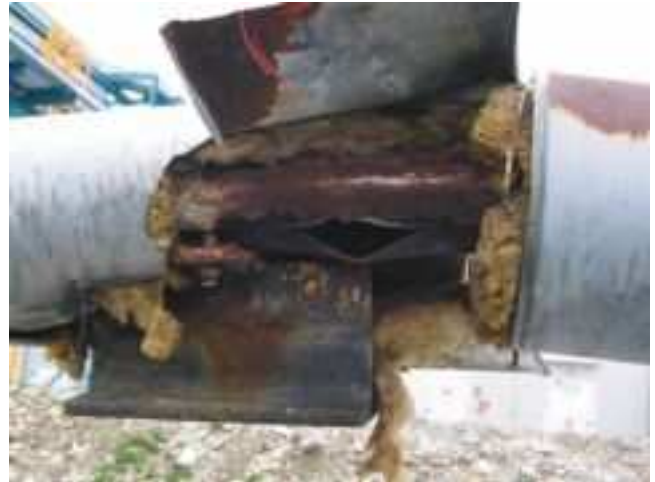
On December 16, 2002 at around 9.00 am, the OLONE shop's shift personnel noted an incorrect supply of cyclohexane. The filters were changed, the pumps checked and the ND100 mm pipe visually inspected and the ADN shop was queried. The next day, the disturbances continued and a visual inspection of the ND50 mm manifold was organised. The cyclohexane leak was located by its odour: the leak occurred on the expansion loop of the DN50 mm manifold that supplies the ADN shop.

The steam tracing, controlled by a valve, had been turned "off" for an unknown length of time and for an unknown reason. It no longer maintained the cyclohexane in liquid form.

In early December 2002, freezing temperatures caused the cyclohexane to solidify in the manifold. As the temperature varied greatly over the weekend of December 15-16, and owing to the play of the expansion and the retraction of the cyclohexane in the manifold, the manifold broke near the expansion loop (an oblong hole approximately the size of the

palm of your hand), which was the part the most exposed to temperature variations due to its shape and raised position in relation to the pipeway.

- ✓ On the leaking cyclohexane manifold:
 - ✗ Installation of output measurements on all cyclohexane lines with remote reporting in the OLONE control room (material assessment display equipped with an alarm system),
 - ✗ Preparation of a procedure in case the line is not used (closure of the inlet valve, drainage);
 - ✗ Annual inspection of the steam tracing;
 - ✗ Regular verification of the status of pipeway lines;
 - ✗ Taking into account of the hypothesis of a leak whenever an anomaly is detected (information for the personnel + instruction).
- ✓ On the site's other transfer dangerous fluid transfer lines:
 - ✗ A procedure for sharing responsibilities between the site's various units;
 - ✗ 67 scheduled modifications on the dangerous fluid transfer lines;
 - ✗ Definition of inspection and servicing of the tracings.
