Release of a chlorine gas cloud in a chemical plant

January 12, 2003

**Saint Auban – [Alpes de Haute-Provence]
France**

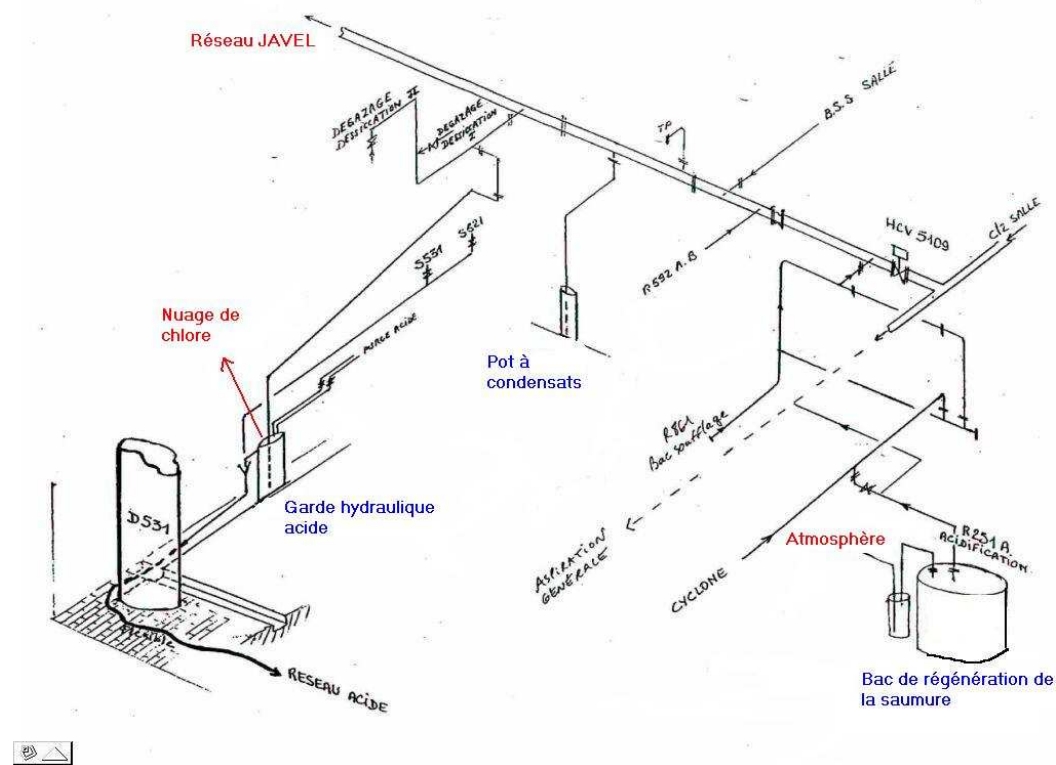
The accident was caused by an unexpected influx of air into the tank used to regenerate the brine coming from the mercury electrolysis cells. This influx of air, resulting from an insufficient water level in the liquid seal protecting the tank, lead to pressure fluctuations in the installation and triggered a high pressure alarm in the tank. The excess pressure lead to the regeneration unit being secured and particularly the automatic connection of the tank valve on the javel water network collecting all of the residual chlorinated gaseous effluents (see diagram below).

One hour after the first incident, an increase in pressure on the chlorine manifolds connected to the electrolysis cells lead to a pressure drop, then the automatic shutdown of the cells, with a very significant amount of chlorinated water entering the javel water system. The start-up of the fans, enabling the rapid degassing of the electrolysis cells, caused a sudden peak flow in the network also disrupting the discharge of chlorinated condensates in the manifolds.

Furthermore, heavy condensation of the water vapour contained in the chlorinated effluents released in the javel water system, condensation associated with the temperature difference existing between the inside of the pipes and the workshop, promoted the formation of solid chlorine hydrate. As the formed hydrate deposited, it blocked the branch connection connecting the javel water network to a condensate collection drain, thus preventing it from fulfilling its function. The surplus of condensate, water + chlorine was thus evacuated via a liquid seal located in the drying facility and containing 98% sulphuric acid (H₂SO₄). The water/acid exothermic mixture promoted the vaporisation of the residual chlorine that spread through the workshop and the surrounding area.

The malfunction of the liquid seal, protecting the brine regeneration tank, was repaired only a month later after the incident happened again, although this time without consequence. The operator will now ensure that it is supplied on a permanent basis.

The branch connection on the condensate tank and the associated pipework was cleaned.

The seal pot containing sulphuric acid, rendered unnecessary by a previous modification, was removed.
