Accidental spillage of a reaction mixture in a busy area

March 4, 2003

**Clamecy – [Nièvre]
France**

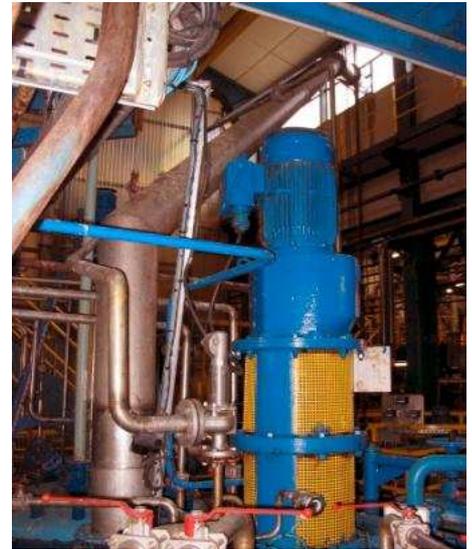
5.40 am: the newly replaced graphite burst diaphragm, calibrated at 3 bar, ruptured; 5,000 litres of reaction mixture (soluble alkaline sulfone) was projected outward and spilled into the 200 m² storage zone protected by retaining catchpit.

*Upper part of the reactor: mixer and burst disk discharge line
(source: DRIRE Bourgogne)*

As a result, the operator maintains that the probable cause of the accident was a burst diaphragm that was calibrated too close to the reaction's service pressure resulting in its rupture by fatigue.

- High-pressure alarm with a threshold at 3 bar.
- Exhaust valve calibrated at 3.5 bar.
- Burst diaphragm calibrated at 4.8 bar maximum at 140 °C.
- Discharge of the burst diaphragm's discharge conduit directed temporarily to a hermetic zone that is not frequently used.

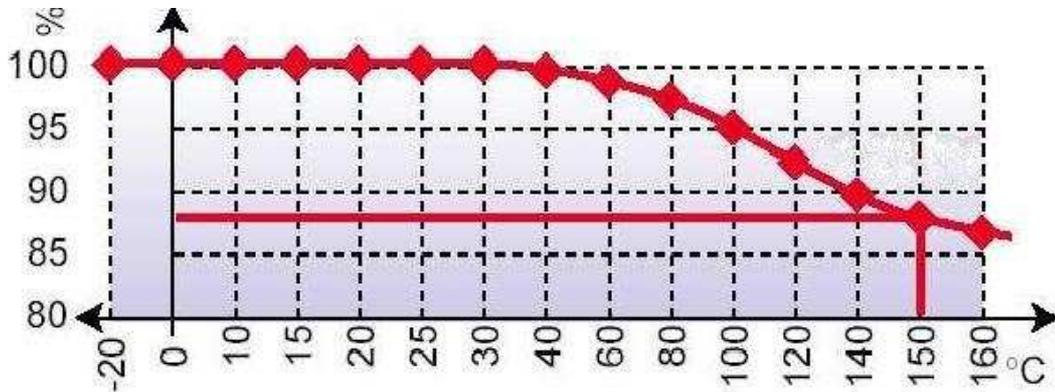
- ✓ **Temperature 140 °C**. According to a chart published by the diaphragm's manufacturer, the burst pressure at 140 °C is equal to 90% of the nominal pressure given for 20 °C.

- ✓ **Manufacturing tolerance +/- 10%**: this tolerance generally varies between 3 and 10% depending on the nature and the price of the diaphragm.
- ✓ **Fatigue coefficient 85% of the minimum bursting pressure**. On a batch process, a diaphragm is subjected to repetitive stresses that weaken it. The fatigue coefficient or service rate enables this phenomenon to be taken into account. It can vary from 70 to nearly 100% depending on the type of diaphragm.

Thus on the incriminated diaphragm, the **nominal burst pressure of 3 bar at 20 °C** is no more than 2.7 bar at 140 °C with a tolerance of +/- 10%. In the unfavourable case, the burst pressure of the new diaphragm is thus 2.43 bar. After being commissioned, however, and subject to fatigue, **the diaphragm may rupture beyond a pressure in the reactor equal to 2.07 bar**.
