Explosion in a dynamite loading workshop

March 27, 2003

Billy-Berclau – [Pas-de-Calais]

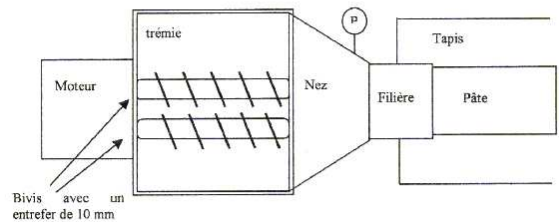
Figure 2 : Vue longitudinale de l'alimentateur de la Rollex 50

An examination of the parts shows that the initial explosion took place in the Rollex feeder, then propagated to other explosives present in the workshop. The explosion could have been caused by the presence of a foreign object in the feeder that may have become caught between the extruder screw and the steel housing. According to the expert appointed by the Inspectorate, the special sensitivity of the dynamite cannot be excluded even if tests conducted on the explosives manufactured at the time of the accident show no signs of anomaly.

- ✓ Modify or remove the die of the feeders.
- ✓ Ensure that the protective housings on the ROLLEX machines are adequate.
- ✓ Limit feeder dimensions.
- ✓ Make the feeders out of a composite material.

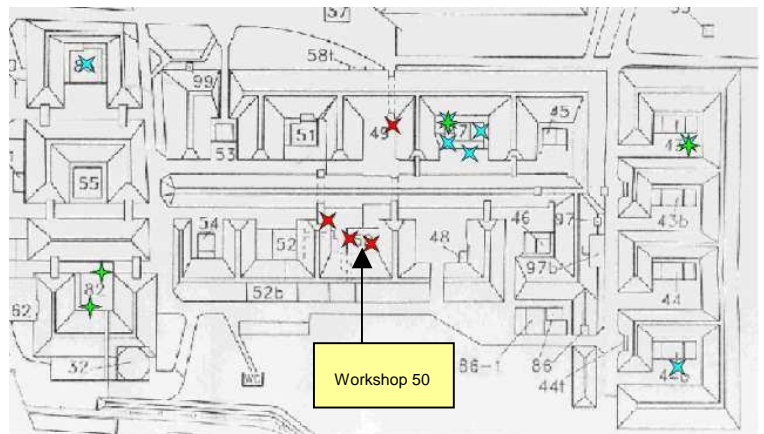
At the alleged time of the explosion, 4 employees were in the shop or in the immediate vicinity: the machine operators, an individual in charge of collecting waste and a mechanic who was passing in front of the shop near the tunnel. All 4 died in the accident

In the diagram opposite, the individuals who died are indicated in red, and the injured in blue and green.

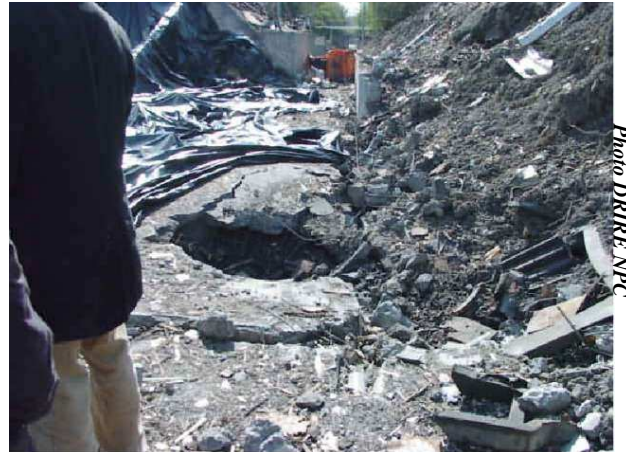
- ✓ One near the passageway between workshops 50 and 48 (1m x 1.30 m and 0.60 m deep) in the location where 2 dynamite bins were positioned, according to witnesses,
- ✓ The other near the feeder itself (0.80 m in diameter x 0.20 m, the floor consisting of a 15 to 20 cm concrete slab then backfill).

Crater at the location of the machine

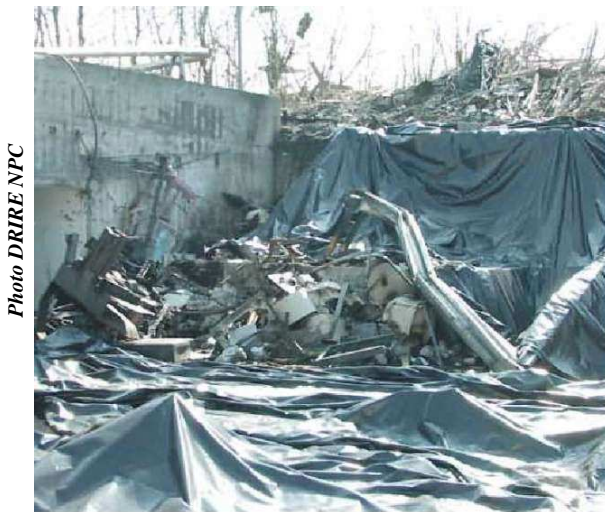
What's left of the machine

Parts of the cartridge machine were found in a radius of 600 m. According to the expert appointed by the Inspectorate, considering the resulting damage, it is difficult to accurately quantify the amount of charge involved: it could be in the neighbourhood of an equivalent of approximately one hundred kg of TNT, although less than an equivalent of 300 kg of TNT.

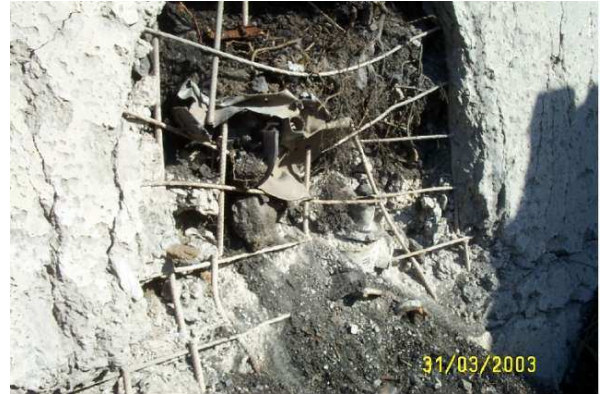
Machine impact in concrete wall
