## Explosion and fire of a reactor in a chemical plant

April 17, 2003

**Oudalle – [Seine-Maritime]  
France**

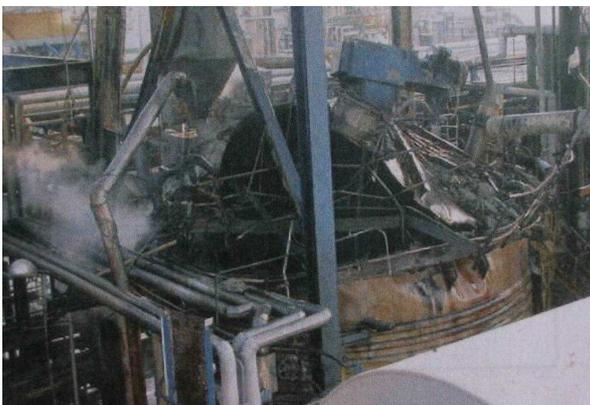
The explosion resulted in very localised property damage. The effects were observed up to twenty metres from the accident (projectiles and broken glass). The reactor had opened up (see photo) despite the overpressure protection device installed.

View of the damaged reactor from above

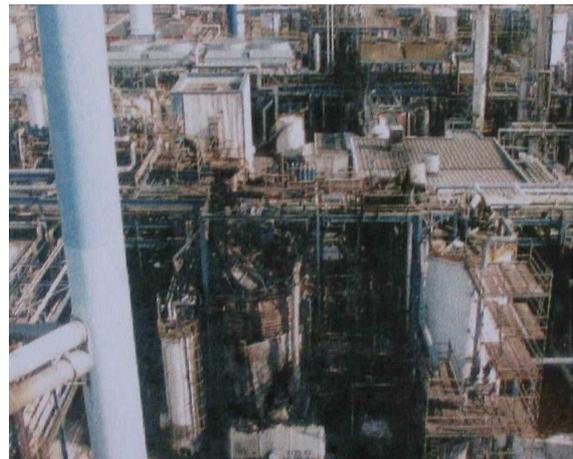
Overall view of the reactor

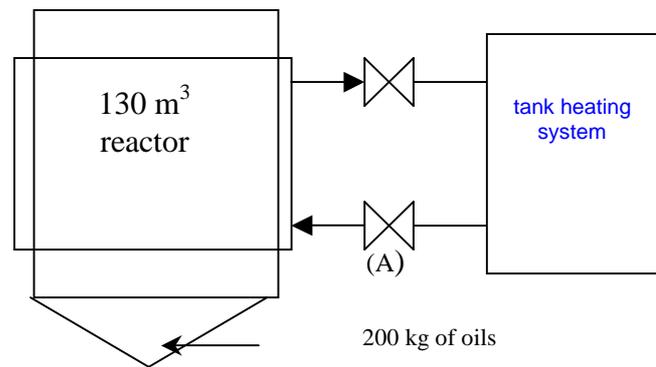
- temperature rise tests were being conducted on the reactor's heating system,
- the reactor was not disconnected from the heating system. The inlet valve (A) on the reactor's heating coil remained open,

- the atmospheric temperature of the reactor thus increased and caused the mineral oils in the bottom of the reactor to evaporate and decompose,
- the unit's monitoring parameters were reported in the control room although no specific action was taken by the operators as the unit was shut down and the production personnel did not consider that the unit presented any danger, a priori.
