Explosion in a cartridges-filling workshop

July, the 30th, 2002

Burbach-Wurgendorf

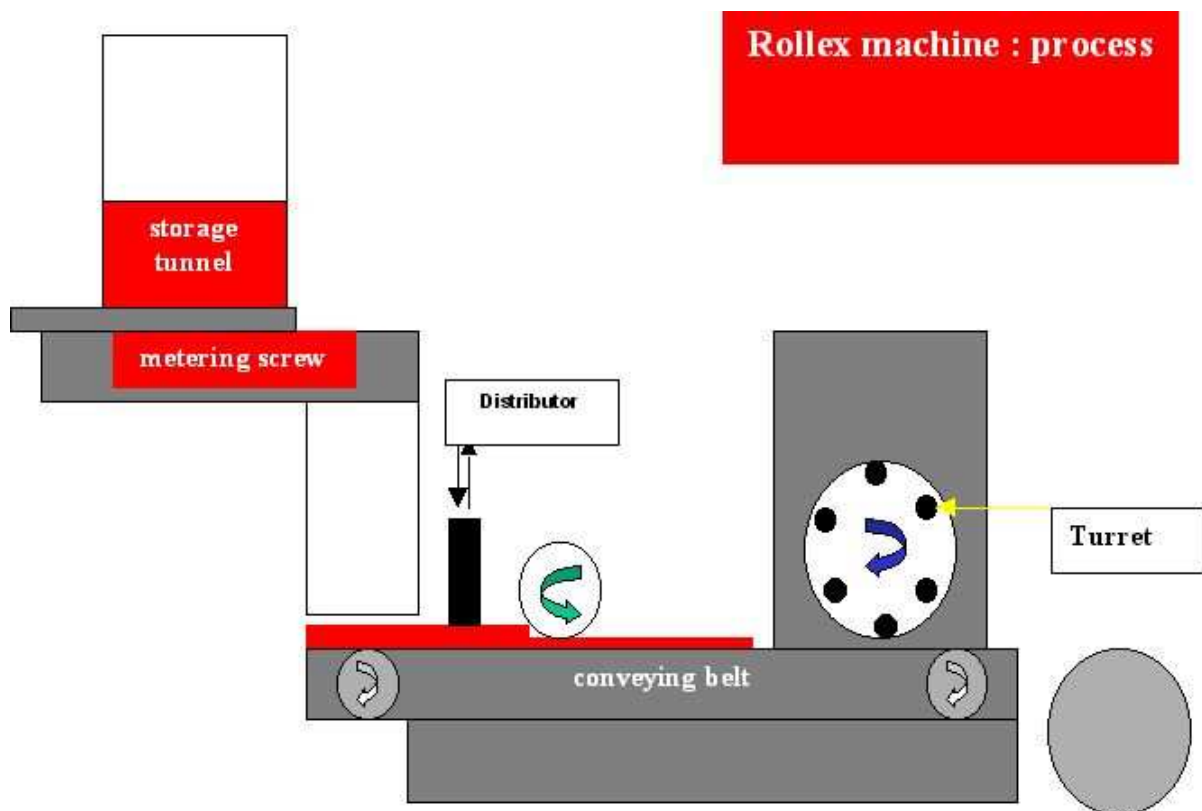
Schema : R. D.

The cartridges are produced by using a "Rollex-Machine". The explosive (25 – 30 % ethylene glycol dinitrate, 60 – 70 % ammonium nitrate and < 2 % collodion wool) for a batch reaches the feeding hopper of the Rollex-Machine. Several explosion interruption devices are installed to prevent any propagation of explosions. From the hopper the explosive is metered to a conveying belt where it is distributed and drawn-out to a fleece. A portion of about 0,4 kg is pressed into a cell of the Rollex-Machine and rolled up with paraffined wrapping paper. After closing at both front sides the cartridge is thrown to a conveying belt. Rolling up and closing of the cartridges take place in the turrets of the Rollex-Machine.

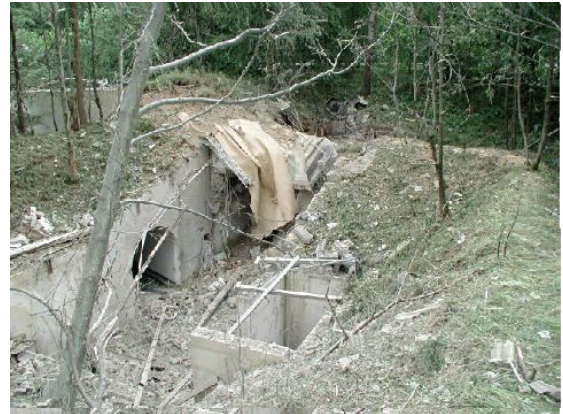
Photo : R. D.

On July, the 30th, 2002, at 12:35 h, the accident took place in the building where the Rollex-Machine was placed. About 90 kg explosives were involved. In the moment of explosion only one employee was working at the machine.

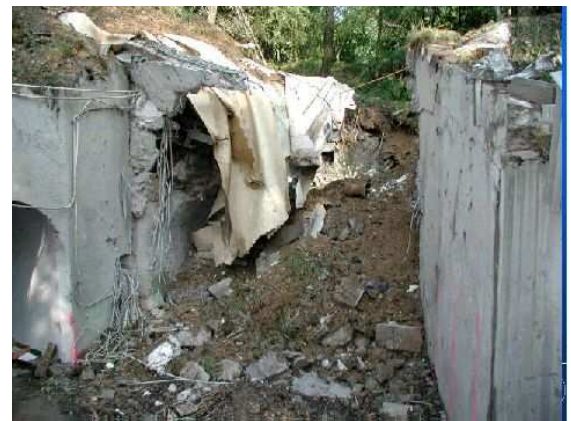
Photo : R. D.

One employee surveying the process was killed: The body was found in a distance of 20 m from the place of explosion, his arms were ripped off and the body showed heavy injuries at his back as well as various fractures.

Additionally, the accident led to heavy damages by blasting debris and overpressure up to a distance of 120 m from the place of explosion.

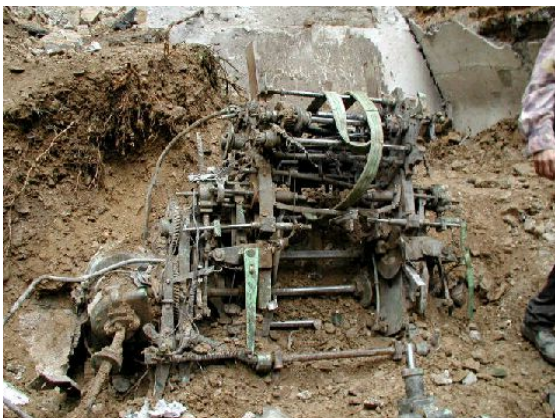
Photo : R. D.

- ✓ The ceiling of the building was completely demolished
- ✓ The Rollex-Machine was encumbered by earth
- ✓ Building fragments were being distributed within a radius of about 20 to 30 m.
- ✓ Some fragments were thrown to a distance of 150 m.
- ✓ Other fragments of the Rollex-Machine were found inside the destroyed building and in a distance of about 15 m from the place of explosion.
- ✓ The estimated cost of damages is about 0,5 Millions of euros.
