Leaks of hydrogen cyanide in a unit producing acrylonitril.

October 1999, the 14th, December 2000, the 6th and April 2001 .

Sittard-Geleen-Born
The Netherlands

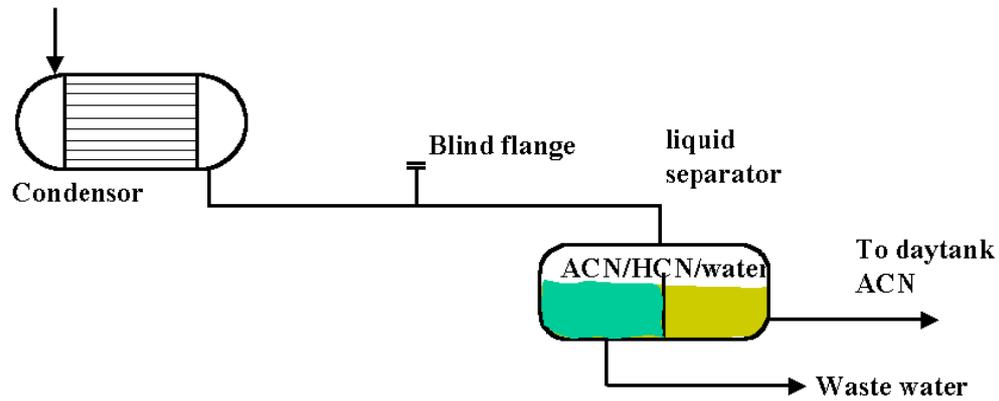
A leak occurred in the part of the process whose normal operating conditions are 30 – 40°C and nearly atmospheric pressure. It took place in a pipe between a condensor and a liquid separator, as mentioned on the diagram here-under. About 4 000 l of liquid were emitted containing about 200 kg of hydrogen cyanide. At one point, the pipe involved contained stump, which should be closed with a blind-flange. However, it appeared that the blind-flange was not present and that the stump was ruptured.

In hindsight, it is expected that this situation was present during at least 1 week before the accident. Moreover, probably the stump was plugged due to polymerised product. However, due to a high level in the crude product storage tank and the omission of opening a proper release valve, an overpressure took place. This caused the loss of process fluid.

The ruptured pipe was replaced and the same pipe in the other ACN-plant was inspected. At that time, no deviations were detected in the other plants so the ACN-plants were restarted.

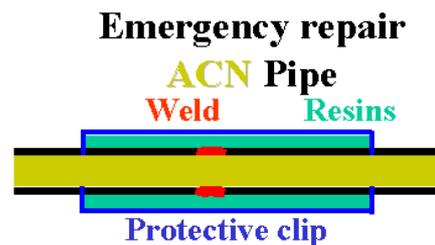
For the control, an emergency repair as shown on the drawing was found. Normally, such repair is a temporary measure but this one was carried in 1994.

It was reasonable to expect that during the next maintenance stop (1996), the pipe would be properly repaired.

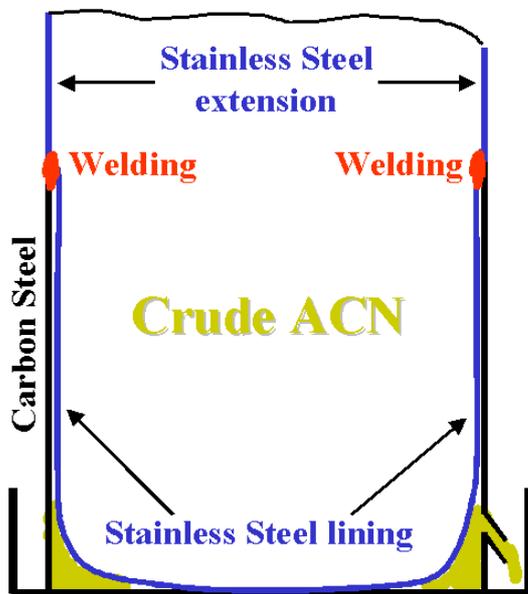
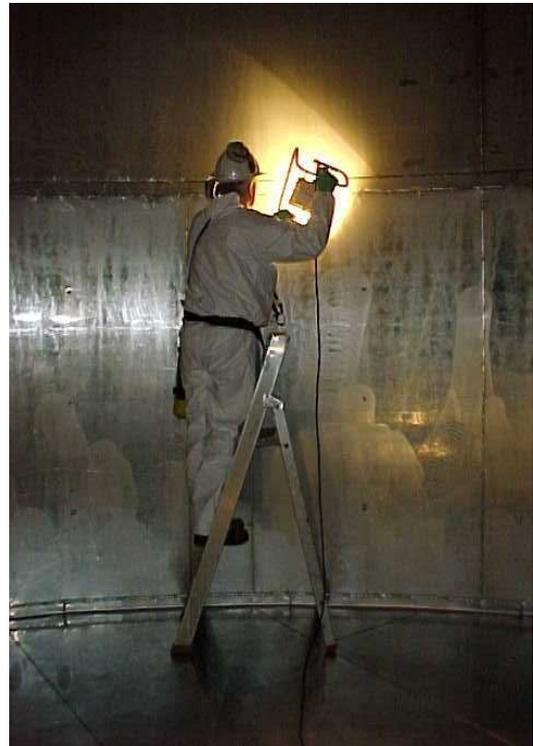
From a carbon steel storage tank with a stainless steel lining, a leakage of about 600 l of crude product took place. Fortunately, the tank was located in a liquid tight tray.

The product contained 10% hydrogen cyanide. The leakage from the tank was caused by a ruptured weld in the stainless steel inner tank lining. This lining had been constructed in 1974, after a leakage due to cyanide stress corrosion. On the drawing, it is possible to see that the upper side extension of the tank was made of stainless steel.

The lining was 2 meter high.

Due to the rupture, the crude product was able to attack the carbon steel material of the tank. Because there was an opening to the environment at the bottom of the tank, the incident was immediately observed.

After investigations, it seems that also in this case, stress corrosion was the probably cause. The operator explained that this lining was made as a low-cost investment.

After this incident, the operator exchanged this tank with a tank completely made of stainless steel. A comparable other storage tank will be replaced in due time..

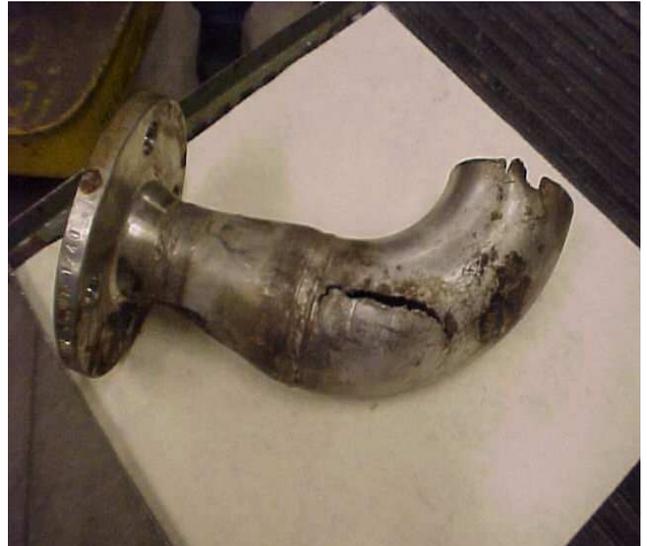
During the start-up after the maintenance stop, a regular water run was carried out for about 2 h. This means that the equipment is filled with water to test the tightness of the equipment. A stainless steel pipe showed an unwanted leakage. Since no toxic process fluid was present, this incident needed not to be reported to the authorities. Nevertheless, the company informed the local authority and the Mayors of the surrounding villages. This incident was also investigated.

Because stainless steel is susceptible for chloride stress corrosion, and chloride is present in the isolation material around the pipes, initially the occurrence of this kind of corrosion was investigated. A large number of spots in various stainless steel pipes were analysed. These results excluded chloride stress corrosion as a possible cause. Further investigations showed that the stress corrosion occurred at the place where frequently the installations are cleaned with caustic soda solution. Because of the polymerised product, the installation must be cleaned frequently. Again, the Public Prosecutor doubted the integrity. Because of the safety risks in this case, the local authority asked again a new assessment to TNO: It agreed that the most probable cause was caustic stress corrosion. Thus, the stainless pipe was replaced.

As an extra safety precaution, the operator was forced to test the equipment tightness by filling the system with water and nitrogen, applying the maximum process pressure for 24h. These tests were carried out under supervision of the local authority and TNO. Since no leakage was detected, the operator received permission to restart the production of ACN again.

As needed measures, the replacement of all carbon steel pipes was ordered before January, the 1st, 2002. Also, the enhancement of the gas detection system should be carried out in this period. Total repair of the outside corrosion should be ready before 2004.
