## Chlorine leak in a liquefaction workshop of a chemical plant

January 13, 2004

Vieux-Thann – [Haut Rhin]  
France

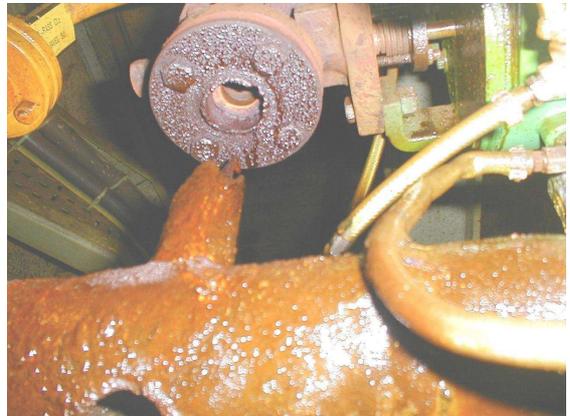
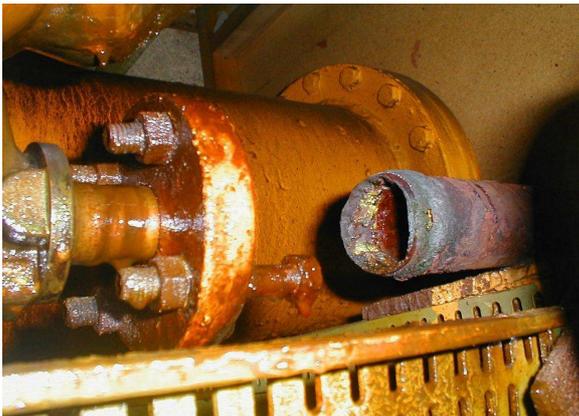
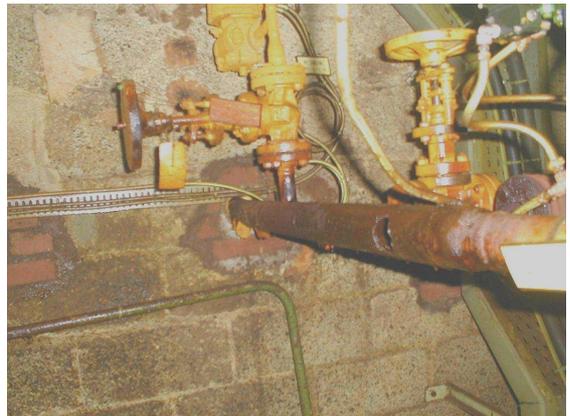
The expert assessment conducted immediately following the incident showed that the leak, located along the limit of the confined zone, resulted from the combustion of the steel in the chlorine on a pipe transporting the gaseous chlorine: at two locations (located near zones in which the pipe size was reduced: valve and venturi), the pipe had disappeared over several centimetres, including a flange. A hole of diameter equal to that of the pipe (8 cm) was created in a third location.

The combustion of steel in chlorine is a process that is initiated when the steel is brought to a temperature above 130 °C. Once this reaction begins, it is self-sustaining until all the chlorine has been consumed.

The operator identified the cause of the iron/chlorine combustion process as a hydrogen-chlorine fire whose ignition energy is sufficiently low to start spontaneously due to an output restriction or a significant flow rate. The increase in the output to 1,000 kg/h could have also supplied the ignition energy required.

Besides the verification of the installations and the replacement of damaged parts, several actions were implemented to prevent the incident from happening again:

- A material assessment was set up to monitor the hydrogen concentration in the residual gases according to the liquefaction rate and the hydrogen content at the electrolysis facility's outlet.
- Implementation of two continuous hydrogen analysers that can be used in the presence of inert gases (cost: 150,000 euros).
- Supervision of start-up phases by a manager.
- Modification of the instructions.
- Re-examination of post-accident actions.
- The installations are shut down if the hydrogen concentration is exceeded by more than 3.5%.
