## Vinyl chloride leak in a chemical plant

February 3, 2004

**TAVAUX (Jura - 39), France**

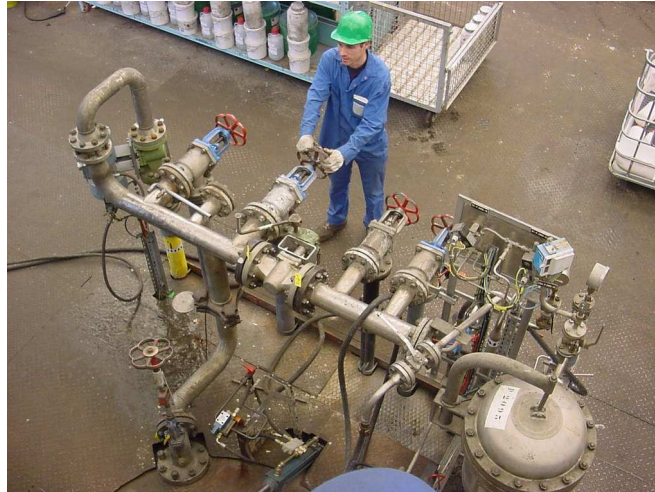
The part of the installation concerned, which dates back to 1969, consists of a set of thirteen 27m<sup>3</sup> autoclaves in which the polymerisation process is carried out according to a discontinuous "batch" process. This process requires that they be opened between 2 polymerisation operations. The installation is only slightly automated, notably in terms of the autoclave filling, drainage and cleanup processes. The accident took place between one of the VCM inlet/outlet pipes:

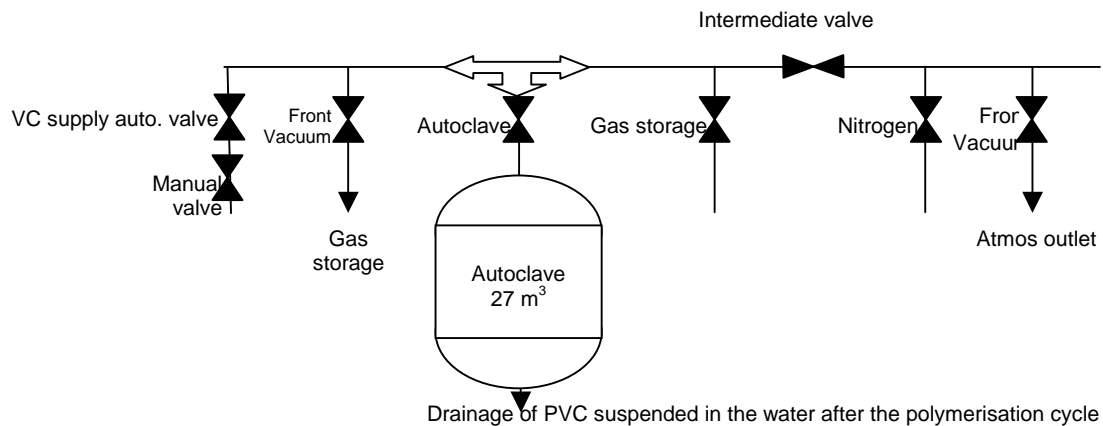
The system can be represented by the simplified diagram below:

Comment: The intermediate valve isolates the autoclave from any circuit not intended to convey VCM.

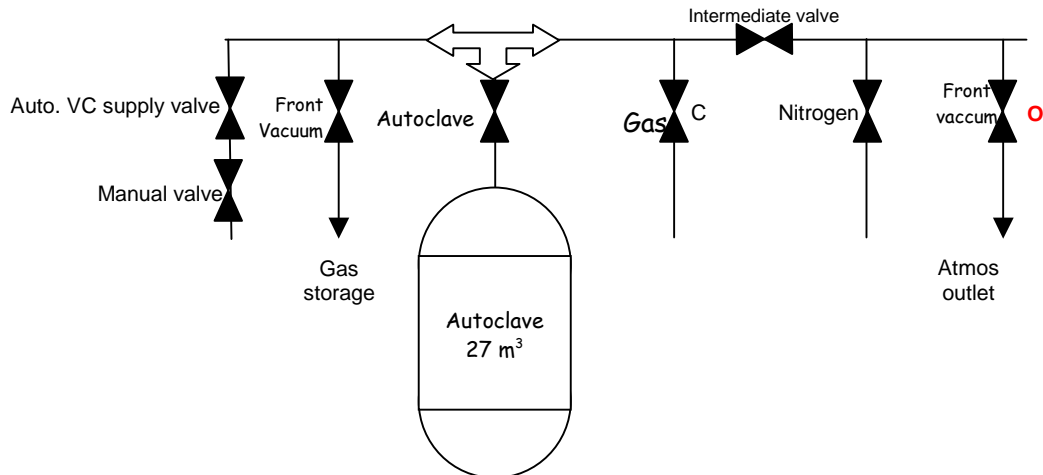
There is thus no instrumentation on the shut-off valves of the other systems (Front Vacuum, Back Vacuum, Gas storage, nitrogen, ...) that is taken into consideration in the VCM loading sequence. There are procedures to check the position of these valves prior to the VCM filling operation. These procedures require that the operator allow the automatic VCM filling valve to be controlled by the PLC. However, the interruption of the operator intervening on autoclave No. 13 caused the sequence of the preliminary manoeuvres of autoclave No. 11 to be lost and authorised the operation when the employee returned even though the "intermediate" manual valve and the "Front Vacuum" valve were not closed.

The diagram below shows the set of shut-off valves and their position at this moment:

Causes identified:

- Cause No. 1: poorly qualified preliminary manoeuvres prior to VCM supply authorisation,
- Cause No. 2: permanent monitoring fault of the "Front Vacuum" network.

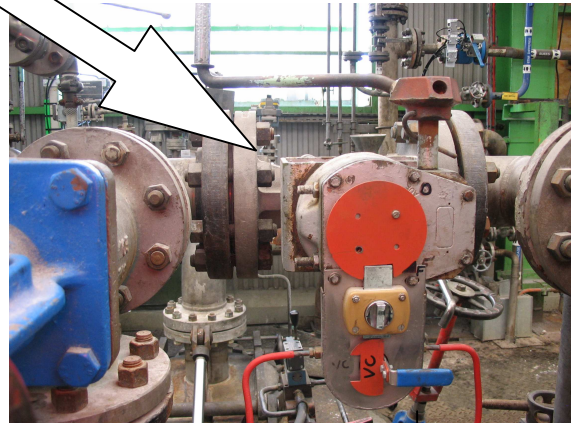
VCM filling authorised

Valve allowing the pneumatic supply of the automatic valve of completion of CVM
