## Leaks of fuel oil and pollution of waterway /

## Pollution of the site

22 August and 13 December, 2002

**Brussels – [Brabant]**

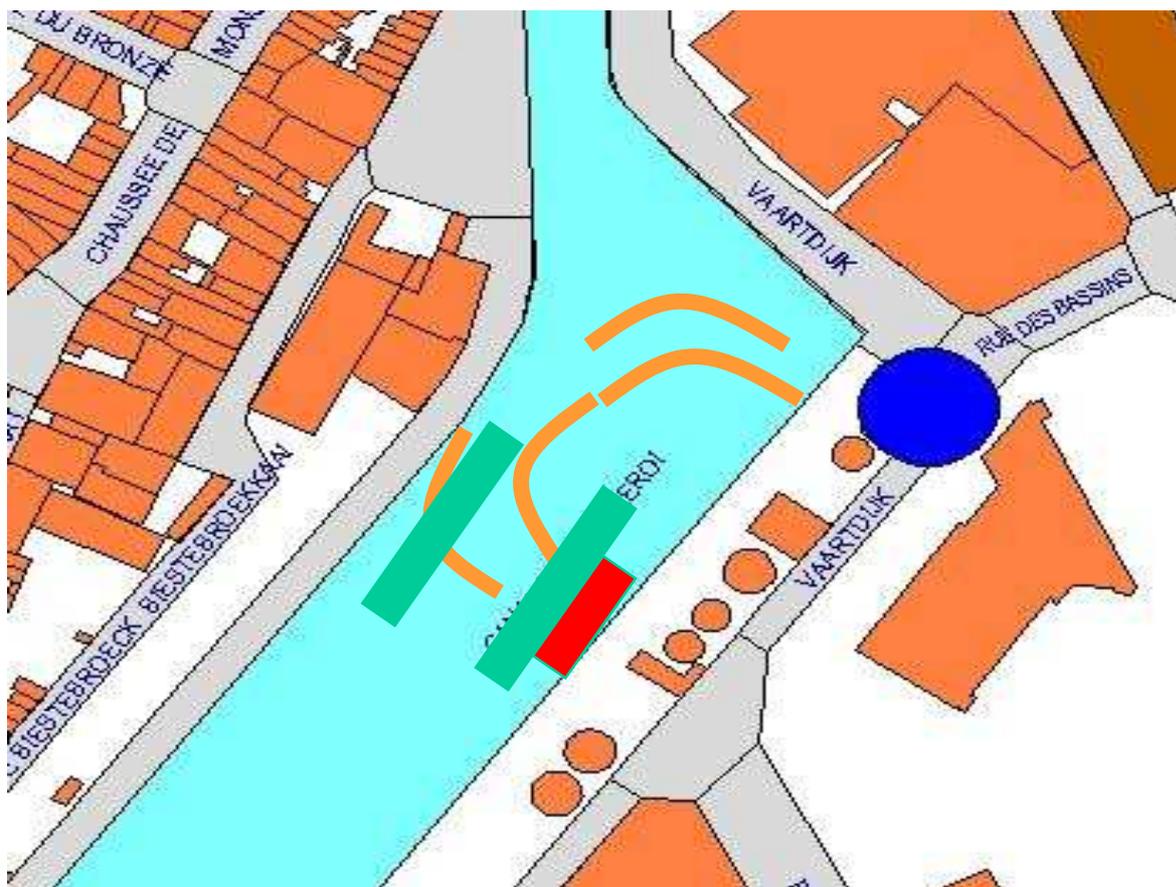
The release involves the « Georges » which is unloading. The schema below shows the general configuration of the site: the boat is the red rectangle on the schema.

As soon as the leak was noticed, the « Marguerite » (boat in green), moved next to the « Georges » in an attempt to contain the spill, but the wind and the current were working against them. The firefighters put two floating dams to prevent further spreading of the spill. Since they did not have the equipment to pump the fuel oil out of the water, they called for the Civil Protection.

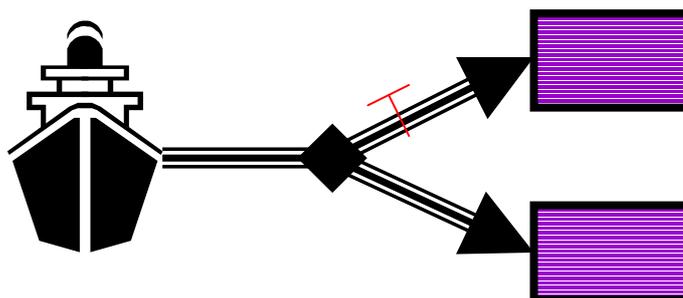
In this case, normally, the boat starts to unload into the first tank. The capacity of the boat usually exceeds that of the tank. When the first tank is almost full, an alarm tells the site manager when it is time to make the switch and start filling the other tank.

This time, the boat was unloading into the tank normally but the operator was distracted by other duties on site and did not hear the timer go off. He did not make the switch and, therefore, the tank overflowed.

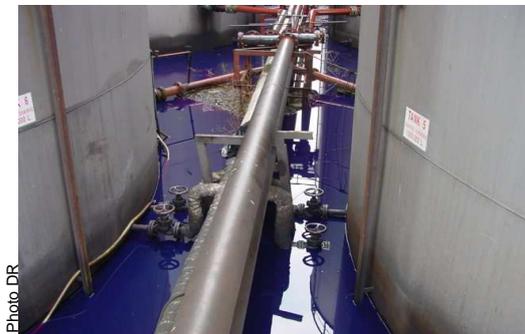
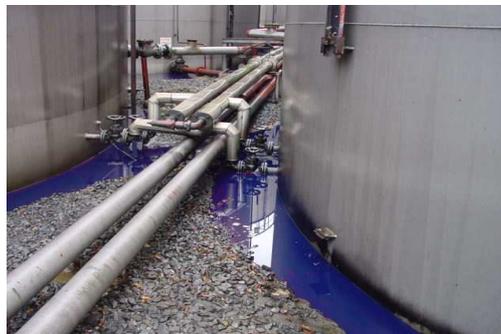
When the inspection arrived on site, the firefighters and the agents from the Harbour of Brussels had already left. The accident was thought to be confined within the walls surrounding the tanks, so, according to them, there was no threat for the environment outside of the company site.

Seeing how close the walls were to the tanks, the inspectors decided to pursue their investigations a little further.

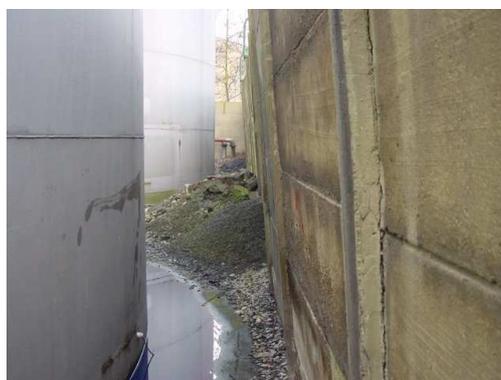
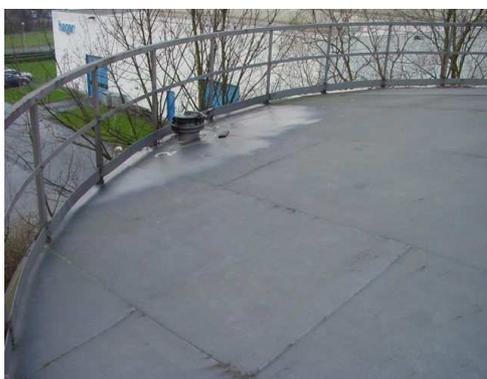
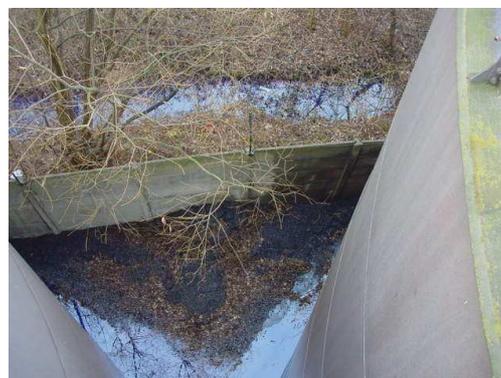
At the top of the tank that overflowed, the inspectors were able to see that the fuel oil overflowed over the containment walls. The walls themselves were not watertight either.

- ✓ Floating dams (2x perimeter of the largest barge)
- ✓ Absorbing products at hand
- ✓ Bilingual instructions concerning loading procedures.
- ✓ Safety pictograms and identification of the pipes
- ✓ Watertightness of the feeding area pit and setting up of a connection from it toward a hydrocarbon separator.
- ✓ Setting up of a non-overflowing device on each tank.
- ✓ Replacement of the damaged pit, in compliance with safety distances.
- ✓ Setting up of anti-run-on valves
- ✓ Building of a new feeding pit area (connections with the barges)
- ✓ Radar detection implemented inside the tanks to check their level during feeding operations plus visual and auditory alarms in connection with these devices.

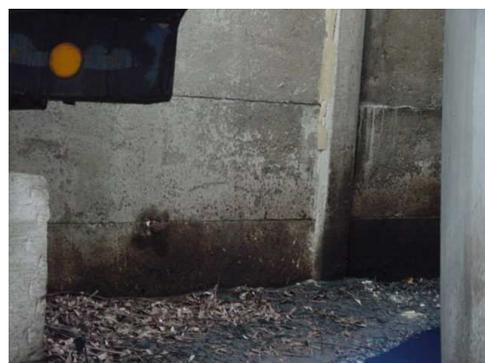
The quantity of fuel oil lost was estimated at 3 m<sup>3</sup> within the walls and 2 m<sup>3</sup> outside of the walls. It had been pumped and then eliminated by the company.

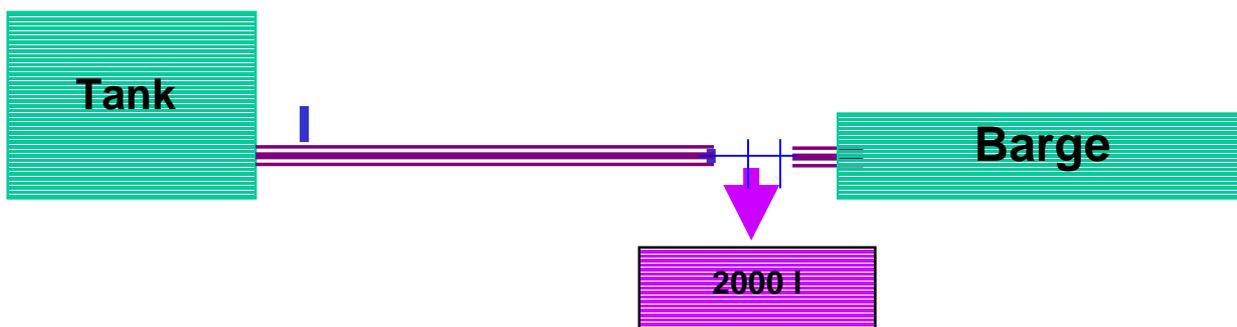
After filling a tank, it is standard procedure to push a little air inside the hose to empty its content into the tank. Then the boat has to notify the site manager so that he can turn off the valve on the tank, and the boat can uncouple its hose.

The « Georges » uncoupled its hose without prior communication with the site, assuming that the valve from the tank was already closed. The strong odour from the fuel oil rushing out of the tank alerted the sailor, but he could not close the valves in time.

Identified causes lay into the lack of clear indications on the procedures, which were not posted nearby, and the lack of communication for the loading operation.

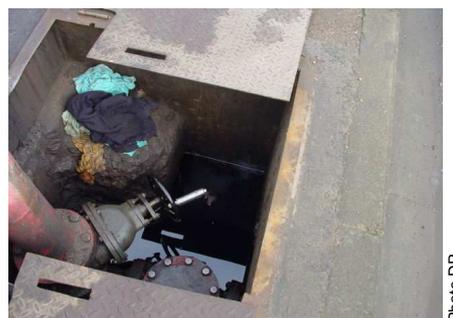
Indeed, apart from the fact that the tanks were very closed to the containment walls, the valves enabling the permutation of the tanks were located in rather deep peephole, so that the access was uncomfortable.
