Ignition of a wood dust cloud in a production unit

11 May 2004

Allouville-Bellefosse - [Seine-Maritime]
France

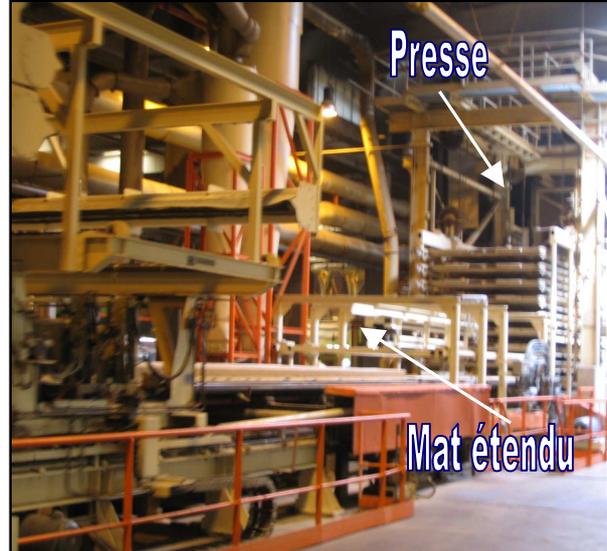
The eleven stages of the press, which measures 9.50 m by 5.50 m, were subjected to high temperature and pressure constraints. To compensate for any possible deformations of the end plates, the manufacturer had installed a heat transfer plate divided lengthwise into three control zones above and below the press.

When the press was modernised (i.e. upgraded from 8 to 11 stages), the last plate was very close to the heat transfer plate. For production reasons and throughout the entire start-up period (July 2002 to January 2003), plate temperature was decreased from 190-215°C to 170-190°C.

In January 2004, when the temperature of the plates was increased, and even when the central zone of the heat transfer plate was not heated, the temperature still reached 165°C. Ignition of the dust particles was a gain observed. These incidents were deemed of no major importance and thus not reported to the Hazardous Installations inspection authority. The company decided to cool the central zone instead of heating it. The plate was supplied with a coolant from a cold source. All the equipment (pumps, piping) was operational as of April and the temperature of the central zone was set at 140°C.

Forming line and press – Photo DRIRE

Thermal insulation has been placed on top of the press so as to insulate the hot surface from dust deposits. Fixed watering ramps have also been installed to enable cooling and extinction from the floor, without therefore having to use an aerial lift should a fire ignite above the press, which is not protected by the sprinkler network.

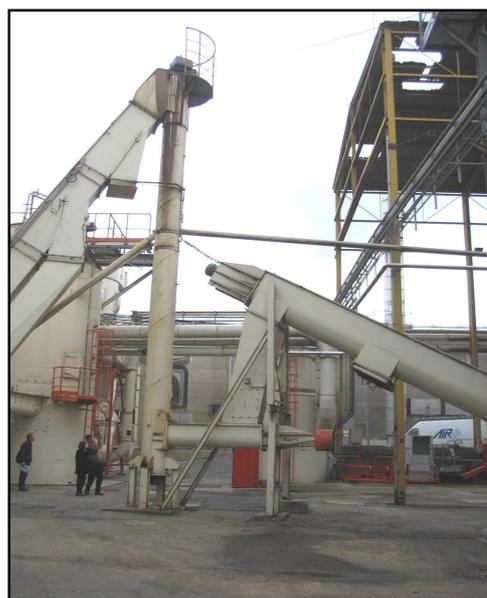
Mechanical transport system with screw-activated decoupling. Photo courtesy of: Dire

The study of hazards will serve to define a number of improvements, including moving the dust silos and resizing pressure vents. It has also placed emphasis on the risks introduced by facilities devoted to pneumatic sawdust transport devices, with preference given to a slow mechanical transport that allows instituting a decoupling system.

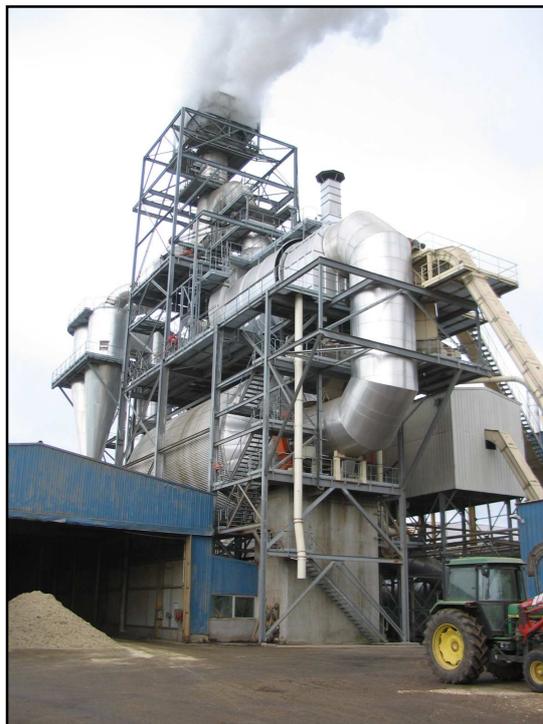
Dryer – Photo courtesy of: DRIRE
