Explosion of a fireworks fabrication and storage facility

June 01, 2004

Villeneuve sur Lot (Lot et Garonne)
France

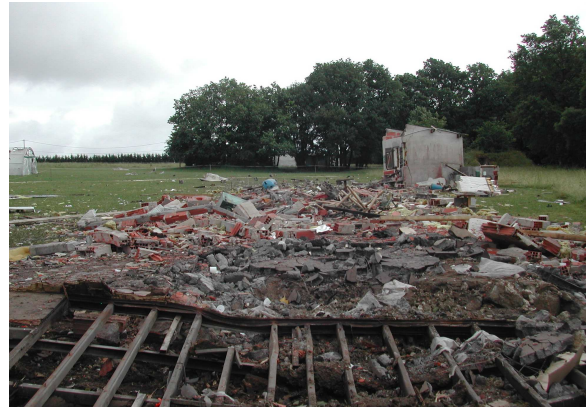
Building 9 was completely destroyed. All of the walls are blown down to floor level, including the 40 cm wall anchored into the ground which had separated the 2 rooms of building 9. In the shell storeroom (room 9A), there was a crater measuring 3 m x 1.5 m and more than 50 cm deep, near the outside wall.

The explosion caused significant damage to the neighbouring buildings due to overpressure and projections. Fourteen buildings were partially or totally destroyed (structure and roof), the roofs of three additional building were damaged and the window and doors of six other buildings significantly damaged.

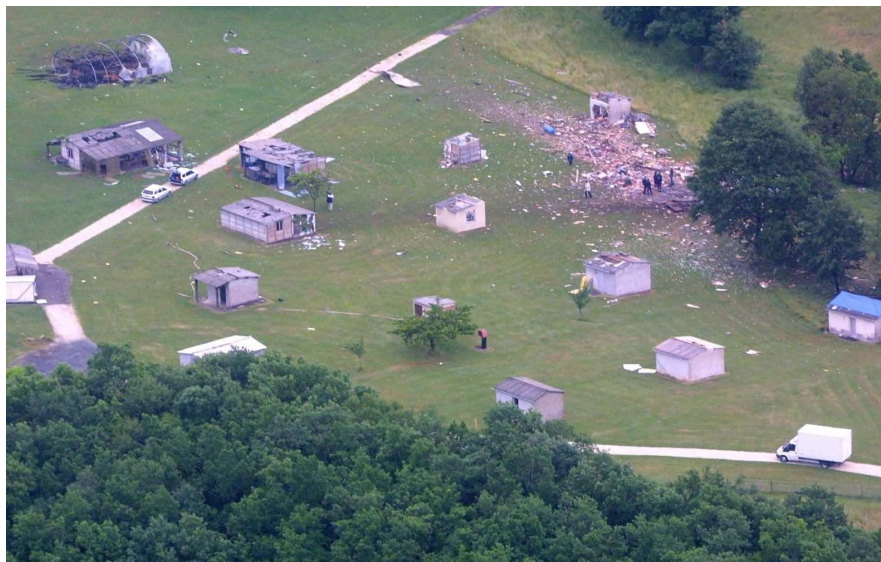
Debris was spread into four zones around building 9, in an elliptical shape. Each of the "pedals", which begin at the building's four walls, had an average length of 50 m. However, wall and roof debris was found up to 160 m away from the building.
