Propane leak on a sphere

June 14, 2004

Saint- Hervé [Côtes d'Armor]

Leak
LPG depot
Pressurised
equipment
Propane
Small branch
connection
Corrosion
Organisation

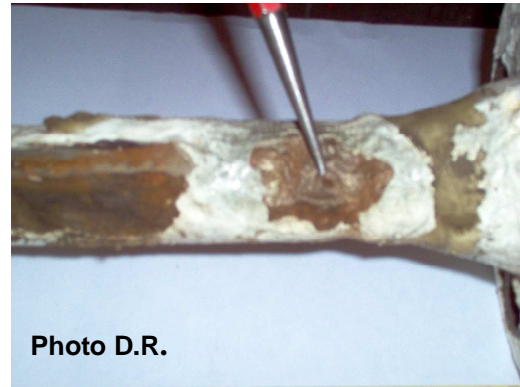
Photo D.R.

Following the incident, the operator requested that an expert assessment of the branch connection be conducted by an organisation specialised in metallurgy. The organisation's report concluded that a tube perforation occurred, measuring several mm, in the tube in the zone near the tube/flange junction weld (10 mm away). The perforation measured 3 mm longitudinally and was due to external corrosion associated with point where rainwater collected. The corrosion zone is a 50 mm plate oriented in the tube's longitudinal direction.

Material was lost on the external face of the tube indicating that the corrosion spread from the exterior toward the interior. Corrosion of the same type was observed on the tube's gusset weld although without perforation. The examinations performed show that the corrosion is cavernous and was initiated on the outside of the tube. Its propagation is isotropic in the structure.

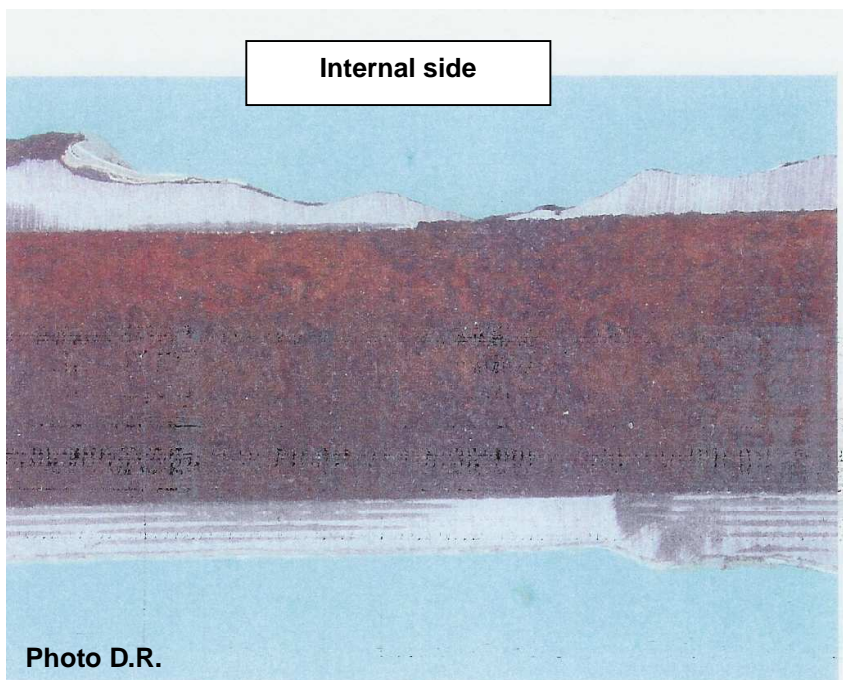
Photo D.R.

No structural or chemical composition anomaly can explain the type of corrosion. The hypothesis by default in this case is that of a rainwater retention point owing to the geometric configuration. A stagnant drop on the "ceiling" triggers a differential aeration mechanism, known as the "Evans drop", resulting in local acidification. This leads to "blistering" of the paint at this point and localised cavernous corrosion of the substrate.
