# Fire in a hydrodesulfuration unit of a refinery

June 26, 2004

Feyzin – [Rhône]

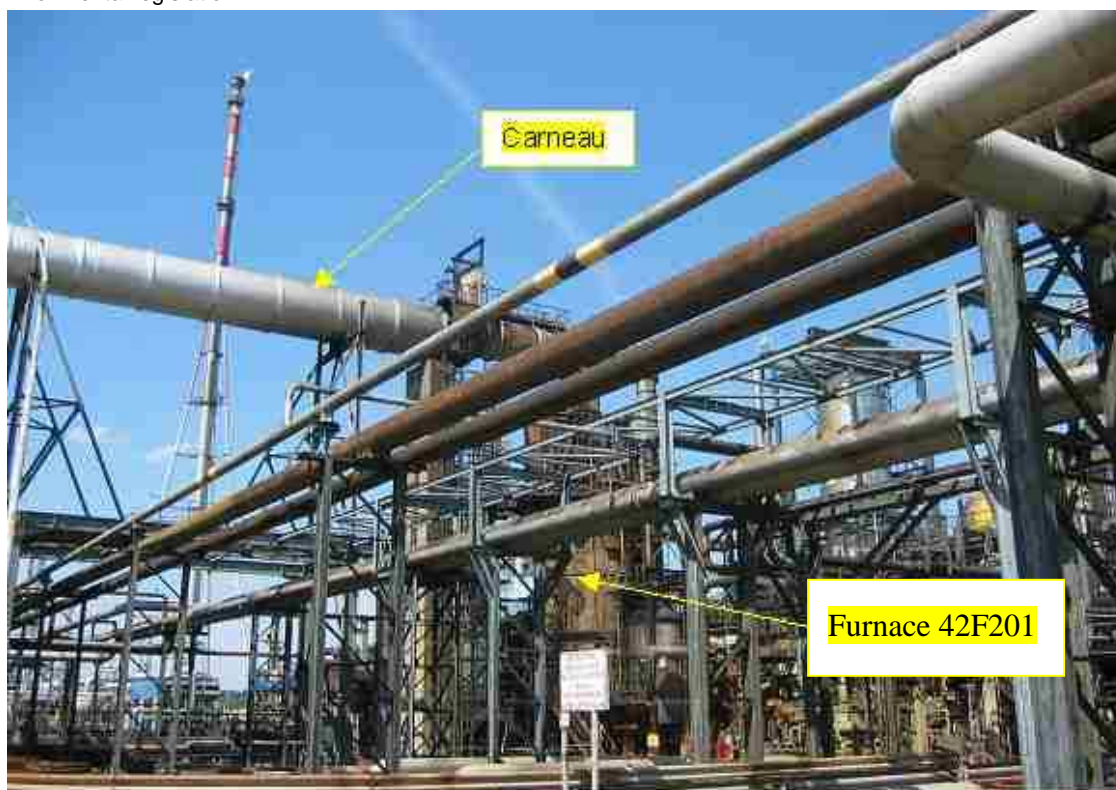
Overall view of the HDS unit (after the fire)

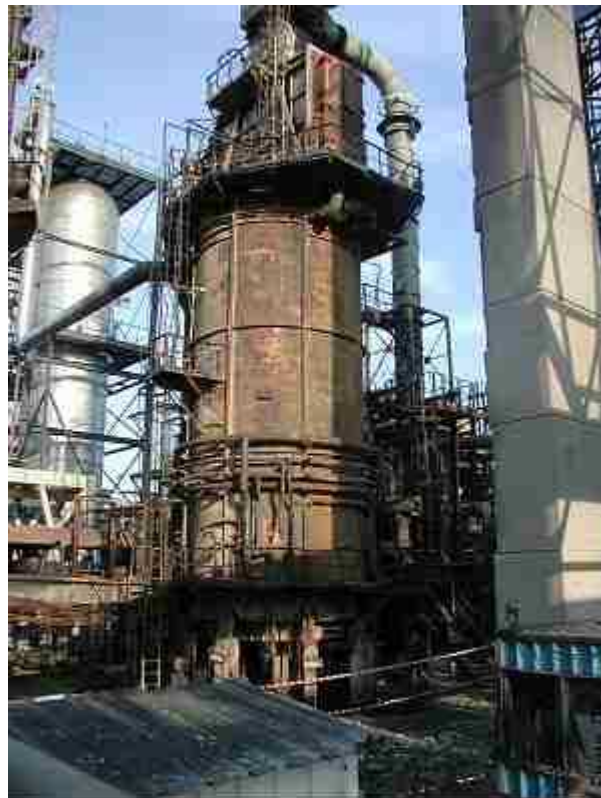
View of furnace 42F201 (after the fire)

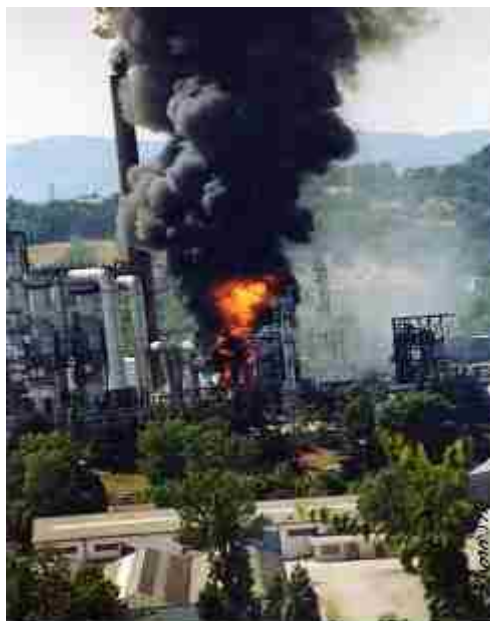
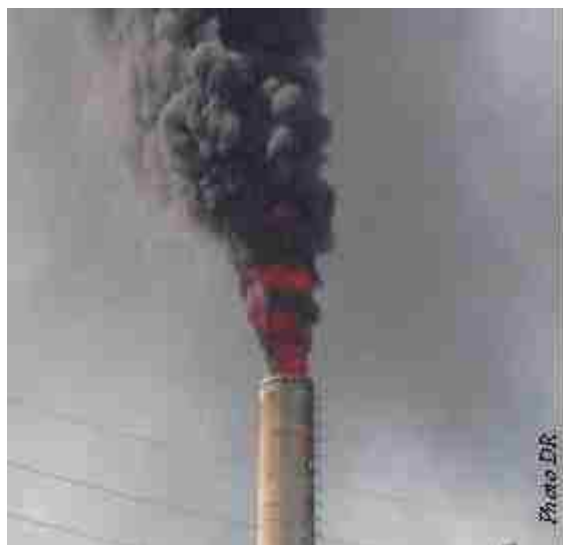
The ignition of the products coming from the reaction loop (reactor 42R202) continued intensely for a few hours in the furnace's convection chambers and flue exits.

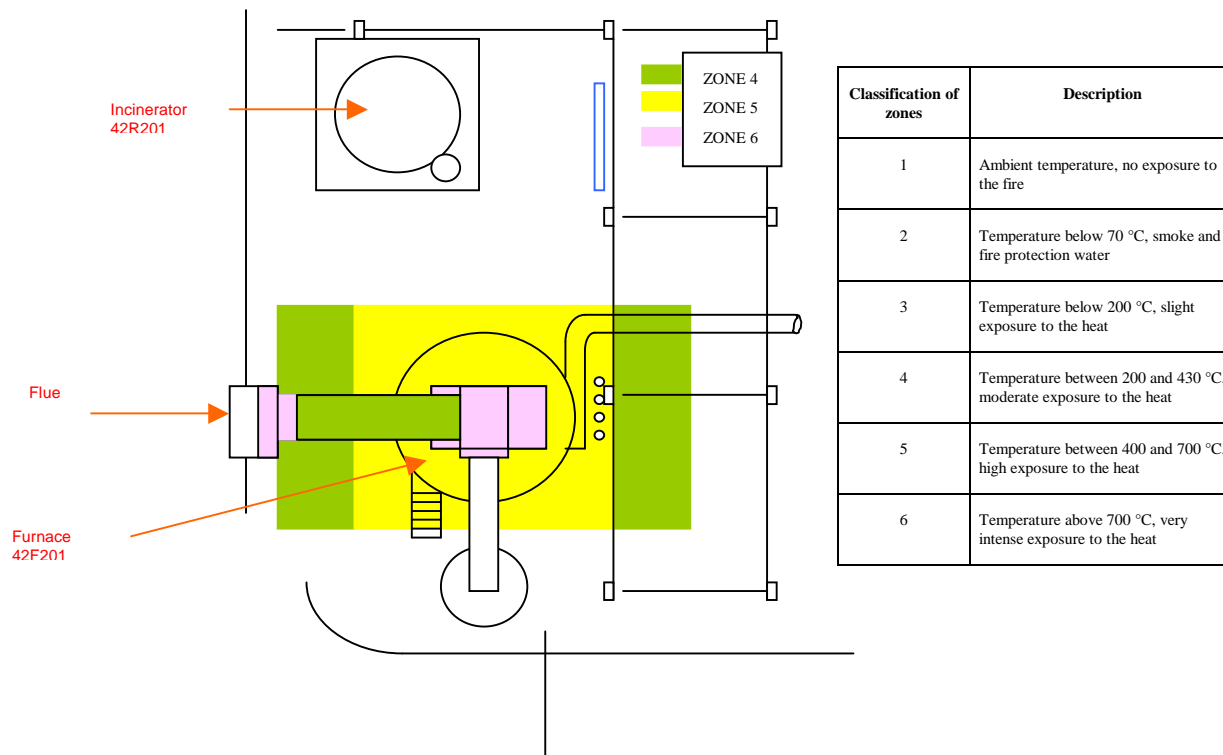
The detailed evaluation of the damage to pressurised equipment involved in the accident was conducted according to API 579 methodology which consists in determining the temperatures reached during the fire, including spatial classification of the 6 corresponding zones and the definition of an acceptance or replacement criterion depending on the zone concerned.

Classification of the temperature levels reached (zones between elevations 8 m and 25 m)

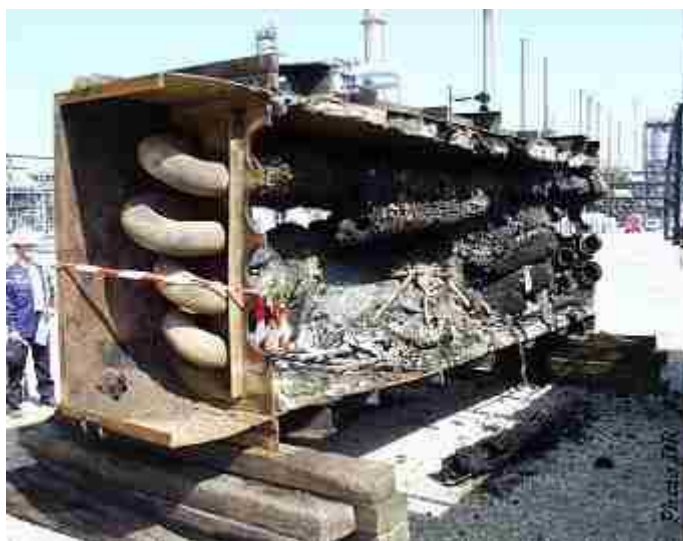
Partial view of furnace 42F201 after the fire and dismantling for inspection

✓ Furnace 42F201 underwent the most extensive damage:

- ✗ Total destruction of the convection array (fusion of the upper levels of the convection, only the lower layer had tubes that were not melted, including a burst tube) (see photo below),
- ✗ Fusion and vitrification of the refractory material on the convection part (see photo below),
- ✗ Overheating of the radiation array,
- ✗ Damage or deformation of convection and radiation wall and structural elements,
- ✗ Degradation of support columns,
- ✗ Deformation of the first section of the flue.

Considering the extent of the damage to the furnace, the decision was made to completely rebuild it, including the associated civil works structures (concrete support posts, first section of the flue). The furnace was rebuilt nearly identically, although the following improvements were made:

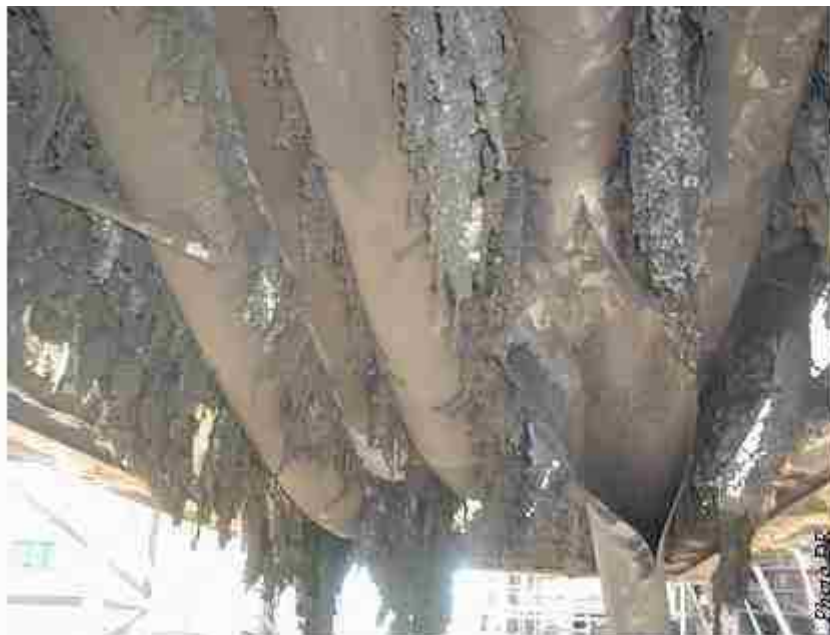
View of the lower convection layer (after the fire)

It appears that the tubes which make up the lower convection layer were not melted due to the fact that they were being supplied all the way to the end by the load and thus "cooled".

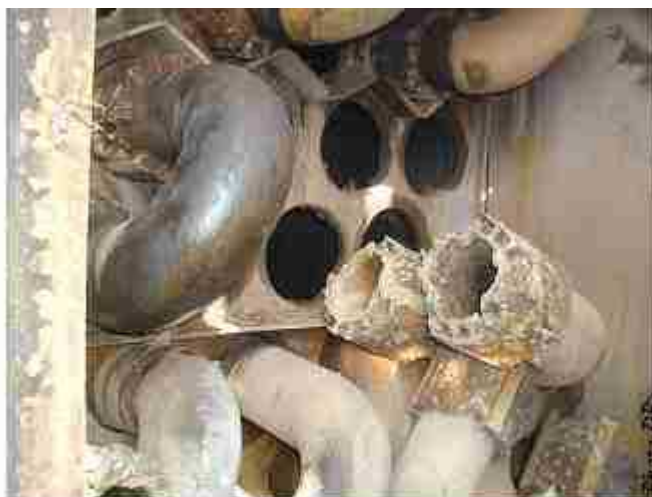
On the convection part, only thickness measurements were conducted on the peripheral elbows (see photo below), and no anomaly was recorded.

View of a peripheral elbow on the convection chamber (after the fire)

The inspection report of the periodic requalification operations conducted in 2002 show that, for the convection part, the visual examination performed by the inspection department on the lower layer showed no signs of anomaly. Furthermore, the history of the thickness measurements on the radiation tubes and convection elbows since 1993 showed no abnormal decrease in thickness.

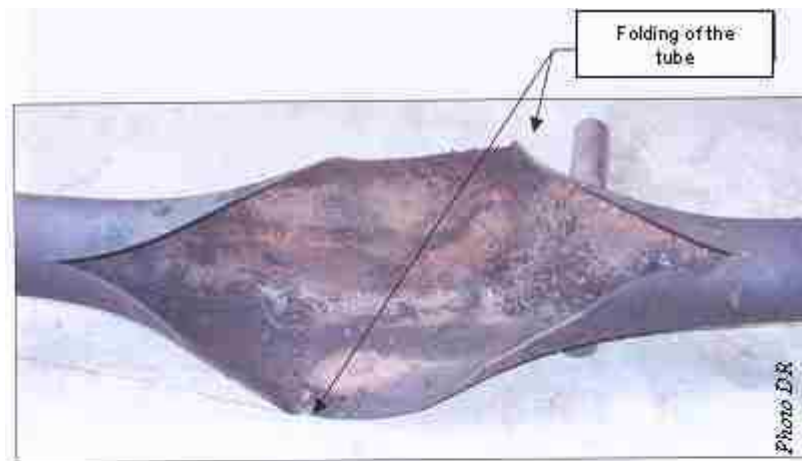
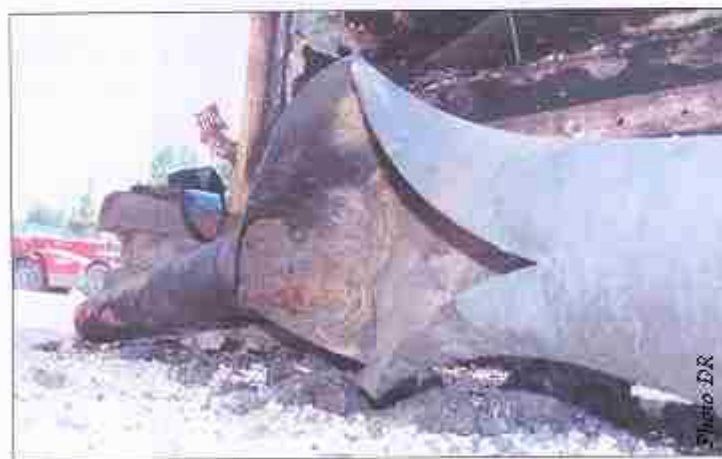
Among them, a tube that was found ruptured (a clean rupture 500 mm in length), was then determined to be the cause of the fire (see photo below).

Views of the ruptured tube

It appears that the rupture was the result of four types of damage which combined their effects and reduced the thickness of the tube to the point where it could no longer resist the operating pressure.

- **presumed corrosion from polythionic acids:** these acids form when the load's sulphur compounds come in contact with oxygen. This situation cannot occur during normal operation, as the load does not contain oxygen. It is encountered during shutdown periods and hydraulic testing operations. To avoid this phenomenon, a passivation operation is performed during the shutdown period (the procedure was formalised in 1985). It appears that the attack may have happened some time ago as the passivation operation has been performed since 1980. It appears to be the result of localised formation of ruts on the inside of the furnace tubes.

- **decreased thickness by oxidation/sulfuration:** in the ruts formed by the polythionic acid corrosion, the material (austenitic stainless steel) lost its corrosion-resisting properties, resulting in reduced thickness through corrosion.

- **presence of sigma phase** (intermetallic compound causing highly marked brittleness of the metal) in small proportion which may have facilitated the development and penetration of the intergranular corrosion.

- **intergranular cleavage leading to slow creep** which eventually generates cracks on the outer skin of the tubes: this phenomenon could be explained by poor heat exchange due to a coke deposit inside the tube. This external tube damage was not visible with the naked eye.

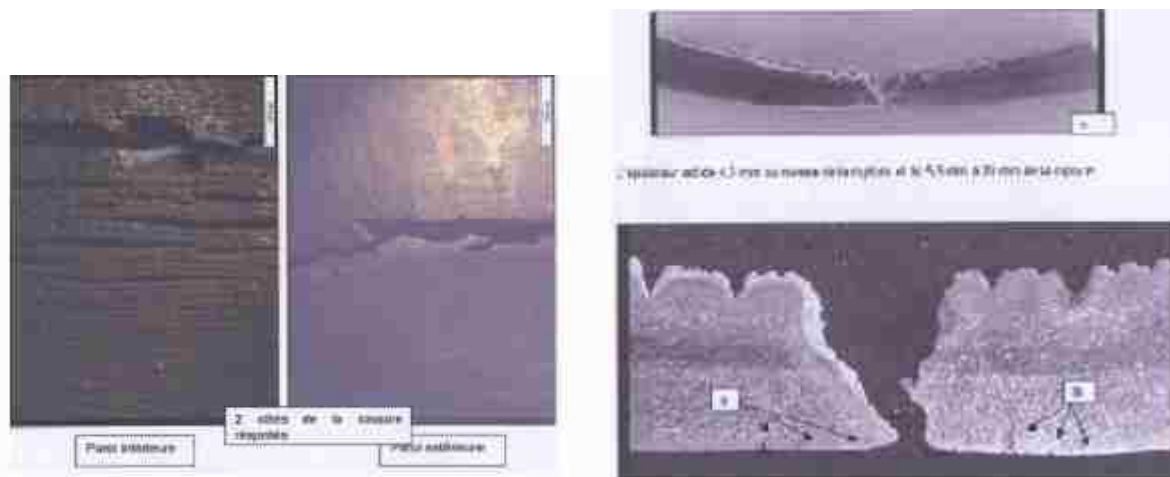
Microscopic view of the break and its two edges readjusted (burst tube)

*Decrease in thickness through oxidation/sulfuration (internal skin), presence of sigma phase (internal skin), intergranular cleavage (internal skin) and cracking (external skin).*
