Overpressure in a reactor in an organic synthesis workshop

March 23, 2004

Montluçon – [Allier]

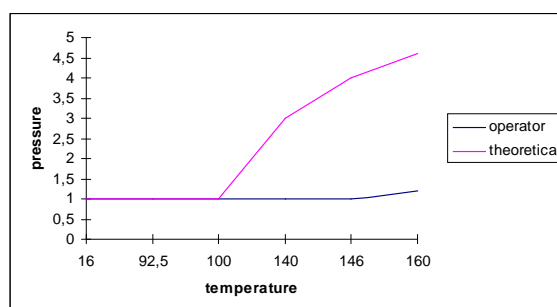
- ◆ 3.40 pm T= 16°C P = P atmospheric
- ◆ 5.00 pm T= 95.2°C P = P atmospheric
- ◆ 6.30 pm T= 146°C P = 1 bar
- ◆ 7.30 pm T= 160°C P = 1.2 bar

As the pressure setpoint had not yet been reached, the operators did not stop the steam heating of the reaction environment. As shown on the graph, they did not react to the inconsistency of the values between pressure and temperature.

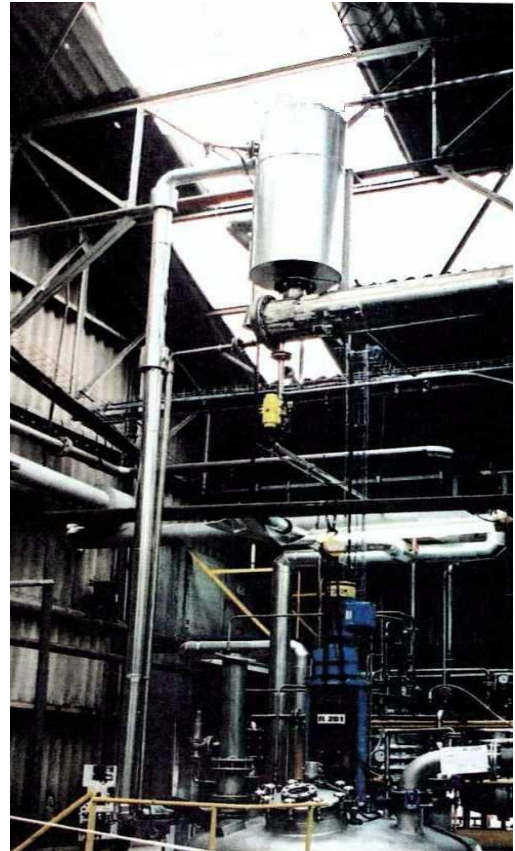
- ✓ one rupture disc destroyed,
- ✓ some pipe jacketing was destroyed,
- ✓ a few m² of fibrocement roofing blown out (see photo).

Roof damage

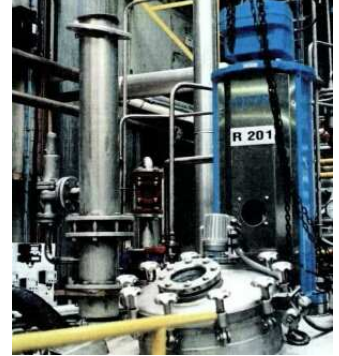
- ◆ a valve (6.3 bar) (at this pressure, the saturated steam output is 1,800 kg/h, or approximately 30 kg/min).
- ◆ a rupture disc (6 bar, ND 150 mm) (at an operating temperature of 20°C).

As the two triggering threshold values are very close, it is difficult to predict, in the case of a pressure increase, which equipment will operate first, considering the precision of the calibrations and the variations of the rupture disc thresholds with the temperature.

- × The trip thresholds of both devices are close and no preventive reflective thinking about their operation was carried out, thus no clearly established defensive strategy was established.
- × The trip thresholds of both devices are near 6 bar, although the nominal pressure of the reaction is two time less (3 bar).
- × The rupture disc's discharge pipe must be connected to the workshop's discharge network.

Finally, the operator undertook in-depth reflective thinking on the defensive strategy against overpressure in the reactors. As such, for reactor R201, after having analysed the operating conditions under pressure and temperature through laboratory work, the operator defined the rupture disc [bursting pressure: 6 bar at 120 °C] as the reactor's ultimate protective barrier. The valve calibration, defined at 5.3 bar, is used to discriminate the trip thresholds. The valve must thus operate first and limit the internal pressure thereby giving the operators enough time to intervene. The design work of the safety accessories thus had to be performed *a posteriori*.
