**Rupture and ignition of a gas pipeline**  
**July 30, 2004**  
**Ghislenghien**  
**Belgium**

A GAS EXPLOSION IN BELGIUM

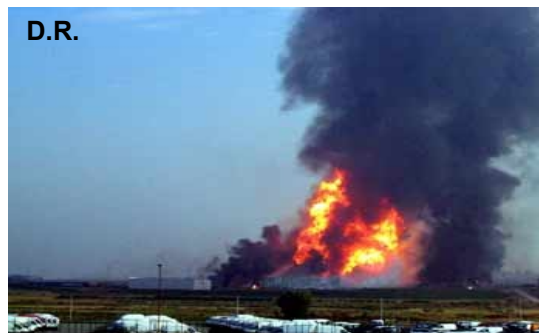
At about 9:00 am, an explosion occurred; two minutes later, technicians were able to isolate the pipe segment between the two sectional valves. The gas cloud ignited, producing a "fireball" that subsequently transformed into a long flare whose height was estimated at 150-200 m. Depending on the estimation source, a temperature of around 3,000°C was reached in the middle of the fireball.

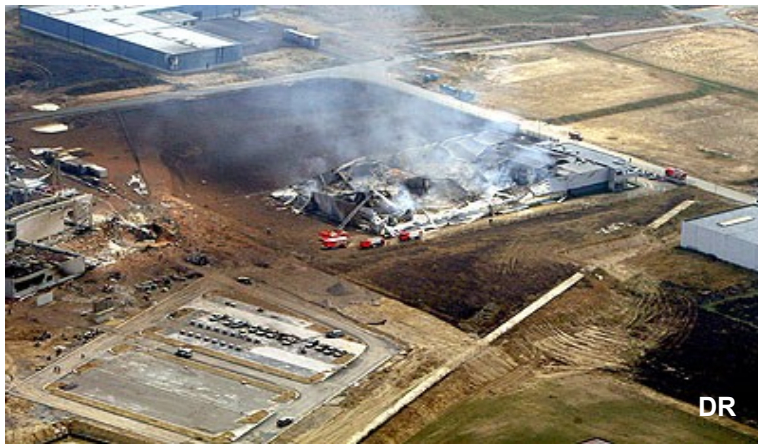
An industrial zone sustained total devastation over a 200-m radius. A 4,000-m<sup>2</sup> cardboard mill, along with a filling station, a large number of roofs and cars were all destroyed. A portion of a construction site was also damaged and many agricultural fields burned.

View overlooking the industrial zone

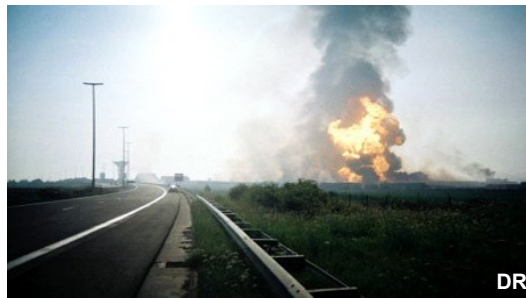
The accident occurred in the vicinity of Belgium's A8 motorway linking Brussels and Tournai; the road had to be closed to traffic in both directions.

View from the motorway
