# Malfunction of safety devices at an LPG depot

October 7, 2004  
Le Blanc [Indre]  
France

LPG depot  
Propane  
Tests  
Shut-off valve  
Equipment failure  
Utilities / compressed air  
Organisation / verifications  
Insects

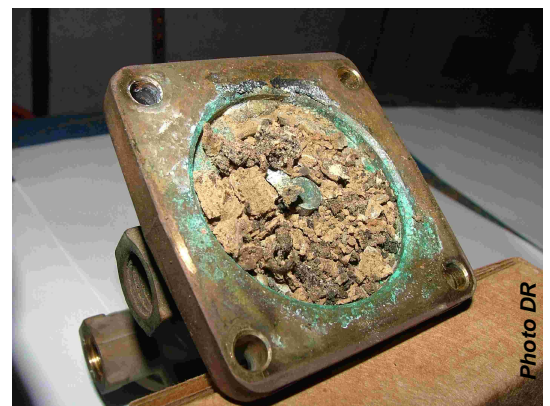
During security testing at the site's truck unloading station, an automatic valve at the base of the arm is not operate. Under normal circumstances, this [positive safety type] valve, is used to shut down the installation in the event of an unloading problem.

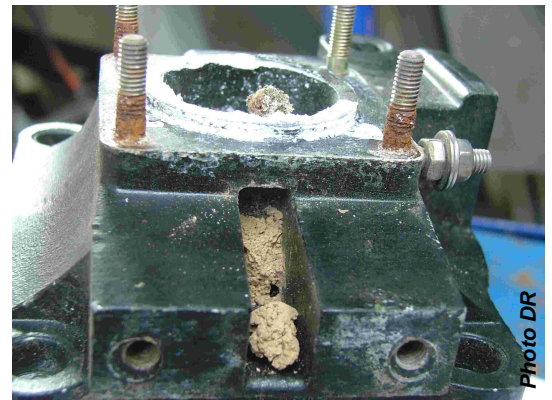
After verifications, the problem is caused by the presence of a wasp nest built inside the air system's depressurisation solenoid valve, preventing it from working properly. The pneumatic distributor is mechanically blocked by the earthy residue built by the wasps. The evacuation device releases directly to the atmosphere.

The insects are entered by this small unprotected orifice.

Pending investigations, the operator stopped using the unloading station until the installation could be refurbished.

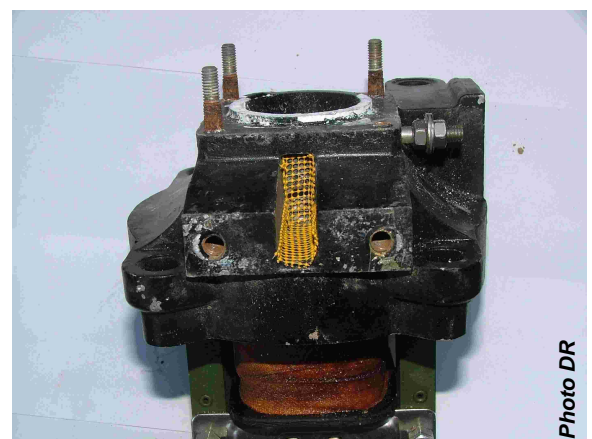
Additional checks, conducted on the site's other solenoid valves of the same type, found additional nests in another device but did not prevent it from operating.

Brass mesh were thus installed on the vent holes (see photo opposite).

The group informed the other sites at the national level, and verifications were performed on valves of this type. The tests showed that only the solenoid valves of the same model were prone to this type of problem. They were also equipped with protective mesh inserts.
