Fire in an electrical service room in a chemical plant and release of toxic gas

October 25, 2004

Lannemezan - [Hautes-Pyrénées]
France

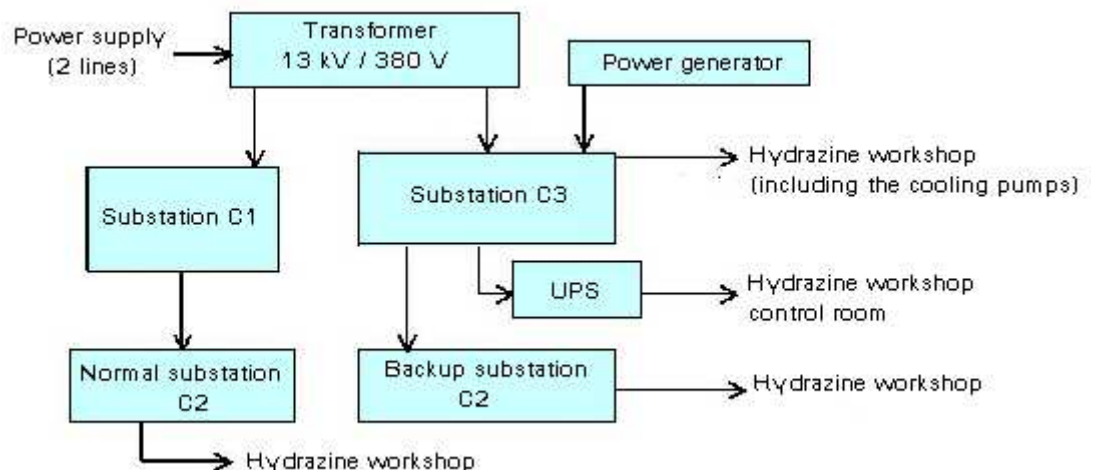
Figure 1 - Workshop's electrical supply system

- a 13kV/380V transformer, in a separate building,
- an intermediate switchboard C3 which includes certain hydrazine outgoing feeders, the 2 UPS supply lines, the incoming generator line and its tripping device, the outgoing line to the back-up C2 switchboard. All this equipment is located in the same building, but in separate rooms.
- an electric switchboard C2, in a room adjacent to the control room and the hydrazine technical room, which supplies the majority of the hydrazine outgoing lines made up of a normal C2 switchboard and a backup C2 switchboard (supplied from station C3)

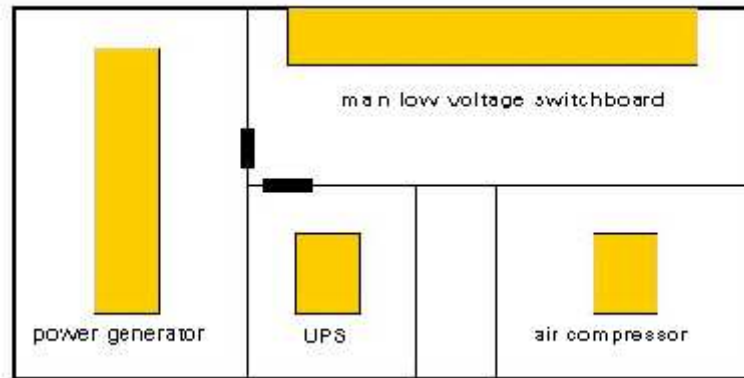
Figure 2 - Electrical service room C3

The electrical column where the short circuit took place was destroyed by the fire and the entire electrical switchboard C3 was badly damaged.

The electrical fault on one of the hydrazine unit's cooling pumps led to a short circuit on one of the columns of the switchboard C3 and started a fire. The fire then spread to all columns of table C3 via the sub-floor (electrical cables).

The circuit breaker upline from the switchboard did not function as it was "stuck".. The electrical problem then shifted to the transformer.

- An expert assessment was conducted shortly after the accident,
- A fault tree was drawn up,
- In order to restart the installations, a temporary switchboard was installed to replace panel C3, in a room geographically separated from the UPS and power generator rooms. The UPS was replaced, the power generator cleaned and the circuit breaker overhauled,
- Definitive replacement of switchboard C3 was programmed for the plant's major shutdown in April 2005. This operation was preceded by a study bearing on the reliability of the power supply and how the common modes, insulation of the UPS / power generator /switchboard rooms are handled, the opportunity of a dual UPS power supply, and the connection of MV Bucchols transformer safety devices.

2. **Heating faults must be eliminated** (the cause of the short circuit) and improve selectivity. The new substation thus includes:
 - A panel capable of performing an IR thermography IR (panel in front of the rack open) of all active parts during their operation,
 - Installation of fail safe racks in the table to test and maintain the "sensitive" circuit breakers in operation,
 - The use of Bucchols safety devices with the transformers (low voltage),
 - Minimise cable lengths and potential hazards (heating, short circuit...),
