# Explosion in a fireworks storage facility

3 November 2004

Kolding

Denmark

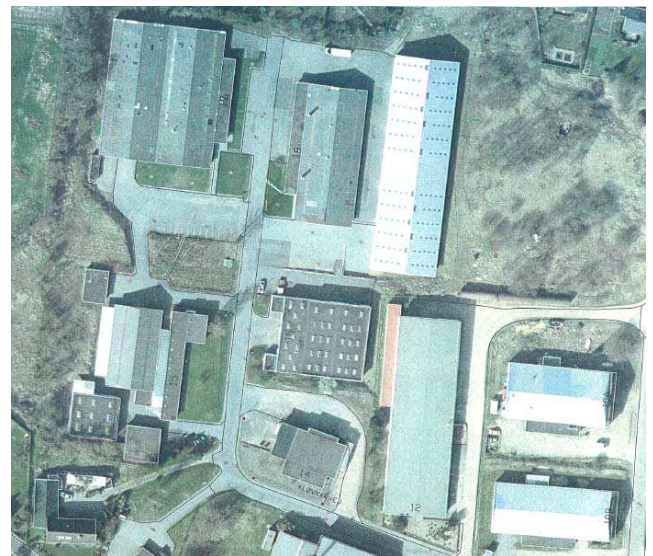
Aerial view of the company before the accident

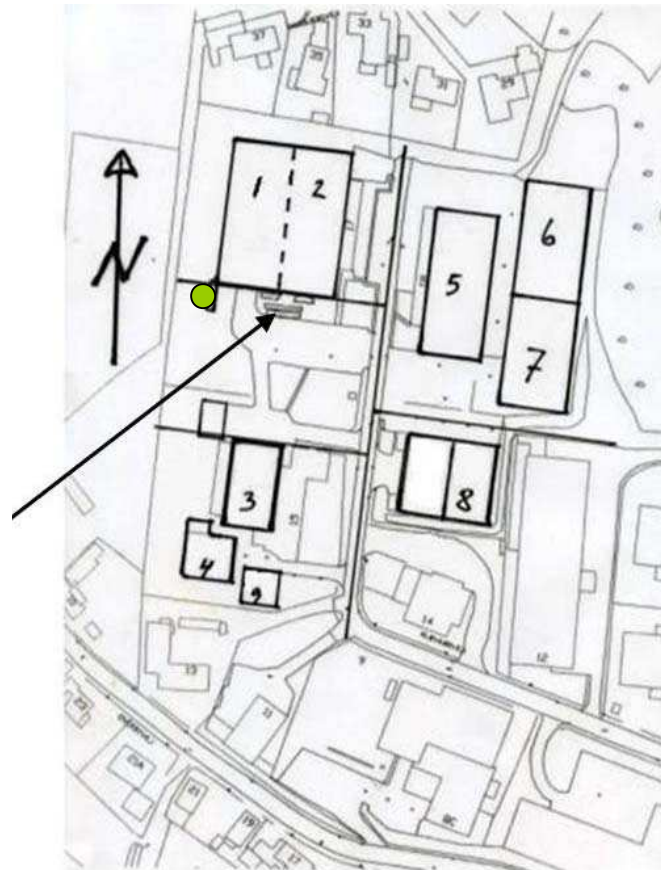
The two 40 feet containers 1 and 2, where the fire started, were 1 m apart and at 20 m from building 1+2.

In the text, container 2 refers to the one nearest to building 1+2.

Two 20 feet containers that were full and closed were located to the north of container 1 and 2.

On the day of the accident, several other 20 and 40 feet containers that are not shown in the drawing were also stored outside in between buildings 5 and 8 and (1+2) and 3. A gas cylinder storage site (green dot) was also located in the vicinity.

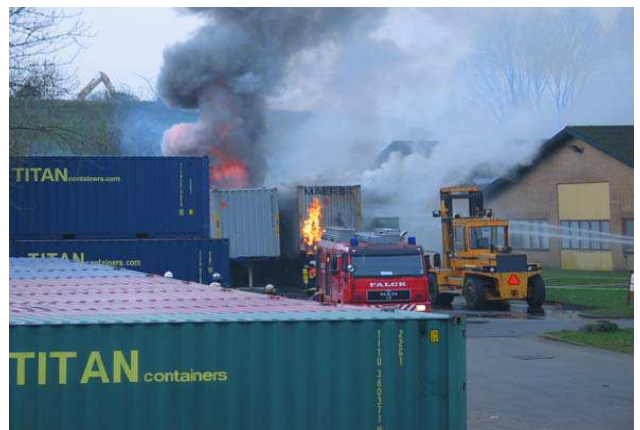
Fire in the 2 containers at 3 p.m. [2]

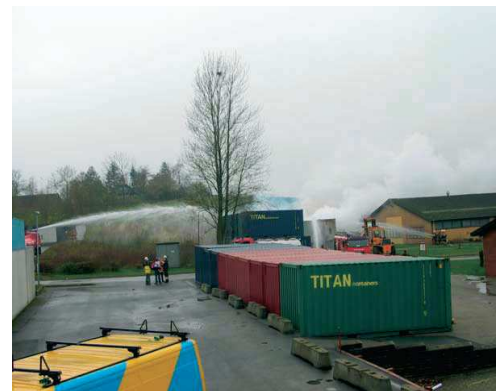
The intervention with the 3 first vehicles. The situation seems to improve.

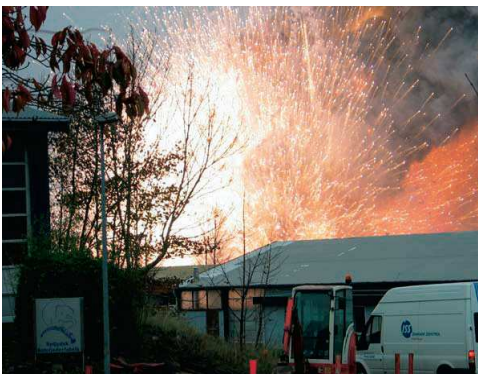
The 3.25 pm explosion

The explosion destroyed the doors and windows of warehouses 1+2 and 4. The ignited fireworks were projected into the buildings. At 3.33 pm, the fireworks exploded in the building 1+2.

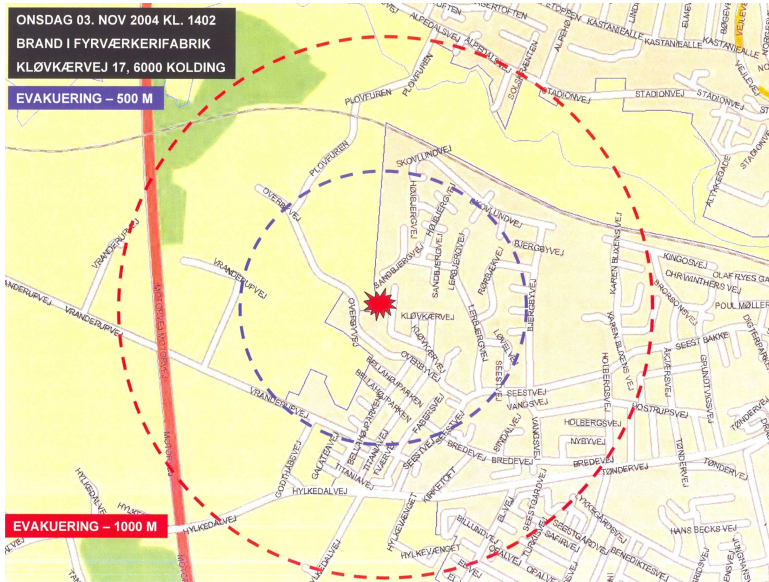
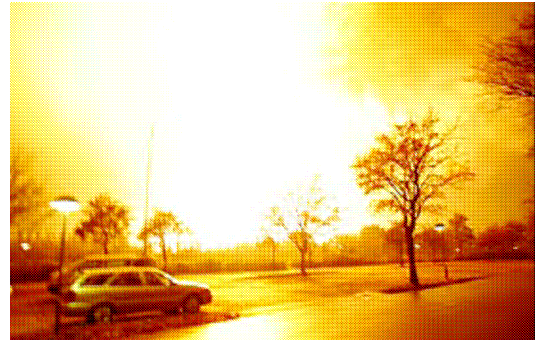
Three major explosions resulting in spectacular fire balls (cf. [8] [9]) of several meters occurred at 5.45 pm (explosions are presumed to have occurred in buildings 6 and 7 containing 150 tonnes of fireworks).

Explosions at 5.45 pm

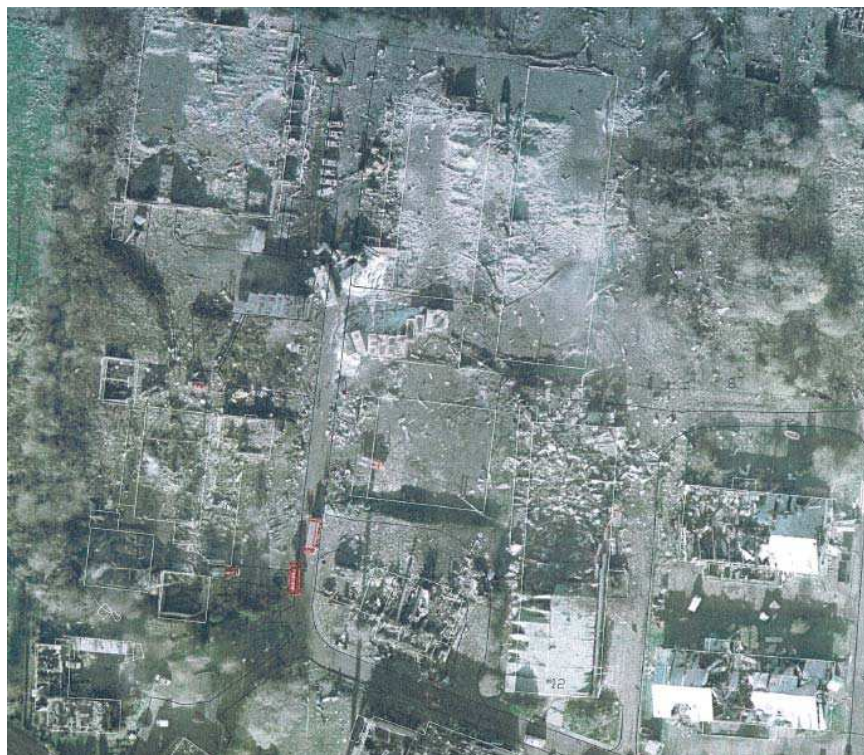
The company, most of the buildings in the industrial zone and a part of the residential buildings in the neighbourhood were destroyed or severely damaged: 450 houses were damaged and some were made unfit for living. Debris of the buildings were found over 1,000 meters away from the disaster.

Aerial view of the site after the accident (cf. photo on first page)

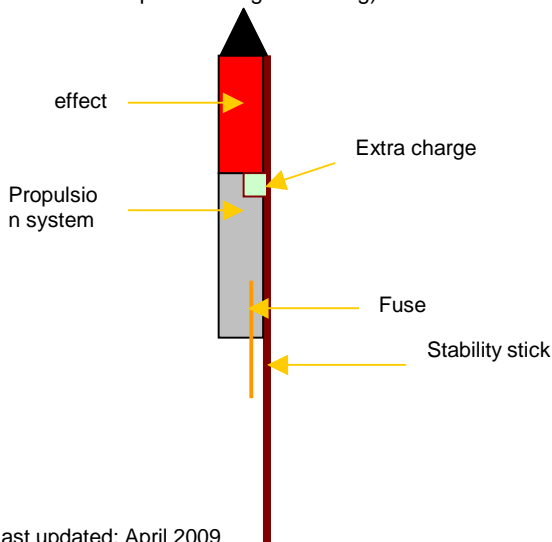
The rocket in question comprises a propulsion system and 3 bombs of 5 cm diameter (effect). An additional pyrotechnic charge between its stabilising stick and propulsion system separates the latter from the support when the rocket is at its peak height.

Danish regulations lay down limitations on the size of fireworks debris when the total weight of the fireworks item tops 200 g. In this case the motor and the support must be separated, which may require the addition of an extra charge.

Initially, an assumption widely spread by the media considered that the extra charge may have been improperly attached and may have been triggered spontaneously by the shock. However, the police found 60 rockets of the same type in Danish shops and proceeded to testing them (chemical analysis, fall test involving a 9 kg load on the support, impact and friction tests. Even though the friction and impact tests conducted by the BAM<sup>2</sup> in Germany revealed that the flash composition of these rockets was more sensitive than other flash compositions, none of the rockets tested were triggered spontaneously during the tests. The assumption could thus not be validated.
