## Leak on grey cast

## iron pipe

26/12/2004

## Mulhouse (HAUT-RHIN)

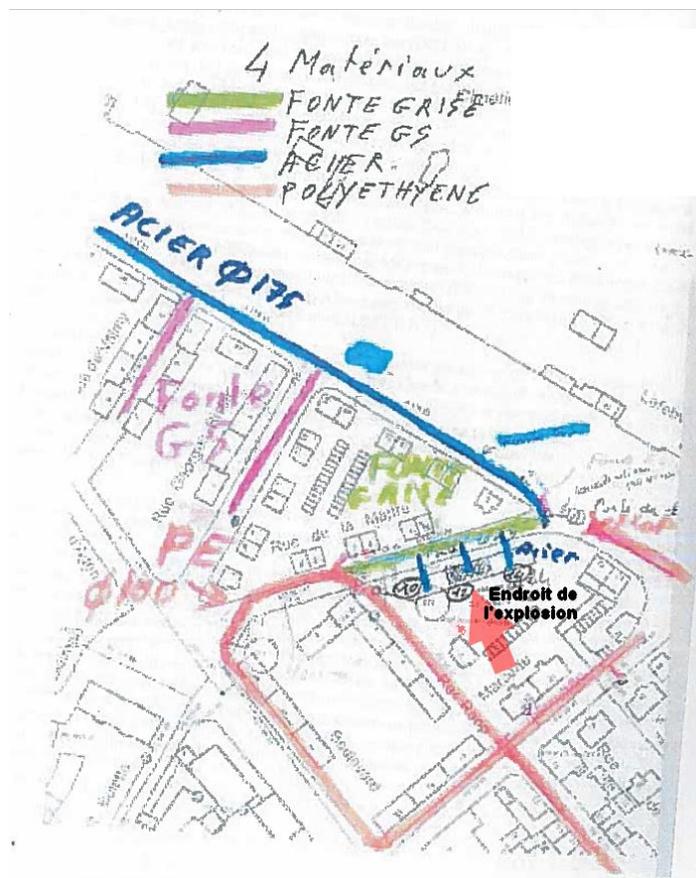
The gas service was tasked with gradually removing the grey cast iron pipes when the network was extended in 1993 (in conjunction with the installation of a pressure regulating station in rue de la Martre), then again in 1995 and 1996 (during the installation of piping on the network and supply of a boiler room). However, a 105 m long section (shown in green in the diagram below), dating from 1957, was still in operation along Rue de la Martre, and located a distance of about 6 m from the façade of that building at No. 12.

Diagram of the natural gas distribution network on rue de la Martre in Mulhouse

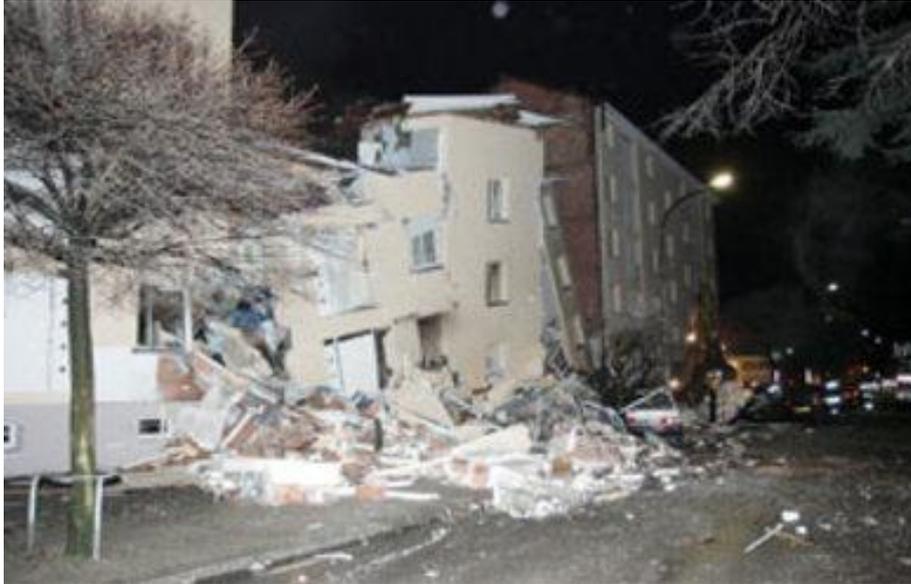
An explosion occurred at 5:03 p.m. on Sunday, 26 December 2004, during the school holiday period. The blast destroyed the 4-storey building at 12 rue de la Martre and damaged the neighbouring buildings (Nos. 10 and 14). The resulting damage caused the building to collapse. The ground floor and the 1<sup>st</sup> floor were crushed down to the basement level, with the upper floors collapsing down from above.

The building after the explosion of 26 December, 2014 (© rights reserved)

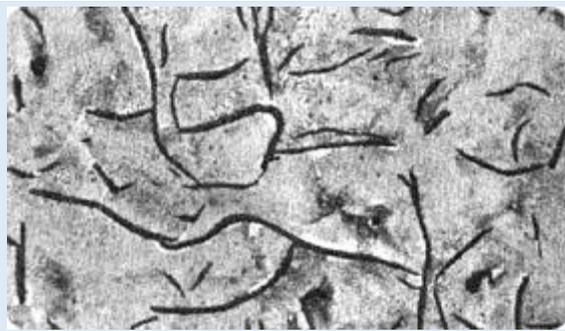
Microstructure of a grey cast iron (© DR)

Nevertheless, it is considered fragile or brittle as attested by the accidentology:

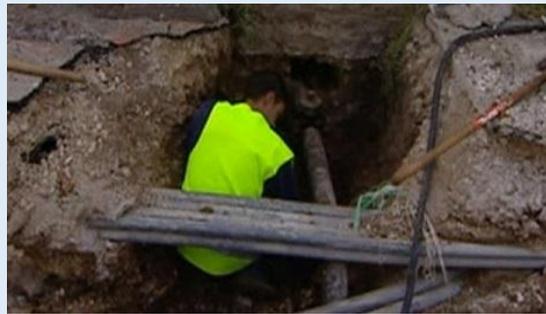
Accident in Dijon (ARIA 21551). A 4-storey building suffered damage following an explosion caused by a natural gas leak on a grey cast iron distribution pipeline. The explosion left 11 persons dead and 3 injured.

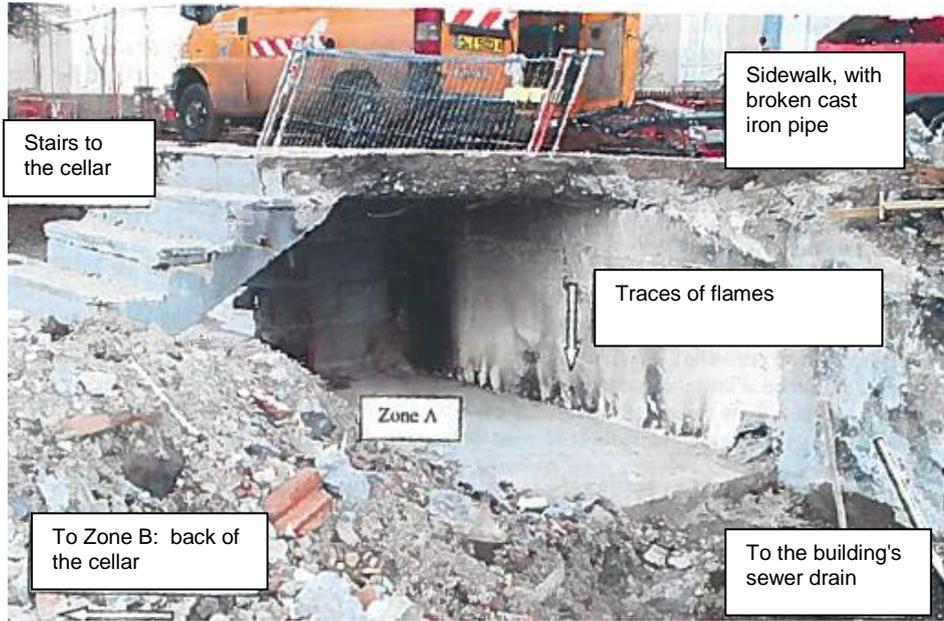
View of the cellar after the rubble had been cleared away – © rights reserved

On this last point, the Mulhouse accident illustrates that horizontal propagation of gas escaping from a ruptured gas pipeline is possible, as well as its passage through defects in walls (as evidenced by the traces of combustion on the cellar's wall: see photo, page 3). Emergency personnel (fire brigade or gas service) must therefore intervene with the greatest degree of vigilance, taking into account the risk of explosion in a confined environment.
