Toxic vapour (HCl) emissions due to overflow of a proportioner in a chemical plant

16th October, 1991

**Chalon-sur-Saône (Saône-et-Loire)
France**

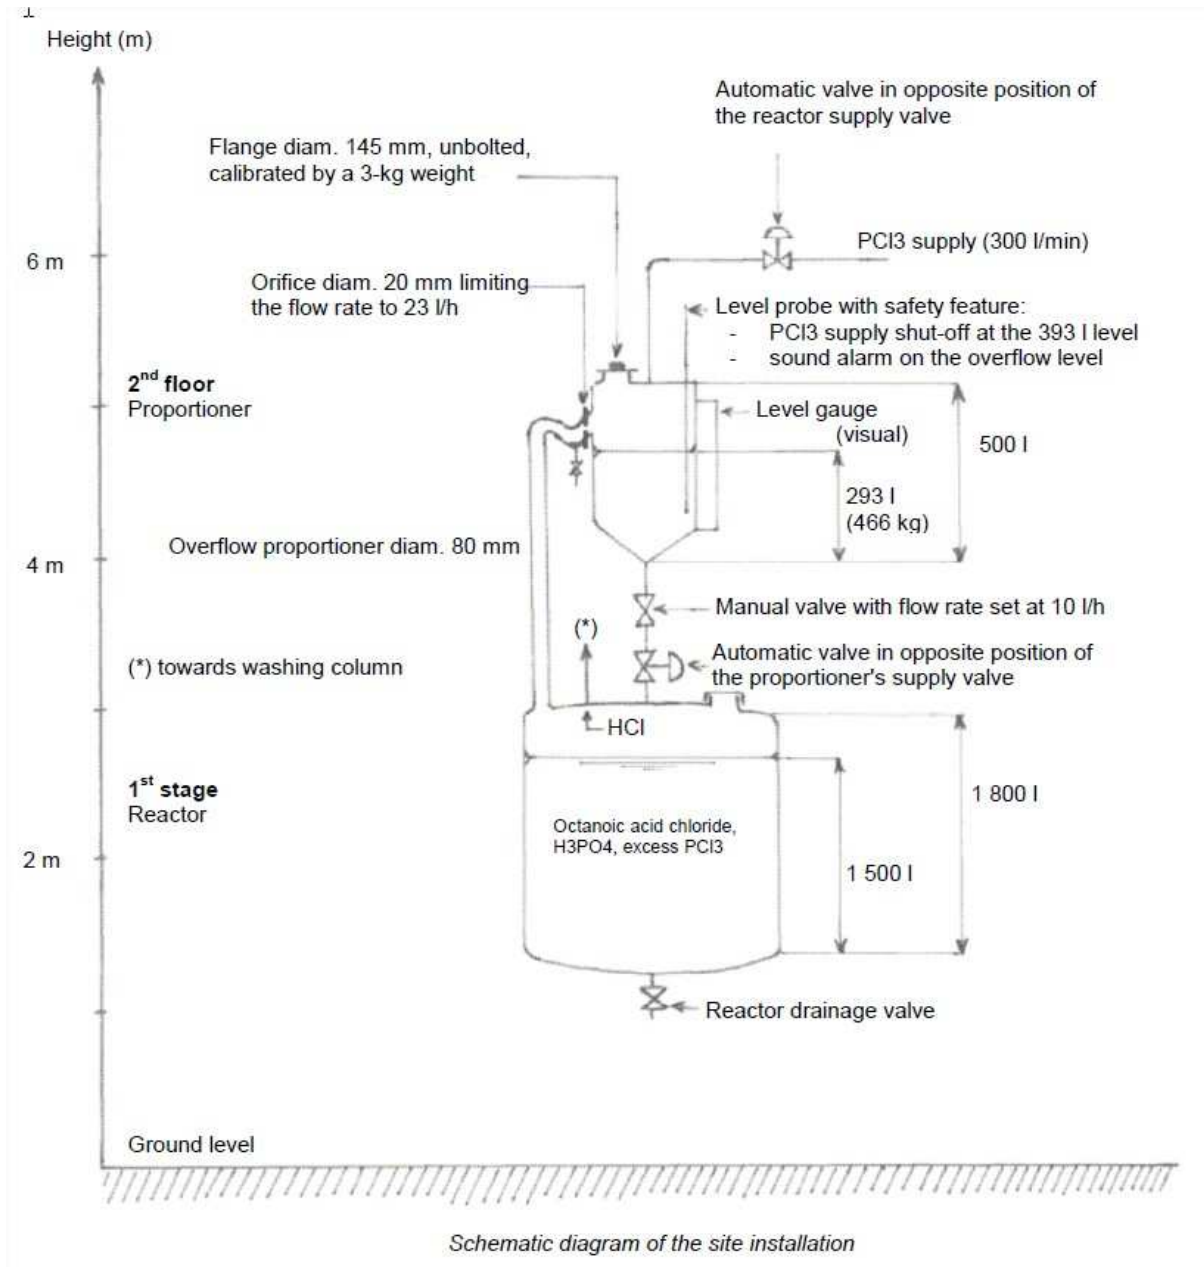
Placed above the reactor (see schematic diagram on p. 2), the proportioner was connected by a pipe and pump to a 22-m³ storage zone located 20 m outside from the workshop. This pump was activated for PCl₃ transfer to the production chains as well as all transfer operations for cisterns supplying the site's storage facilities. Hence, the maximum pump flow rate (300 l/min), designed to accommodate these transfers, was too high compared to both the proportioner's actual capacity (500 l) and the quantity needed to be introduced per batch (293 l, i.e. less than 1 minute of transfer).

- Work station ergonomics were not well adapted. More specifically, the liquid level was difficult to distinguish inside the proportioner (requiring use of a mirror), and the control cabinet was not visible from the lower part of the installations.

- An (overly) complicated control circuit included many time lags capable of generating interactions. The only pump used for the PCl_3 transfers was being controlled by a set of switches distributed at 4 different points, none of which were mutually visible.

- The maximum pump flow rate (300 l/min) was too high compared to the proportioner's actual capacity (500 l) and the quantity to be introduced per batch (293 l, i.e. less than 1 minute of transfer!), thus forcing the technician to hurry to turn off PCl_3 supply prior to triggering the high level alarm.

- Due to the excessive PCl_3 supply flow rate (see above point), monitoring of the PCl_3 quantity introduced into the proportioner was too imprecise and the installation regularly switched into security mode. To avoid this phenomenon, the safety function was bypassed by altering the prescribed point to "end pump filling".

- The installations using PCl_3 were not adequately confined. A manhole on the proportioner was blocked by an unfastened flange despite the indicated design locations. The PCl_3 that spread wound up reaching the sewer network via a low point sump in the building (inside a plant without retention).
