Explosion of a wood chip refiner and fire

20 and 25 January, 2005

Corbenay – [Haute-Saône]

Explosion / Fire
Chipboard
Silos
Dust
Risk analysis
Organisation
Uncoupling
Thermal imaging camera
Vents

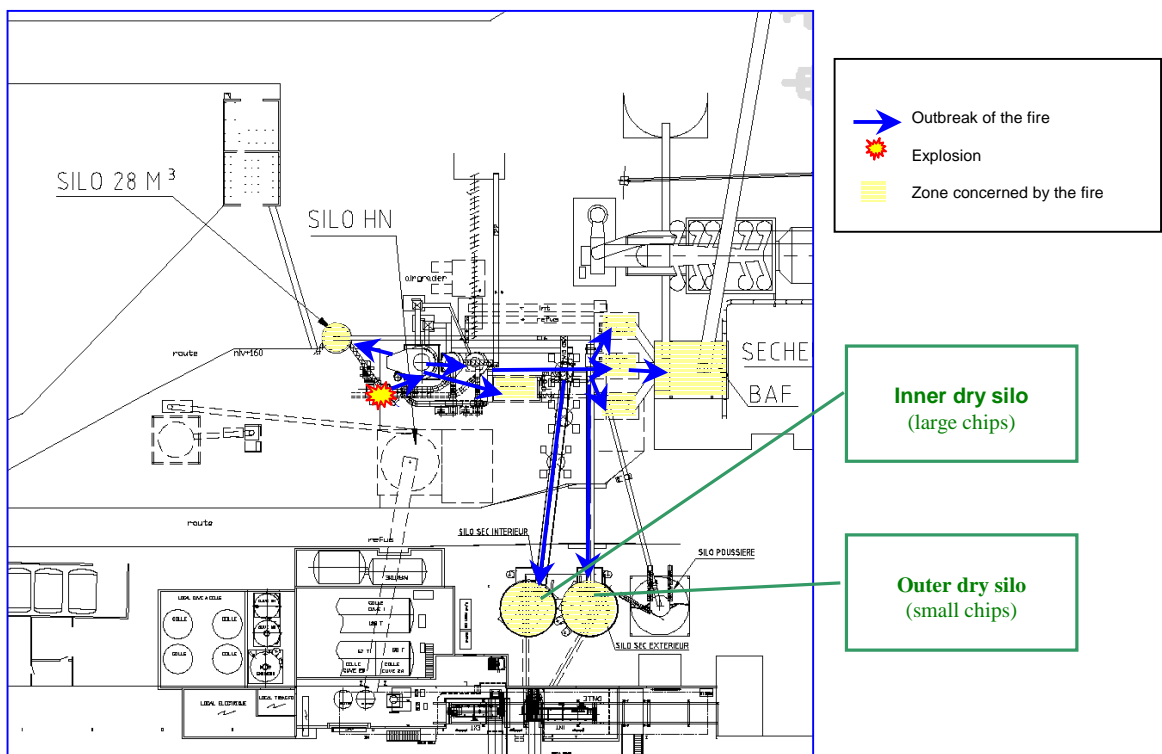
Schematic diagram of the chronology of explosions on January 20, 2005

January 20, 2005 at 2.58 am, at part of the refiner breaks (the mill grinder that transforms large dry chips into small dry chips). The resulting spray of sparks is carried along by the suction and ventilation equipment.

At 2.58'02", the refiner's cyclone explodes. The force of the explosion causes it to rupture, despite the presence and operation of the vents. The fire spreads to all the adjoining installations: redler conveyors, suction equipment, air graders, sorters, dry silos, etc.

At 2.58'07", an explosion occurs in the suction equipment causing the vents to open.

At 2.58'10", the "inner" and "outer" dry silos explode. The fire reaches the refiner silo, cyclones, cyclofilters and suction equipment, sorters, fire boxes and the "inner" and "outer" dry silos.

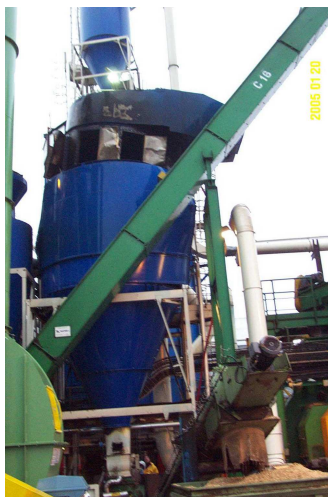
Photo Drire Franche-Comté

Material losses were evaluated at 250,000 euros, attributed to the replacement of the refiner (at the origin of the accident), and the damage caused to the sorter and cyclofilter. The silo and cyclofilter vents also have to be replaced. The plant also reported 750,000 euros in production losses due to the production line being shut down for two days.

- ✓ the refining installation was uncoupled from the rest of the installations. As a result, a cyclofilter dedicated to the refiner was installed and a fire box was added.

- ✓ the emergency response procedure, comparable to an internal contingency plan, was submitted to evaluation by a third party.
- ✓ the rupture of the cyclofilter, even though vents had been installed, led the operator to check their dimensions.

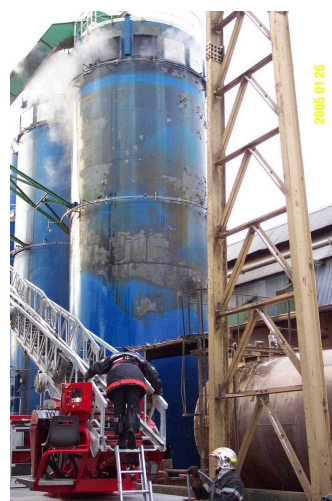
Photo DIRE Franche-Comté

On January 25, 2005 at 6.10 am, an explosion followed by fire occurred inside the "inner" dry chip silo. The silo's vents opened, thus limiting the effects of the shock wave.

The consequences were minimal in comparison to the first accident. The production shut-down was limited to 14 hours; the storage silo's explosion vents and electrical cable that melted during the fire must be replaced.

The cause of the second accident was attributed to embers that had remained in the bottom of the "inner" dry chip silo, following the fire of January 20, 2005. Smouldering embers had been trapped under a very heavy bell-shaped piece of equipment, the silo's extraction unit. The fire had been smouldering for 4 days. In the morning of January 25, 2005, the silo's level had dropped until it was empty and the embers ignited the cell's dusty atmosphere, resulting in an explosion. The cause of the second explosion, which occurred while the installations were being cooled down (accident of January 25), was not determined. Several hypotheses were submitted : BLEVE, water gases, dust particles in suspension, etc.?

- ✓ modification of procedures dealing with accident intervention and post-accident silo restart operations, with the addition of the verification of the extraction unit.

- ✓ the purchase of a thermal-imaging camera to check installations after a fire.
- ✓ call upon a third-party expert to inspect the installations, the safety systems and the intervention procedures. The main conclusions of the third-party inspection are presented below.
