Explosion followed by fire In a hydrocarbon tank farm

October 7, 1991

**Saint Herblain – [Loire Atlantique]
France**

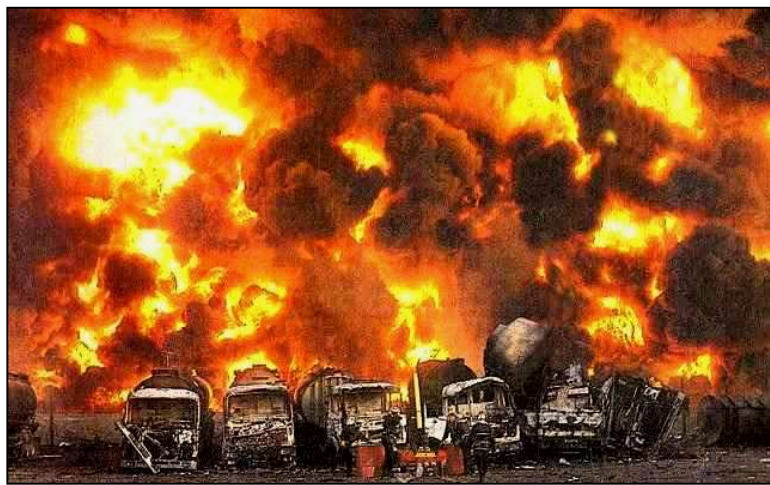
The fire generated flames up to sixty feet high

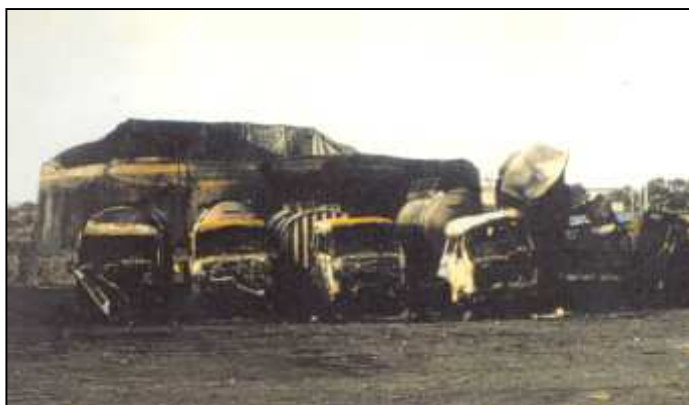
- Two tanks, 15 tanker trucks, wash station and 4 cars were destroyed. The changing rooms and offices were damaged and piping deformed. The blast from the explosion pushed the fence over. The accident also damaged 3 hydrocarbon tanks in a nearby tank farm.

Camions-citernes et bac détruits lors du sinistre

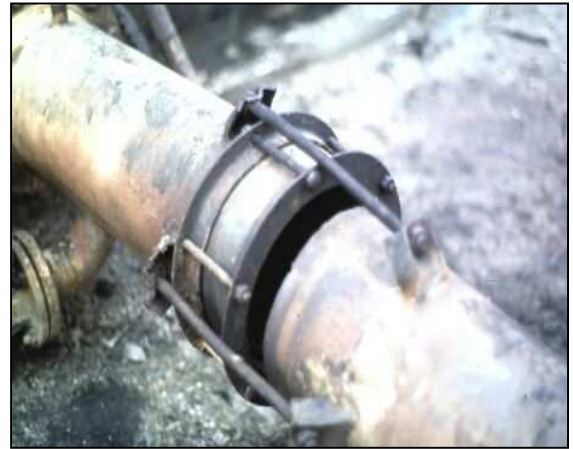
- The explosive cloud could have formed from gasoline fumes according to 2 scenarios:
 - a massive 'guillotine rupture' type leak creating layer of liquid. The evaporating liquid would create a fog from the cooling atmosphere, saturated with humidity (*)
 - a pressurised leak of gasoline from a rubber seal in a union on a 12" fill line.

Union responsible for the leak

- On the other hand, the hypothesis of a faulty seal enables a flow rate of this magnitude to be obtained based on a hydrostatic leak under pressure (the height of the liquid had reached 9 m), considering that at least 10% of the jet is vaporised immediately. The high vapour pressure of this product (0.6 bar) makes this hypothesis plausible.
- Other accidents (particularly the perforation of the SPMR pipeline at Vallaurie (Drome), January 4, 1989) highlighted the capacity of premium-grade gasoline to form an aerosol fog from a turbulent jet. In these conditions, the risks presented by a cloud formed by premium-grade gasoline are comparable to those of a cloud of gas and flammable aerosols.

- At the time of the accident, the strength of the joints was guaranteed by their manufacturer to concentrations of aromatics up to 30%. At the time of the accident, the union at fault, commissioned 15 years ago, was subjected to lead-free premium-grade gasoline containing 55% aromatics.
- Despite the various hypotheses concerning the triggering and development of the accident, there remains doubt as to the exact origin of the leak and the diffusion of the hydrocarbon cloud.

- A better understanding of the content of aromatic components in lead-free premium-grade fuels with a high octane rating and the behaviour of seals is indispensable when designing and maintaining installations in which premium-grade gasoline is implemented.
