## Release then flash of LPG at tank truck loading point in a refinery

April 23<sup>rd</sup> 2004

Germany

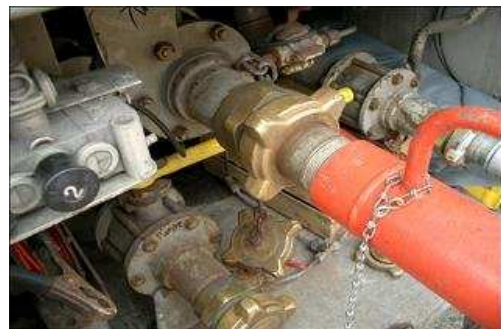
At 7h30, when the loading had commenced and when 15t of product had already been transferred, the unexpected separation of two parts of the tank / connecting arm occurred. A release of LPG followed and this caught fire provoking a flash which engulfed the driver. The explosive force of the separation was such that the extremity of the arm was projected towards the cladding of the loading point, which provoked the activation of the stop valve and halted the arrival of product from the refinery. The flash burned the feed hose from the bottom valve of the tank, and this valve closed, preventing leakage from the truck.

Example of connection arm –tank

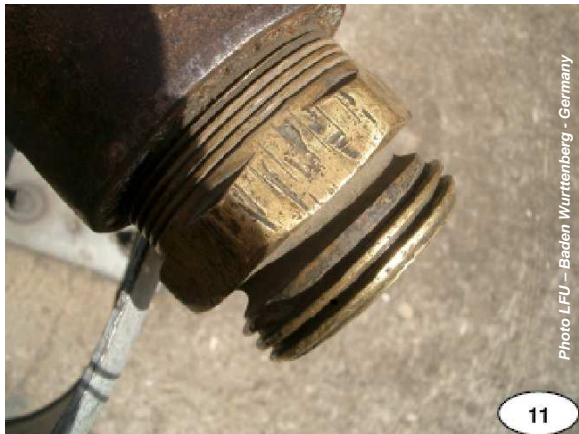
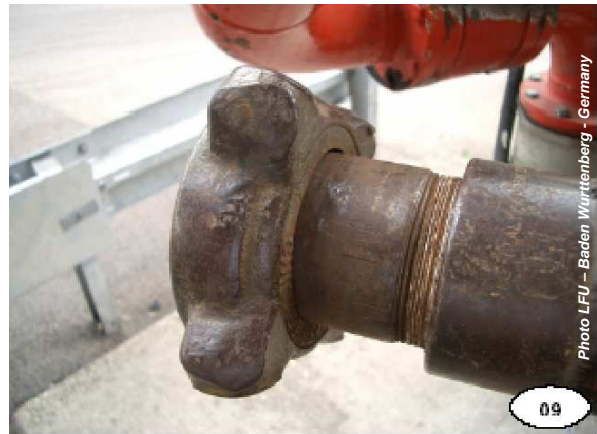
Investigations following the accident showed that the cause of the release of the LPG lay in the failure of a bolted connection between the feed arm and the tank. A detailed examination brought to light that the bolted connection, of the ACME 3 ¼" type was heavily worn, the profile of the threading of the bolting ring was in fact reduced to a triangular profile from excessive wear. The other part of the connector in the tank was also very badly worn and showed a conical form. Consequently the connection between the two parts was extremely unstable. Thus, even vibration or slight movement would have been sufficient to provoke the failure of the equipment.

*Examples of worn bolted connections : connector at tank end and bolting ring.*

Marks due to impacts from hammer blows intended to ensure tight connection were clearly visible on the "ears" of the bolting ring. This practice is actually current while presenting harmful effects such as abnormal wear on the thread due to excessive tightening of the connection – or even leading to the ring taking on an oval shape

The threading was to be checked in taking into account its profile, anomalies presented (flattened areas, spot corrosion, broken threads). Furthermore, the state of the ears on the tightening rings was to be checked for evidence of possible tightening by "hammering".

- ✓ Ensure that the use of a hammer for tightening connections is clearly forbidden, this having been a common practice.
- ✓ Proceed to check regularly, either visually or with test equipment.
- ✓ Importance of the process of exchange of experience as follows:
  - × Seek out the causes,
  - × Determine the measures to be taken and the follow-up
  - × Communicate the causes, measures and follow-up as widely as possible throughout the field of activity concerned but also to the national authorities and international bodies
  - × Trace the information received

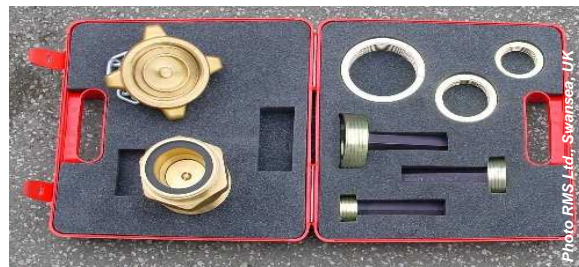
During the checking campaign and during exchanges with the LPG professional union in the United Kingdom, a new method of testing was developed. The use of testing rings allowed for rapid and simple testing of the degree of wear of the two parts of the connector. As an example, if the ring made one turn, the connector is in a good condition, failing that, it is considered as worn. On the ring used at the time of the accident, four turns could be made.
