Explosion inside an isomerisation unit

March 23, 2005

Texas City

Explosion
Refinery
Isomerisation
Gasoline
Facility start-up
Maintenance
Victims
Property damage
Organisation /
management

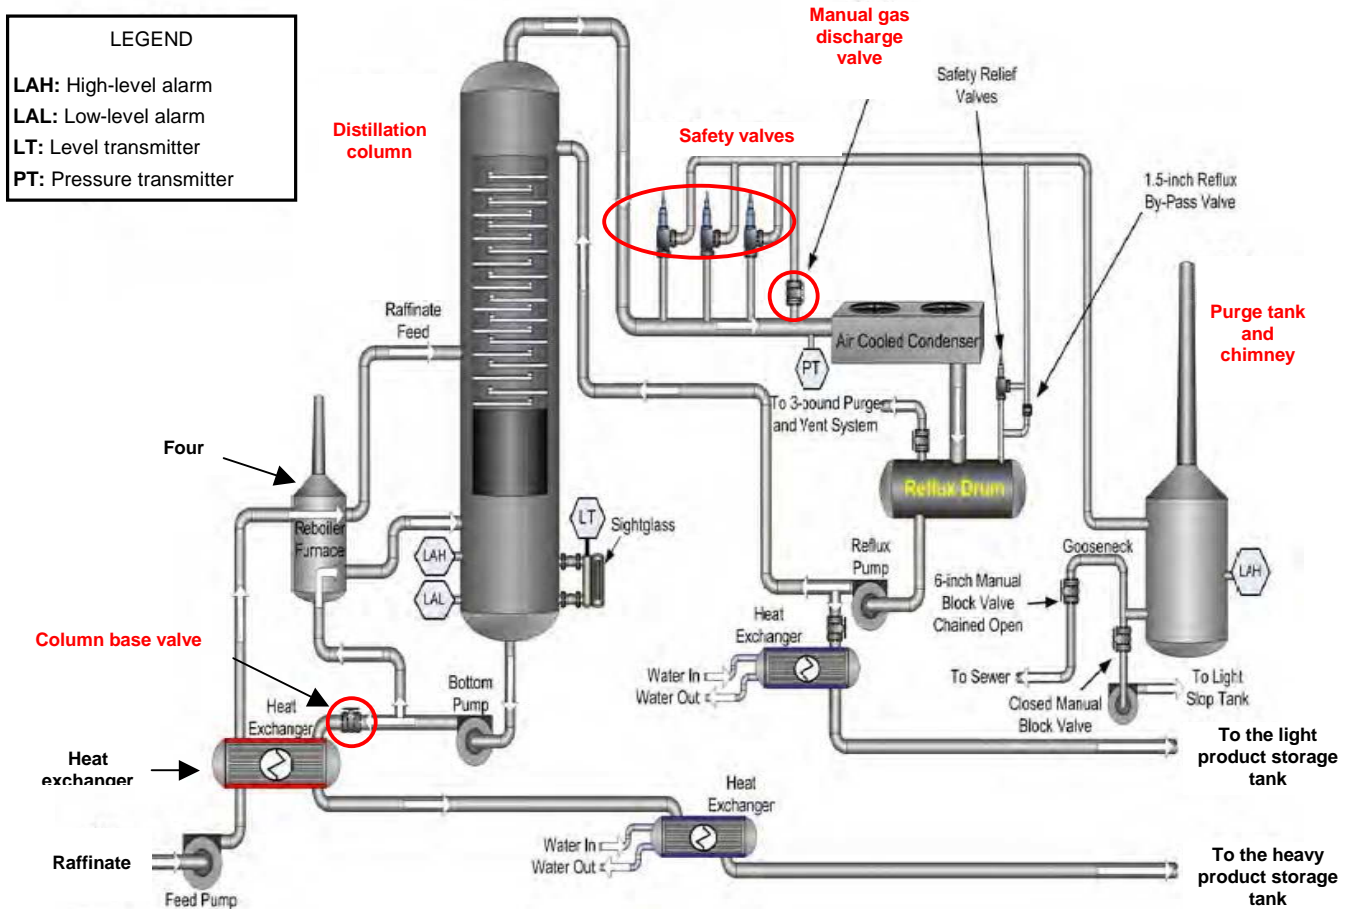
The accident occurred at the level of the unit's gasoline separator part (see diagram on the following page). The separator comprised, among other things, a simple fractionating column 54 metres high, containing 70 distillation trays, encompassing a volume of 580 m³ and capable of supplying up to 7,155 m³ of light crude product per day. This installation also featured a blow-down tank associated with a chimney stack directly open to the atmosphere. Introduced at the refinery during the 1950's, this equipment was designed to receive mixes in the liquid state and/or hydrocarbon vapour stemming from both the backup purge systems and drain valves; it was also equipped with a high-level alarm.

The isomerisation unit's separation column (Source: CSB)

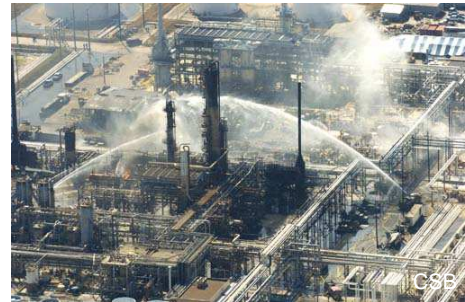
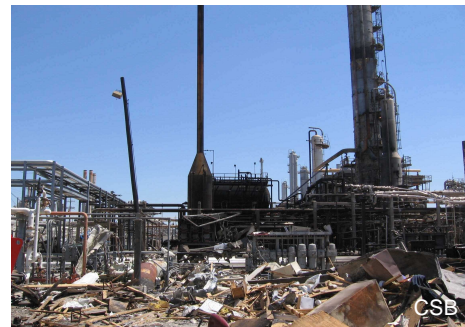
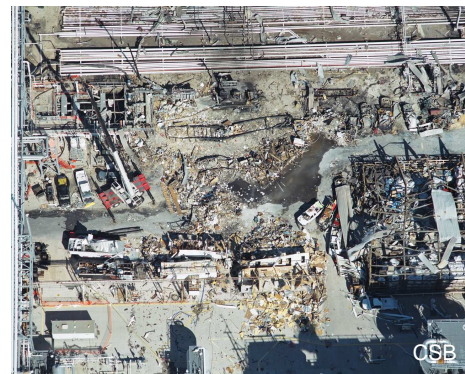
From an equipment standpoint, damage was considerable not only in the isomerisation unit, but also at the level of the storage zone, 80 m away, where over 50 tanks were damaged. Except for isomerisation, the refinery's other units continued to operate normally.
