Rupture of a crude oil storage tank

25 October, 2005

Kallo – Belgium

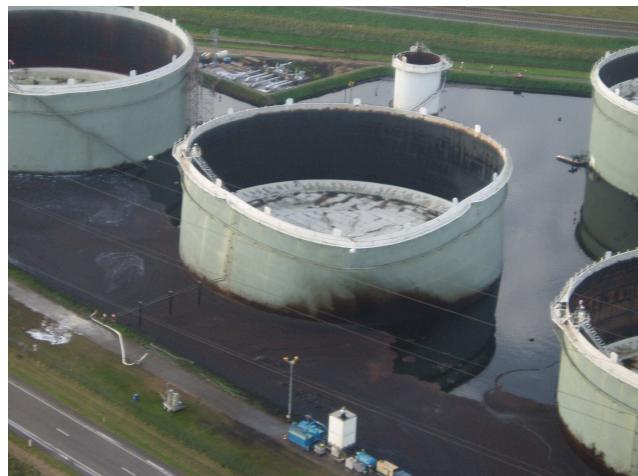
Because the content of the storage tank was released in such a short time, an enormous crude wave was created. This wave moved in the direction of the several meters high earth dike, which fortunately resisted against the power of the wave. The released crude oil filled the whole bund ($40\ 000\ m^2$ large) with crude up to a height of 1 m.

After the release the storage tank was leaning forward and a part of the foundation of the storage tank had disappeared.

Figure 1 shows a picture of the situation in the bund the morning after the major accident happened.

The company took several measures for cleaning and rehabilitation of the environment. As a result of the soil samples that were taken an area of about 4ha was excavated to a depth varying from 10 cm to 1m. This contaminated soil (including the sand that was used to cover the bund) was removed for further treatment. Several odour catchers were installed around the terminal to prevent possible odour pollution during the cleaning operations. The released crude oil, which was contaminated with 214 tonnes of foam, was recovered from the bund. The polder ditch at the outside of the terminal was cleaned. Several extra gauge wells were installed to establish possible groundwater pollution and to ensure further monitoring of the groundwater quality in the future.

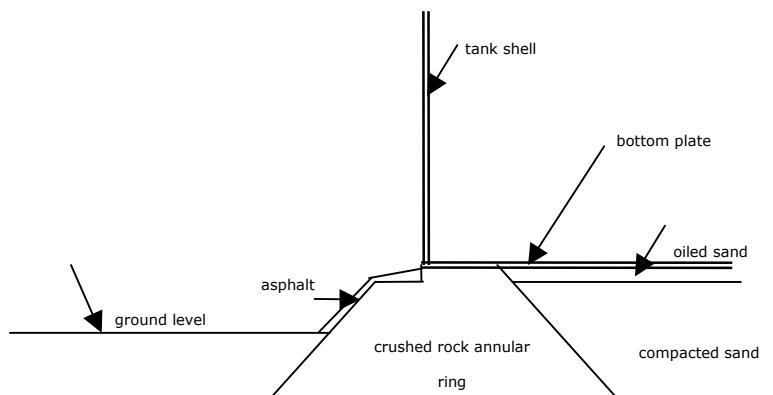
Figure 2: Schematic view of the tank foundation

The foundation of storage tank D2 consisted of a crushed rock annular ring. The rocks had a diameter between 50 mm and 150 mm. The crushed rock annular ring had a height of approximately 120 cm of which a part was below the ground level. The crushed rock ring had a width of approximately 340 cm at the bottom and 100 cm at the top. The shell was situated in the middle of the width of the crushed rock ring. The inner part of the annular ring was filled with compacted sand. Above this sand there was a layer of 5 cm consisting of oiled sand, to avoid external bottom corrosion. Figure 2 provides a schematic view of the foundation of storage tank D2.

As mentioned before, a gutter was situated in the tank bottom at a distance of 1,5 m from the tank wall. This is just beyond the annular plates on which the tank shell is welded. The first normal bottom plates after the annular plates were cracked during the accident. The gutter has been formed due to settlements in the tank foundation, which at that place consists of compacted sand. The gutter has probably been formed during the first hydrostatic tests on the storage tank. The moment a storage tank is loaded for the first time, the compacted sand settles. In the neighbourhood of the crushed rock annular ring, which consists of coarse rocks, it is difficult to compact the sand bed in an appropriate manner during construction. At the moment the storage tank is loaded for the first time, the sand in that area will be more compacted, but because of the existing holes in the crushed rock annular ring a part of the sand will disappear in the holes between the coarse rocks. Due to these phenomena a gutter is formed in the bottom plates nearby the crushed rock annular ring. Calculations based on a finite element method showed that based on the information about the foundation of the tank in combination with the underground under the tank foundation and the size of the storage tank, the forming of the gutter could be predicted.

Existing storage tanks can be lifted up and the foundation underneath can be restored. In this case it must be kept in mind that by performing a hydrostatic test it is possible that new settlements can take place. For existing tanks there is also the possibility to analyse the foundation and the underground under the storage tanks in order to gather enough information to perform calculations. These calculations can indicate if the risk of gutter forming exists or not. For new storage tanks a detailed calculations of the foundations can be performed during the design phase to reduce the risk of gutter formation.

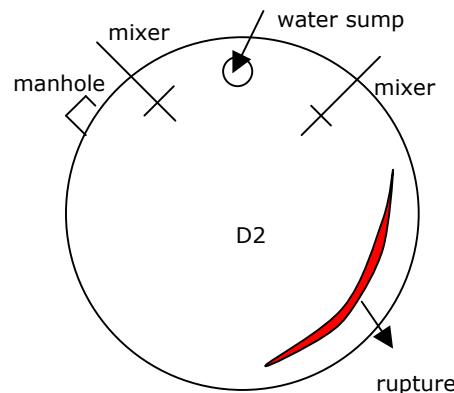
Figure 3: Schematic view of the bottom of storage tank

The investigation of tank D2 showed that the bottom plates in a long, small circular band at approximately 1,5 m from the shell of the storage tank were extremely weakened due to internal corrosion. In this band the thickness of the bottom plates was nearly reduced to zero. This band had a length of approximately 35 m and a width of approximately 20 cm.

In this band the bottom of the tank formed a gutter. In this gutter uniform, internal corrosion was found and no pitting corrosion.

The bottom plates showed no external corrosion in the long, small band. The other bottom plates indicated no extreme corrosion.

During the exploitation of storage tank D2 a gutter was formed in the bottom of the tank. This gutter is situated at a distance of 1,5 m from the tank shell. Due to the formation of the gutter the present water could not longer flow to the drain water system to be removed. The accumulation of stagnant water in the gutter caused strong corrosion which strongly reduced the thickness of the bottom plates in that area.

In the gutter in the bottom of the tank, the present water could not longer flow towards the water sump. This situation of stagnant water in the gutter enabled very fast corrosion in the gutter with the rupture of the tank bottom as the major consequence.

Before start-up all crude oil storage tanks shall be coated with a lining to stop the internal corrosion of the bottom plates.

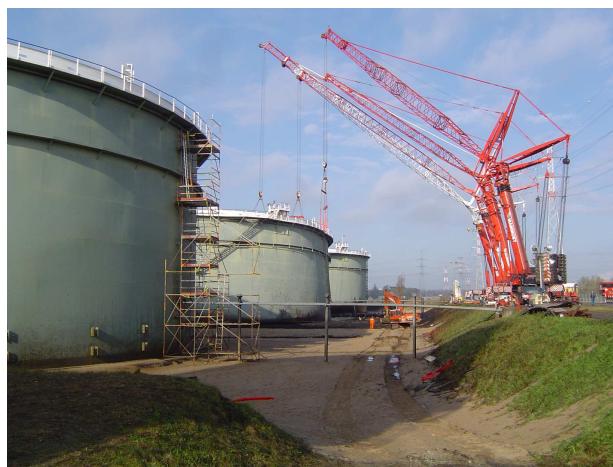
Figure 4: Major cranes stabilising tank D2

The stability of all storage tanks was periodically measured. The stability of storage tank D2 on the place where the foundation was blown away, was achieved by hanging the storage tank on 4 large cranes (figure 4).
