Explosion of a fireworks storage

14 February 1991

Culemborg

The Netherlands

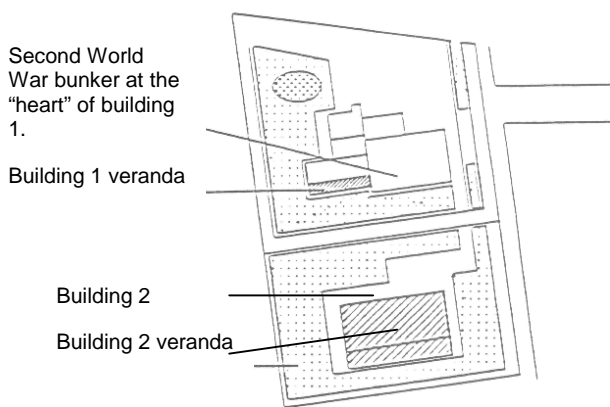
The first building (building 1) comprised a bunker that dated back to the Second World War, 5 small storage rooms and one 25x16 m meeting room.

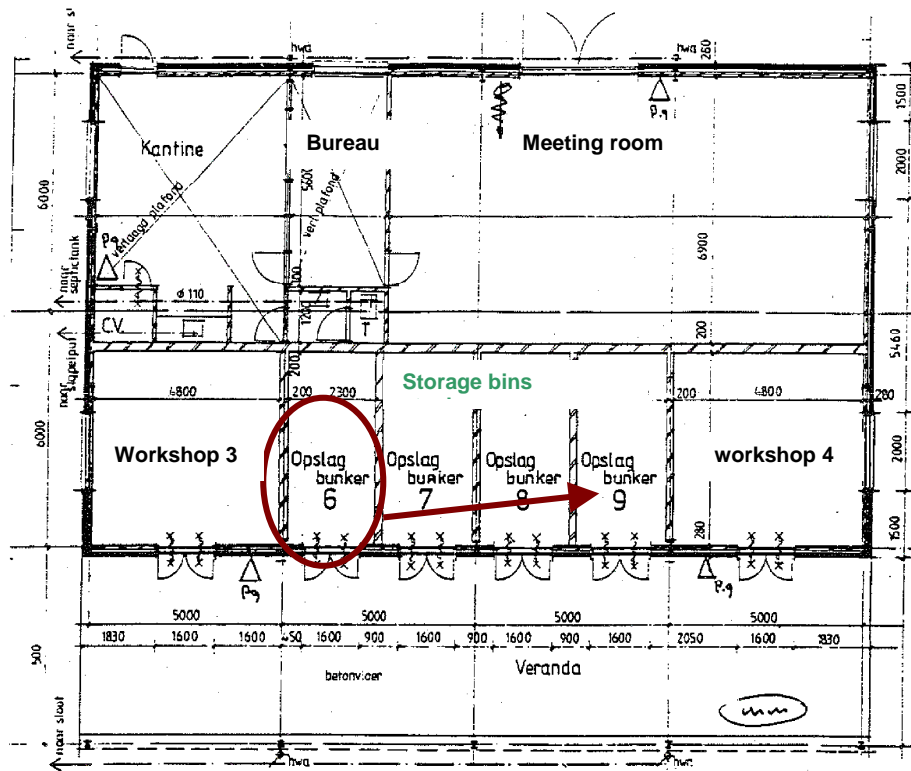
Building 2 was destroyed leaving behind a 10 m x 5 m crater more than 2 m deep. Building 1 caught fire and minor explosions occurred during the rest of the day in its warehouses.

The analysis of craters and fissures in the concrete slabs revealed that the explosion probably occurred in the warehouse of room 6 and was immediately followed by another explosion in rooms 7, 8 and 9.

Plan of the «new building » levelled by the explosion. It most likely started in bin 6 and spread on to the other bins.
