Explosion in a sulphuric acid tank

26th November 2005

Pierre-Bénite [Rhône]

France

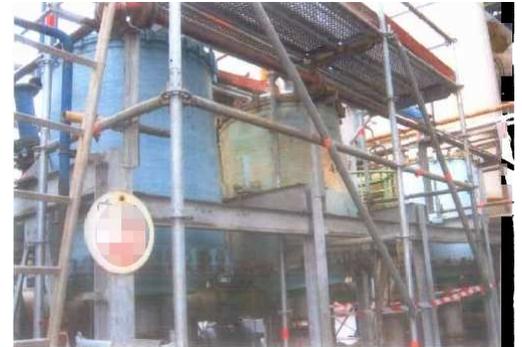
On 22/11, the restarting of the installations was interrupted during the preparatory phase, following a leak in the water/acid heat exchanger of the 1st absorption column. This leak, detected by the rising temperature on the coil and on the acid exit pipes, required the replacement of the exchanger, which was completed on 24/11.

Replacement of the exchanger

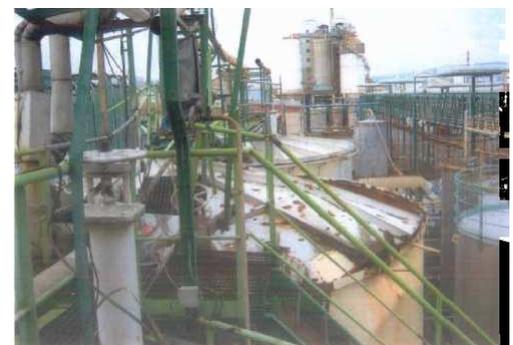
At 11:43, an explosion was heard on the site : the dome of the storage tank was partly opened around the circumference (ring die-dome). Only a few fumeroles were observed on the right of the opening on the dome.

The dome of the storage tank is partly opened around the circumference.

The formation of a small quantity of hydrogen (of the order of several dozen grams) - a gas which requires very little energy for ignition, was the probable cause of the explosion. In the absence of movement in the reservoir between 4:30 and 10:30, a zone of high concentration of H₂ (10 % at a minimum) could develop in the tank; its ignition (which requires very little energy, of the order of a few mJ) could result in an electrostatic phenomenon when the agitation process was initiated.

The primary cause of the accident was therefore the production of diluted acid which corroded the steel interior of the tank while forming hydrogen.

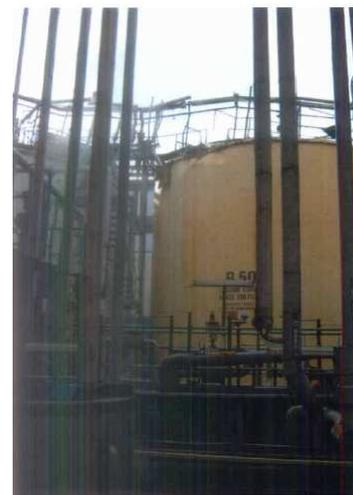
Equipment above the tank was deformed or broken (acid entry piping from the factory, pipe towards the dryer from the other storage tanks, gangway, vapour pipe...).

Deformed gangway
Source : exploitant

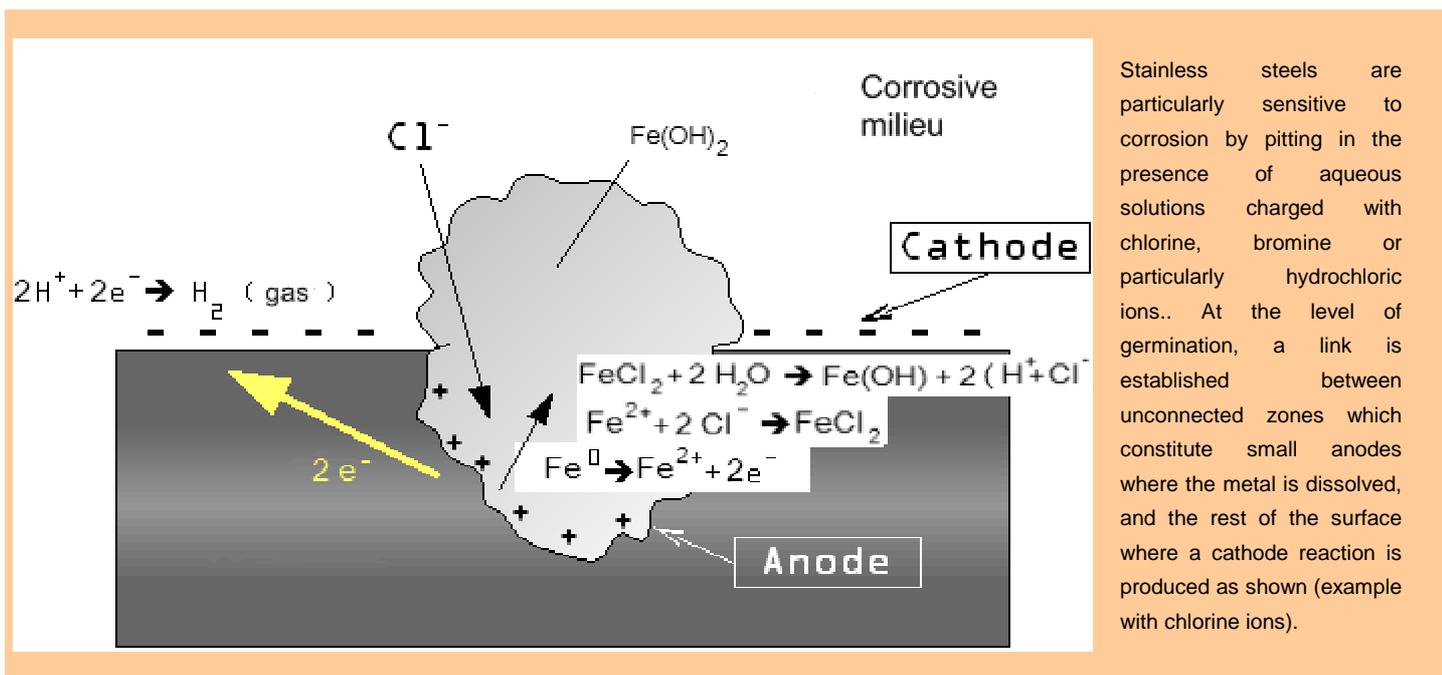
Observations on site and analyses conducted on the metallurgical slices of the exchangers provided evidence of a phenomenon of corrosion by pitting (observation of pits of 3mm in depth) initiated on the "water cooling" side, around welds and on the maintenance covers of the metallic envelope (zone where the material is heavily strain hardened).

The sudden rapid corrosion which caused the piercing of the exchangers followed a flow of water onto the acid side, the heat generation of the reaction accelerating considerably the phenomenon (speed of several dozen mm/year).

In fact, the usual anti-legionellosis treatment (biocide following a bromide base) was replaced by a continuous treatment with sodium hypochlorite. This must be overdosed to ensure its effectiveness as a long-term biocide taking into account also the pH over 8 of cooling water, considerably increasing the oxidising power of the latter. Moreover, the lowering of the speed of the flow of water following the reining in of the exchangers associated with the operation at a low regime in the factory for a long period, caused an increase in the temperature of the water which amplified the phenomenon: increasing the oxidising potential of the milieu and lowering the temperature required for the pitting (between 15 and 30°C for a chlorine content 500 mg/L for the most sensitive zones such as those affected by strain hardening or those affected thermally at the level of the welds).

The pitting observed being almost exclusively on one side of the welds (the closest to the passage of sulphuric acid and thus the warmest) this pitting began during normal operation of the exchangers.

The treatment of the water with Javel was replaced by a non-oxidising biocide treatment associated with an increase in the doses of a bio-dispersant until the entry into service of new heat exchangers.
