Release of ethylene to the atmosphere

21 July, 2005 and 21 September, 2005

Saint-Avoid – [Moselle]

Petrochemistry
Polyethylene
Ethylene
Rupture disc
Clogging / Fouling
Equipment failure
Organisation /
maintenance fault

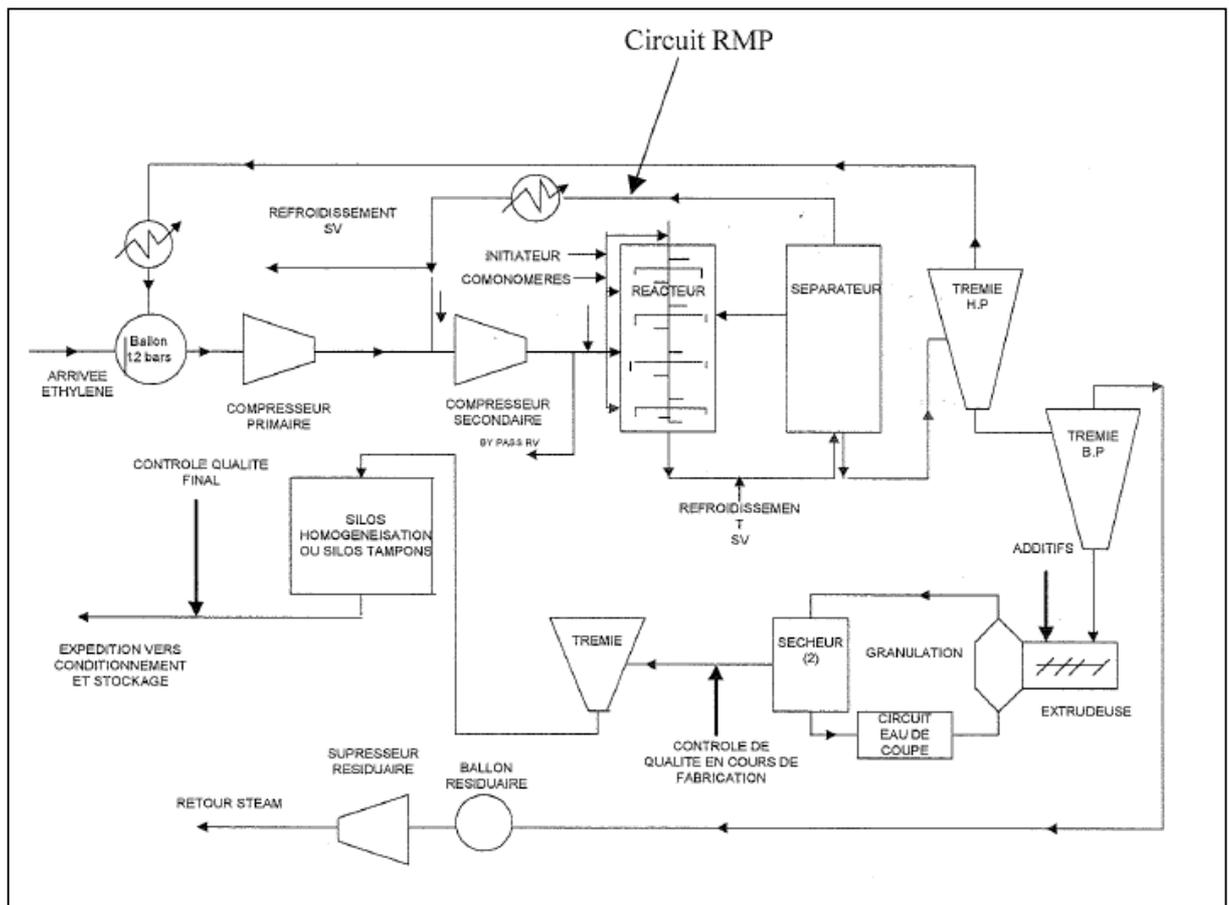
Figure 1: Simplified diagram of the process

A simplified description of the reaction is as follows (see figure 1): the ethylene undergoes polymerisation in a reactor pressurised between 1,000 and 2,200 bar and at temperatures ranging from 150 to 300 °C. The pressure is controlled by a valve located at the outlet of the reactor; this valve also is used to extract the reagent / polyethylene mixture. The mixture is then directed to the separator of the Medium Pressure Return line where it is separated into two phases (approximately 20% polymers and 80% ethylene as the conversion rate of the reaction is in the order of 20%). The polyethylene drawn from the lower part is then conveyed to the high then low pressure hopper. The ethylene is also conveyed with the polymer phase.

The largest fraction, the ethylene which exits the upper portion, is cooled then recycled by the MPR line to the intake of the secondary compressor.

The low polymers (greases) are extracted during the cooling of the recycled ethylene in the medium pressure return lines. These polymers are trapped in the tanks (grease cylinders) which are purged to the grease hoppers one after the other. The greases can then be drawn or reinjected to the low-pressure hopper.
