Polluted effluents released into the Cher River

14 September, 2005

**Saint Victor – [Allier]
France**

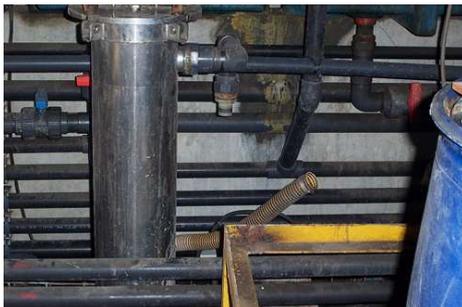
Photo DRIRE Auvergne

On Wednesday, September 14th, 2005 around 8.15 pm, a technician discovered a leak on the multiple treatment line slightly before the end of his shift; a filter outlet pipe on a tank containing alkaline copper cyanide had become disconnected causing the bath (approx. 1,000 l) to flow into the concrete catchpit.

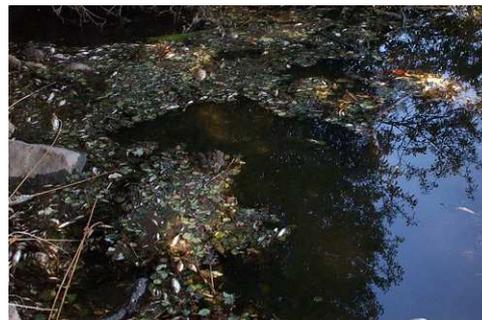
Photo DRIRE Auvergne

- ✓ according to the plant operator's estimate, approximately 20 m³ of effluents containing cyanides at a concentration of 3 to 5 g/l was released into the Cher River,
- ✓ fish mortality (approximately 2.5 tons) was reported by agents of the National Commission for Fishing,
- ✓ no health problems were reported by residents living near the site or near the point where the effluents were released into the Cher.
