## Fire in an aromatic extraction unit in a refinery

21 April, 2006

**Notre-Dame de Gravenchon –  
[Haute-Normandie] – France**

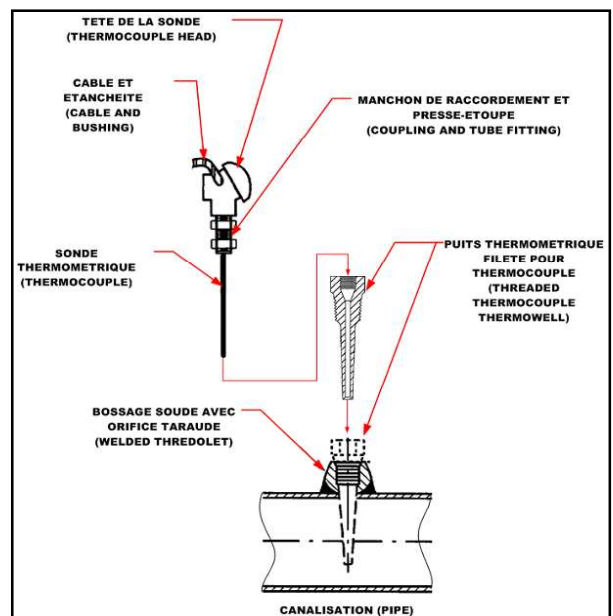
Temperature sensor assembly diagram

The analysis of the incident discovered that the thermocouple was improperly installed on the bottom circuit of the raffinate stripping tower. The installation was not in compliance with the construction drawing of a thermocouple well on a pipe.

A proper installation of a temperature sensor (see diagram below) adapted to the installations' service conditions would consist of the following:

1. A threaded boss on the pipe wall intended to receive the thermocouple;
2. Screwing of a "sensor pocket" on the aforementioned boss and reinforcement by means of a weld bead;
3. The thermocouple is then screwed into the pocket;
4. The wires are connected to a signal transmitter, once the cable is connected to the sensor by means of a coupling.

In this configuration, while ensuring a reliable temperature measurement, the thermowell guarantees that there will be no direct contact between the process fluid (for which we are attempting to measure the temperature) and the thermocouple. In the case of accidental rupture (contact between the process fluid and the thermocouple), the tube fitting limits/prevents the loss of confinement provided that the leak is not excessive.

The investigations conducted following the incident showed that the thermocouple had been installed without a "sensor pocket", thus without protection. The hot raffinate was thus in direct contact with the sensor. As the quantity of product was excessive and the fluid very hot (320 °C), the tube fitting was unable to properly maintain the seal, leading to self-ignition of the product released and in contact with the air. The equivalent diameter of the break at the pipe level is roughly 10 mm.

3. Stipulate in the specific "Instrumentation" Specifications what verifications must be performed in order to ensure that a thermowell is present before installing a thermocouple.

4. Work with the platform's Inspection Department so that the lines equipped with thermowells are tested with the "sensor pockets" in place (plugging the pipe bosses intended to receive the thermowells is prohibited).
