## Release of sulphur dichloride and hydrogen chloride

26 April, 2006

**Catenoy – [Oise]  
France**

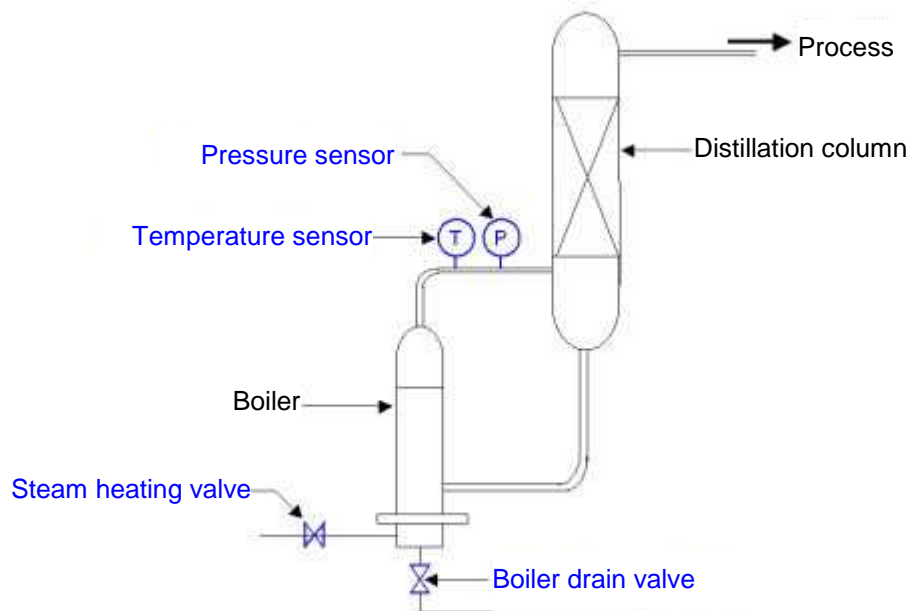
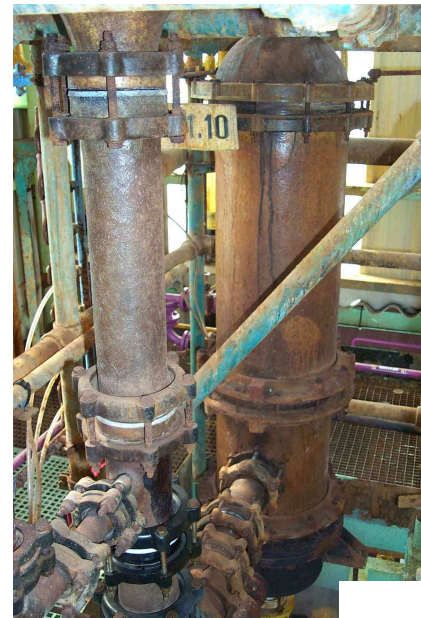
Boiler

- ↺ **the presence of 150 kg of sulphur dichloride in the boiler during the maintenance operation (lock-out defects):** the potential hazard subsists as it was not possible to drain the boiler due to the clogged bottom valve. The analysis highlighted the presence of glass debris (failure of the mounting of the packing support disk) mixed with product deposits (low-quality sulphur dichloride) was the reason for the clogging;

- ↺ **boiler reheating :** when the high-pressure level was detected (> 100 mbar), the steam control valve heating the contents of the boiler was shut by the process control PLC. Disconnection of the sensor during its replacement triggers a -25 mbar signal to be transmitted that controls the re-opening of the steam control valve and reheating of the boiler;
