Fire and explosion of ammonia synthesis gas

1st June 2006

Billingham

Ammonia
Joints
Piping
Valve
Organisation/Maintenance

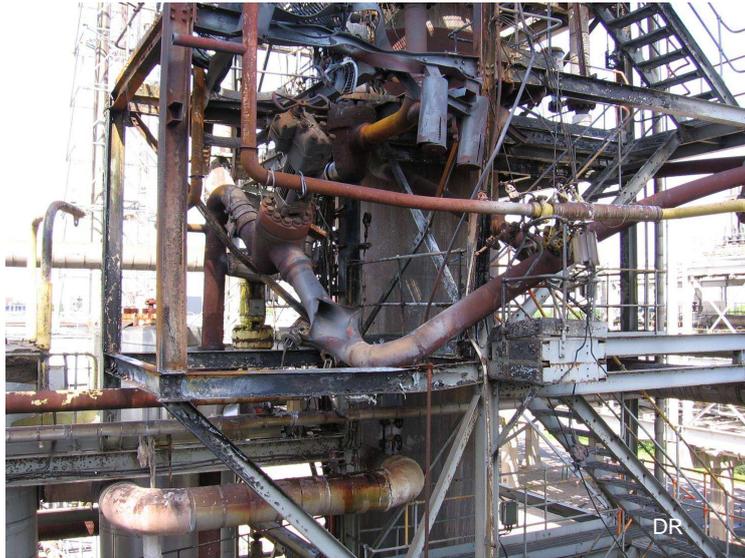
The gas, released at a pressure of 220 bar and a temperature of 120°C, ignited spontaneously, forming two flame cones directed along the pipe connected to the valve. The pipe could not resist the heat from these flames; and under such internal pressure, it burst in freeing its contents, which in turn exploded. The quantity of gas released during the accident was estimated at 1.45 tonnes. The gas continued to burn for more than two hours, given the quantities found at the site when the fire broke out.

The consequences of this accident however remained confined to the zone adjacent to the valve.

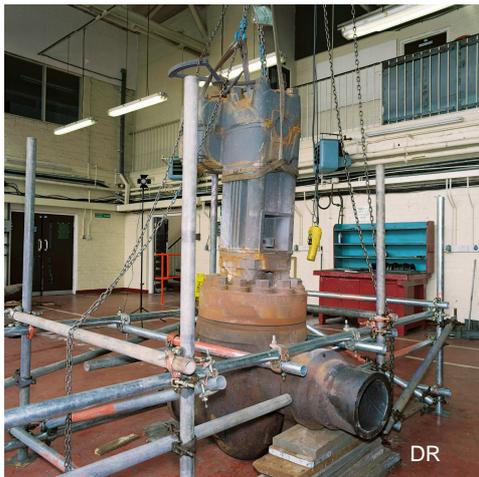
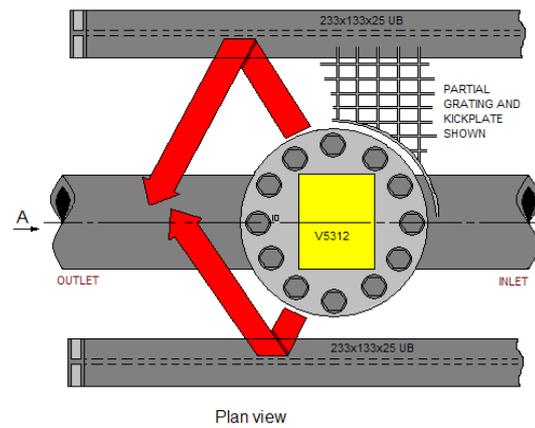
This accident was caused by a gas leak on the joint between the body and cap of a shut-off valve [V5312] on a pipe transporting synthesis gas. The valve, in the open position, was operating at full flow. The seal between the two parts, held together by 12 bolts, was applied to a metal-on-metal contact. Inspection of the valve indicated that gas had leaked in two spots prior to ignition, meaning that two distinct flames were produced.

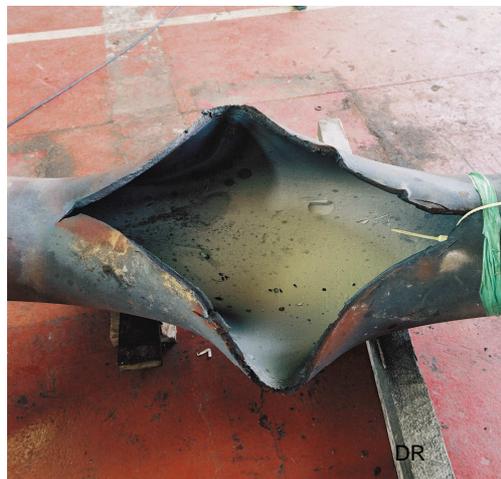
Given the layout of the structure's metal frame, one of the flames actually "ricocheted" off the side and reached the pipe on the outflow side of the valve, causing it to heat for some ten to fifteen minutes, before bursting open over a full metre and releasing gas at a pressure of 150 bar.

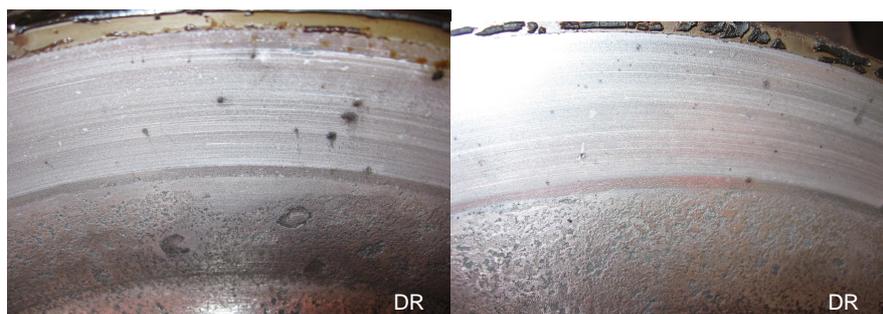
- inadequate clamping of nuts, the subcontracted firm did not follow any pre-established set of procedures or specifications in conducting this operation;
- a metallurgical examination of the valve seal surfaces revealed a degraded surface condition: a sizeable lateral surface groove, presence of particles (though below manufacturer's standards). Also noteworthy was that the particles were apparently of a shape and composition analogous to those of shot blasting material used to clean metal surfaces.

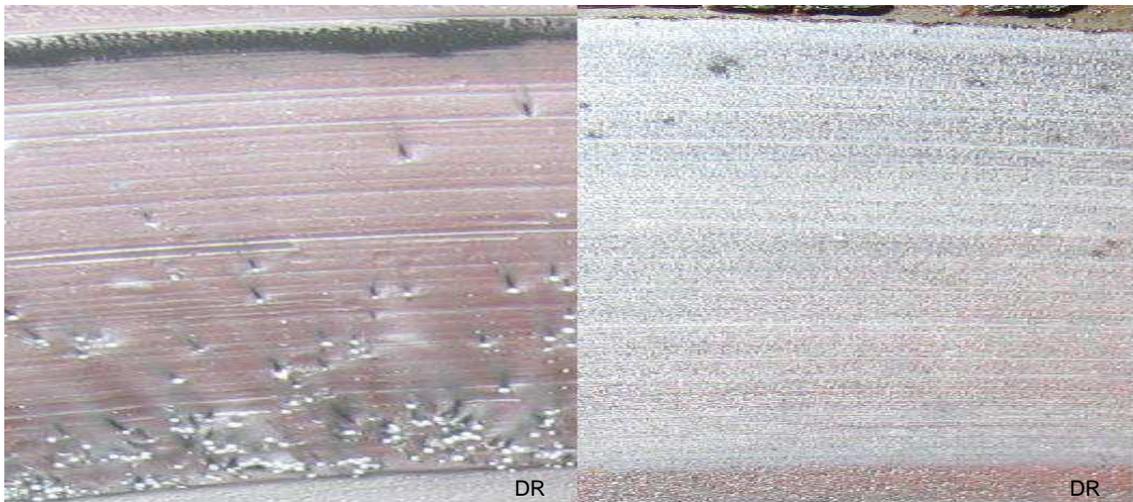
A comparison of seal surfaces on the valve that caused the accident with those of an identically-designed valve clearly highlights the particles responsible for surface defects: the surface roughness of this deficient valve was twice that of a similar valve (see photos below).

- The operator did not inspect work performed on the valve.
- The particles detected on seal surfaces were similar to materials used when shot-blasting metal surfaces. Their origin remains unknown but were undoubtedly deposited prior to the maintenance work of 2002.
