# Explosion during a cupola drop inside a foundry

May 15, 2006

Vivier-Au-Court [Ardennes]

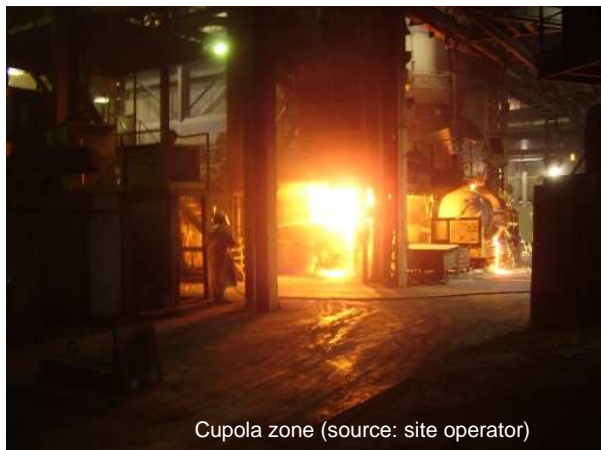
The explosion took place at the time the molten residue was being dropped into the skip.

Cupola zone (source: site operator)

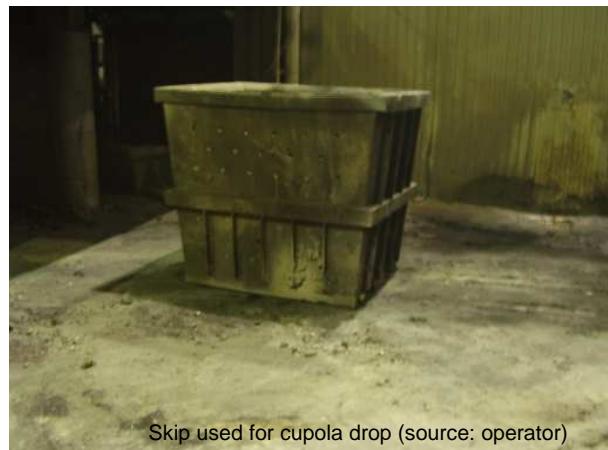
Skip used for cupola drop (source: operator)

The water / molten metal reaction was the cause of this accident: the refractory cement lining the residue recovery skip was only set into place the same morning and the drying period proved insufficient. This skip, intended to serve as a receptacle for residue after melting, contained residual humidity. Water entering into contact with molten residue either triggers a vapour explosion (purely physical phenomenon) or leads to the formation and subsequent explosion of hydrogen or CO (chemical redox phenomenon).

- ✓ acquisition of three skips so as to better manage equipment utilisation and ensure sufficient drying time for the refractory cement (36 hrs). Skip labelling was also introduced;
- ✓ storage of this containment capacity at a site protected from water;
- ✓ drying of the skip intended for daily cupola drop using a gas burner;
- ✓ placement of a bed of black foundry sand at the bottom of the skip to both eliminate all eventual traces of residual humidity and provide additional protection at the skip bottom.

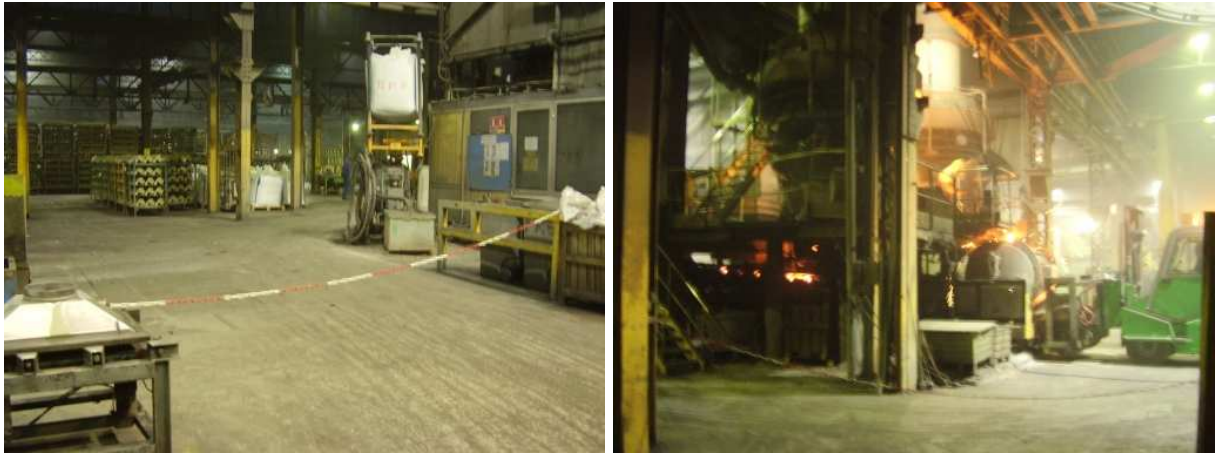
Delimitation of the protection zone (source: operator)

- ✓ clearly identifying the protection zone by demarcating a boundary around the cupola furnace;
- ✓ installing a sound alarm designed to notify personnel during the cupola drop period;
- ✓ designating a cupola drop supervisor with the responsibility to trip the alarm and ensure that the protection zone is always free of any unprotected or unauthorised individuals;
- ✓ revising operating guidelines and appointing a Head of Operations, who among other things is to verify that the refractory cement lining the skip is well dried;
- ✓ updating, in conjunction with employees, the list of individual protective gear (by occupation or by workstation) to be worn: helmet with a face shield, safety jacket and aluminised gloves, and appropriate pants;
