# Detonation of an explosive during compression

June 8, 2005

**Bourges [18]**

Pyrotechnics / Explosives  
Detonation  
Explosive compression  
Safety distances

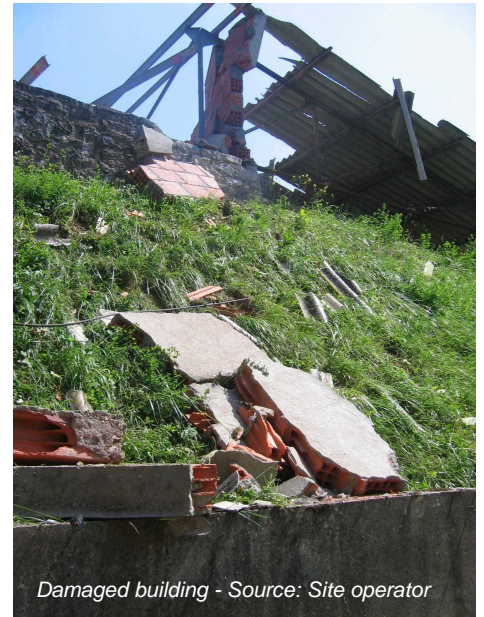
The roofs on the exposed building as well as on the closest neighbouring building sustained damage due to the effects of the blast and projections, with broken window panes observed on some of the buildings composing the enclosure.

*Damaged building - Source: Site operator*

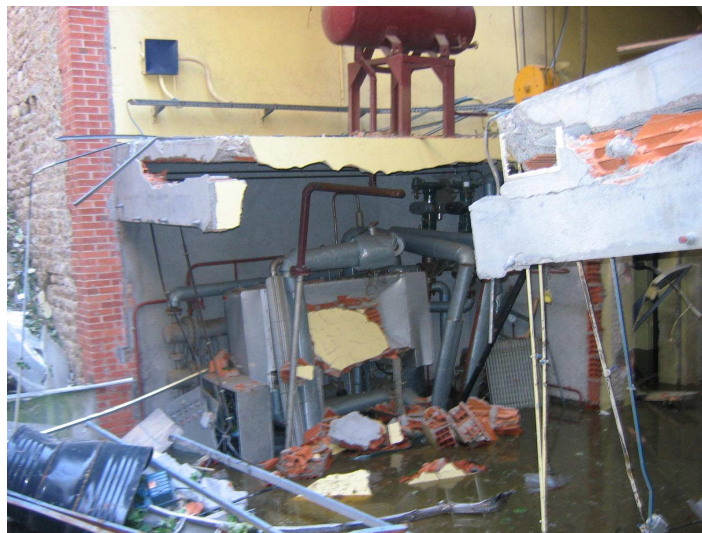
Around 9:25 am, a detonation occurred at the level of the tooling station for the large-capacity press. The personnel, protected by the configuration of these premises, were not hurt by either the excess pressure wave or flying debris; they evacuated the building via an emergency ladder and gathered in an adjoining building, from where they could notify safety staff.

*Press room damaged by the explosion (Source: site operator)*

- an adiabatic compression of air within the powdery explosive,
- electrostatic discharge,
- the presence of a foreign body inside the explosive.

- separating the weighing station (the 14-kg drum, positioned close to the press, further complicated the accident) from the compression station, thus decreasing the mass capable of reacting;
- prohibiting the resumption of compression operations on products with similar masses.

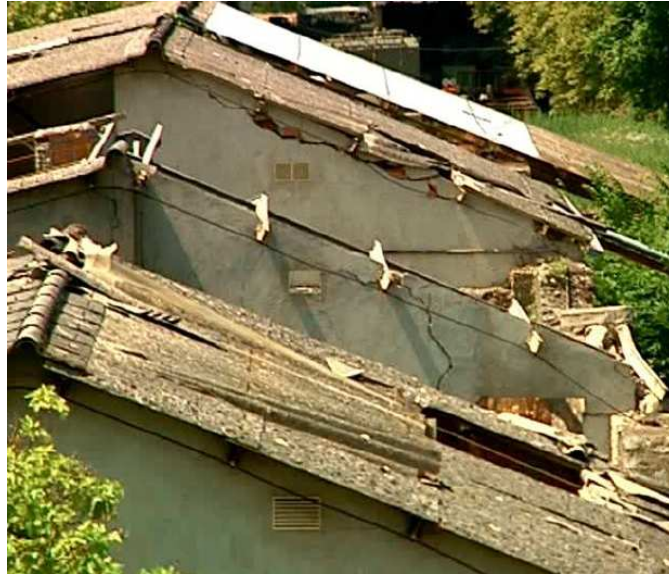
Destroyed roof on the premises (Source: site operator)

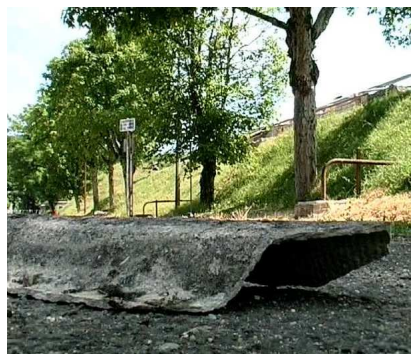
A fragment of translucent polycarbonate (0.30 m x 0.40 m) was found 65 metres from the scene of the explosion; it might have been part of the lightweight, explosion-venting partition wall between the press room and the expansion conduit.

*Debris found in Z4 (Source: site operator)*
