Fire on a burning area within an explosives plant

July 28, 2006

Pont de buis les Quimerch [29] France

Pyrotechnics
Waste / Destruction
Organisation /
Operating guidelines

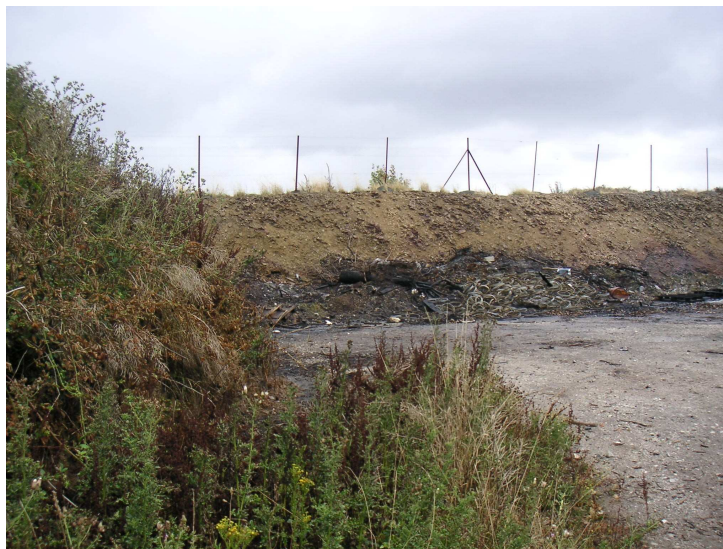
Burning zone: The combustion source was taken left of the photo; piles of waste and unburned product opposite (source: IPE)

The site's installations were not damaged. Traces of unburned pyrotechnic wastes (powders) remained in the zone, thus confirming the "random" nature of their combustibility (depending on their rate of humidity).

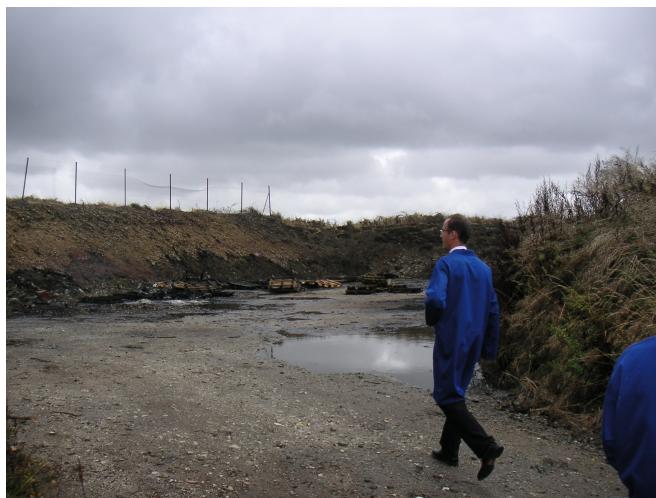
During the second loading, around 3 pm, a spontaneous fire ignited adjacent to where the EU Manager was standing, trapping him in flames and smoke. The fire raged over the entire burning zone. The other two employees were able to escape without injury. One of them, a volunteer fire-fighter, proceeded by sounding the alarm and began fighting the fire.

The EU Manager was found at the base of the embankment slope 30 m from the point of ignition; he died from injuries within the hour.

Overview of the burning zone, photograph shot from the entrance: the fire propagated from right to left (the body was found towards the back on the left) - Source: IPE
