Pollution of the river ENNS following a leakage from a hydrocarbon storage tank

31 May, 1998

Downstream from the City of STEYR Austria

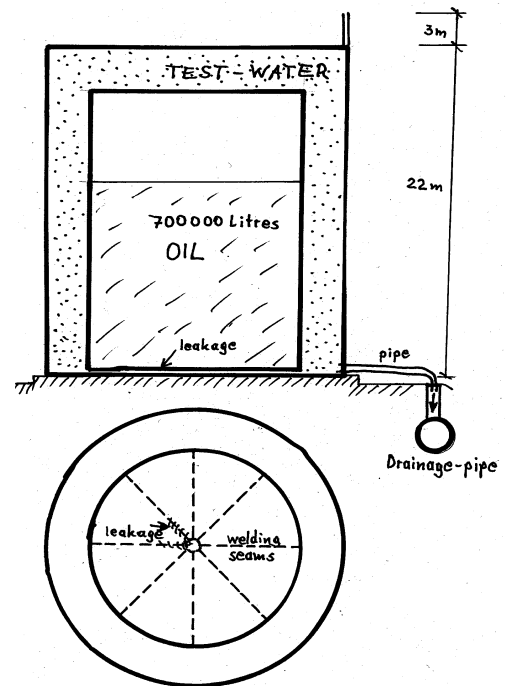
Tank structure

This tank consists of two envelopes as shown in the diagram below. The reservoir containing the product, made of steel, is housed inside another reservoir. The assembly measures approximately 22m tall and can contain approximately 1,000 m³.

During the test, no one was able to detect the crack on a section of weld seams located on the bottom of the main tank, i.e. the tank containing the hydrocarbons. As a result, approximately 70m³ or more drained into the river by way of the water drainage valve.

- ✓ The drainage phenomenon was amplified by the test of the exterior tank as the leakage of hydrocarbons is assisted by the draining water;
- ✓ Drainage operation should be done during the day so that a possible accident should be prevented or controlled by the on site personnel;
- ✓ The installation configuration, with a purge emptying directly to the river, is inadequate.

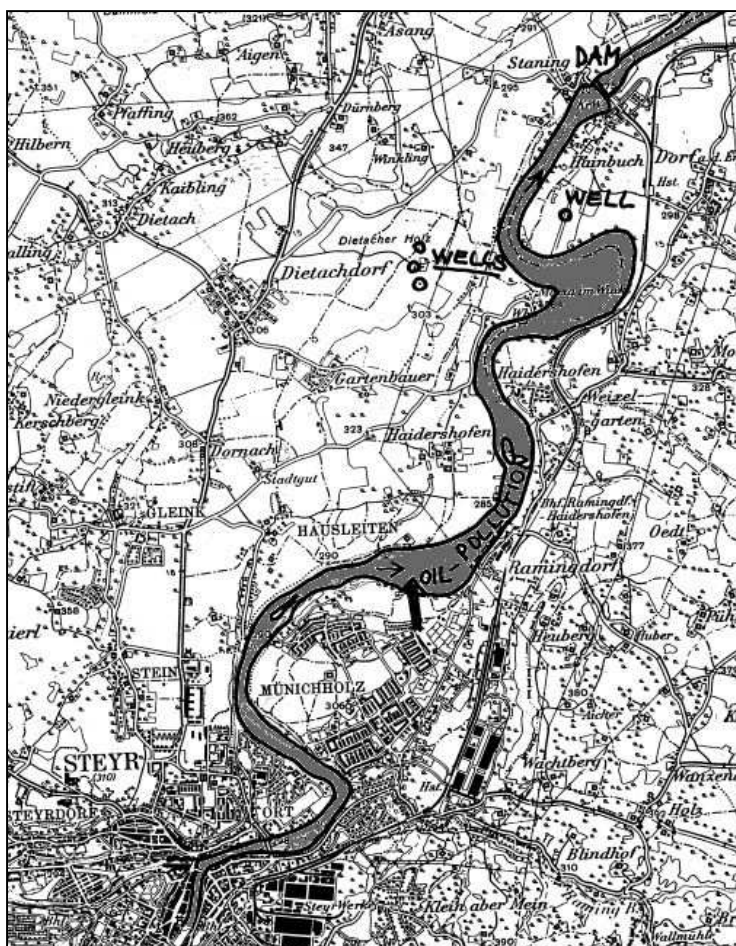
Map showing the extent of the pollution caused by the accident

In the morning, fishermen inform the police that the river is polluted. The majority of the pollution is located within the impounding lake formed by the STANING dam, thus near the drinking water well zone.

The pollution extended 35 km, affecting 3 hydroelectric dams located within this zone.
