Leak on a pipe conveying MTBE

October 2004

Stein Port - The Netherlands

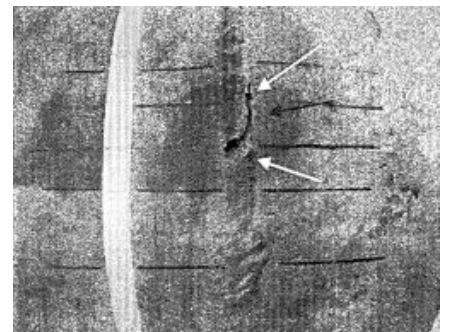
A crack on a pipe weld resulted in the MTBE leak. This defect resulted from multiple failures during the construction of the pipeline.

In 1976, construction began on each side of the project to save time. A difference of 70 cm in height between the two sections thus required the addition of an improvised S-shaped junction. Poor adjustment of this part required a 1.5 cm gap to be plugged by welding.

The welding of this junction part, poorly performed and left unchecked, caused the pipe to crack. The crack, the appearance of which remains difficult to establish, most certainly widened over time, notably due to ground motion.

Crack on the weld
Source: VROM-Inspectie (The Netherlands)

Following the detection of the pollution in October 2004, the pipeline was repaired and several methods were used to treat the site's polluted zone:

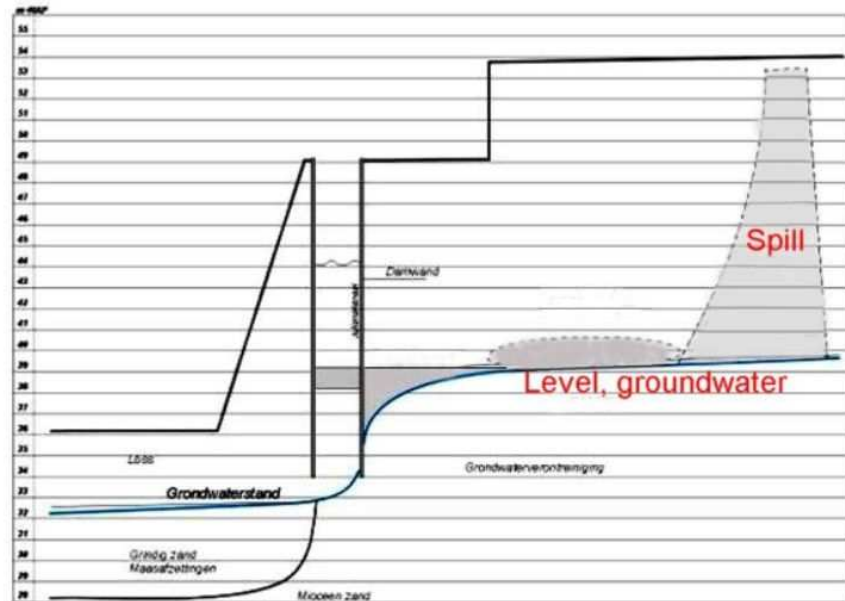
POLLUTION TRANSFER DIAGRAM

The transfer of pollution from the leak zone to the Meuse, despite the presence of a 15-m deep reinforced steel dike (forming the Juliana canal) can be attributed to the presence of a strong water table current flowing through the Meuse gravel bed (see photo below).

Furthermore, to prevent the pollution from spreading, the steel structure of the Juliana canal dike was reinforced up to 15 m in depth, i.e. below the level of the water level.
