Fires and BLEVE of LPG tanker lorries

7 May 2007

Dagneux (Ain)

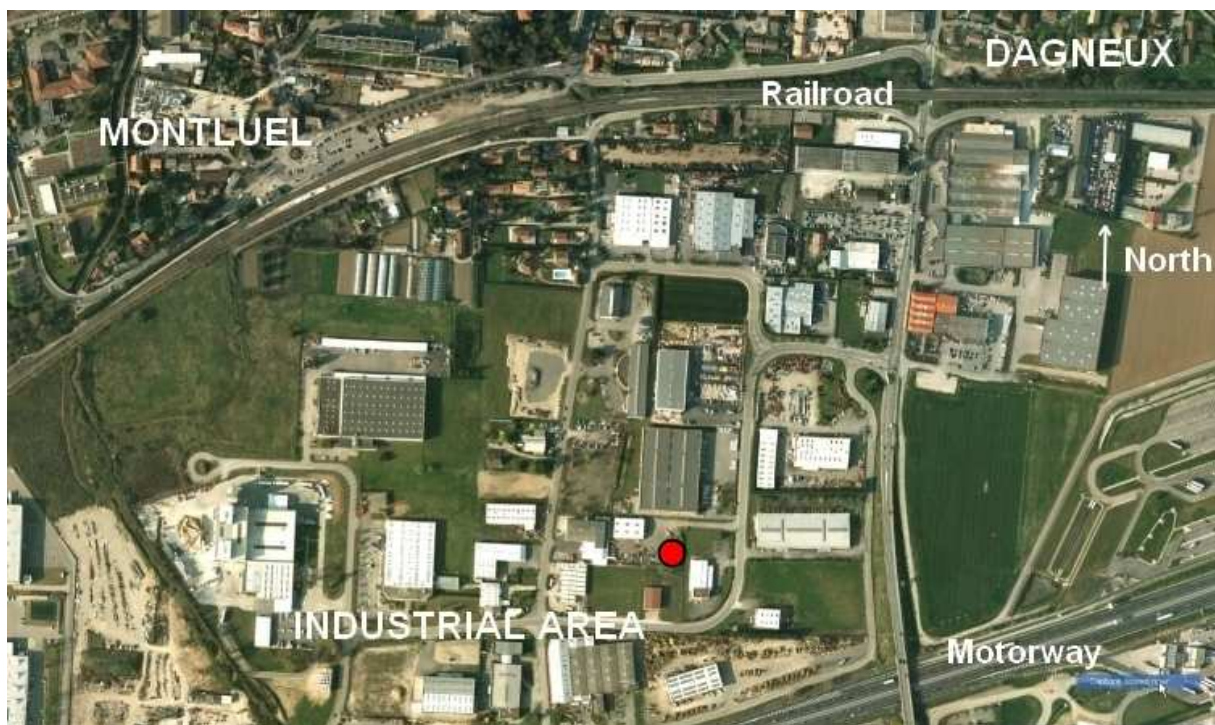
Parking zone used by tanker lorries (red dot)

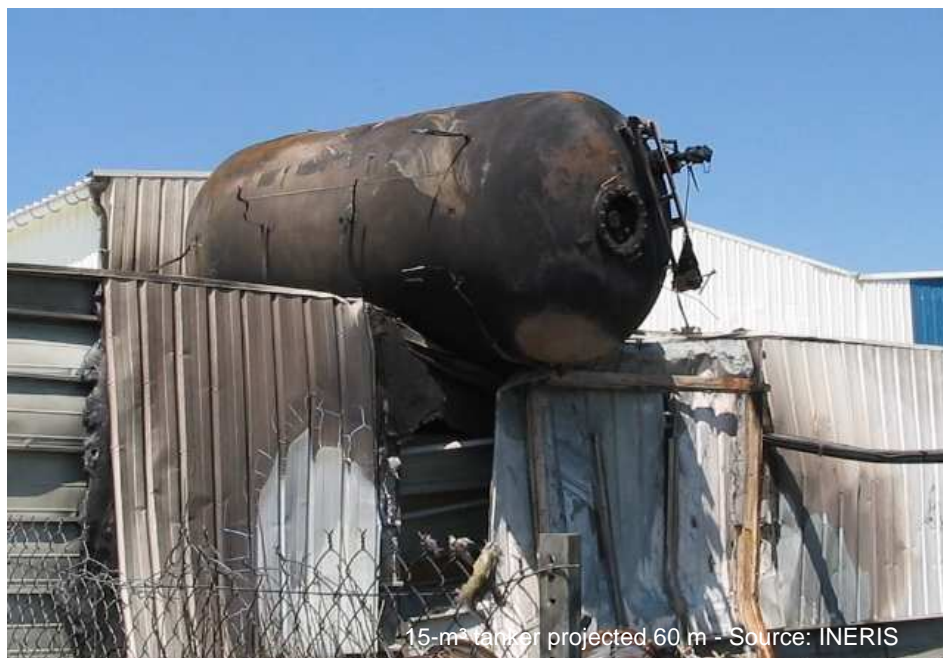
15-m³ tanker projected 60 m - Source: INERIS

The 15-m³ tank, weighing an estimated 3 tonnes, was ejected 60 m onto the roof of an adjacent company. Both the 20-m³ cisterns burst into multiple fragments; 13 pieces of tank were counted, though without being able to ascribe each piece to a particular origin, along with considerable debris projected out to 300 m; the materials sprayed included sheet metal, parts of lorry chassis and cabs, sun visors. Only the 13 pieces of tank and the intact vessel could be inspected with precision, yet smaller elements might have gone unidentified; 10 fragments (with a mass of between 50 kg and 750 kg) were ejected up to 250 m away, with 3 pieces (masses: 100 kg to 1,000 kg) falling at distances from 400 m to 900 m.
