## Fire within a food processing plant

30 July 2007

Renaison (Loire)

Fire  
Pollution  
Food processing industry  
Fire-fighting water  
Electrical defect  
Retention facilities  
Environmental analyses  
Communication /  
information / crisis

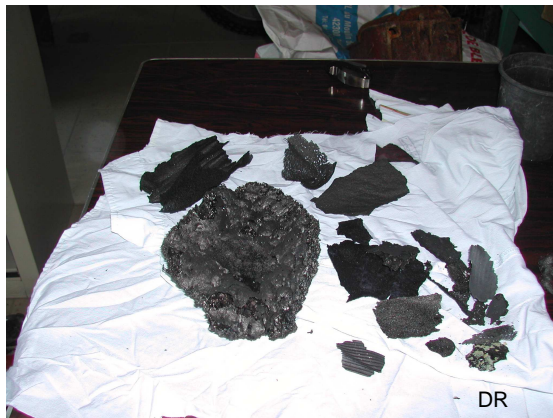
Debris collected in the garden of a residence  
3.8 km south-southwest of the accident

The captain of the fire brigade indicated to the facility inspection team on July 30, 2007 that a significant amount of black particles of varying sizes was released during the fire. The storage of cardboard and other packaging materials was found to be the source of these particles.

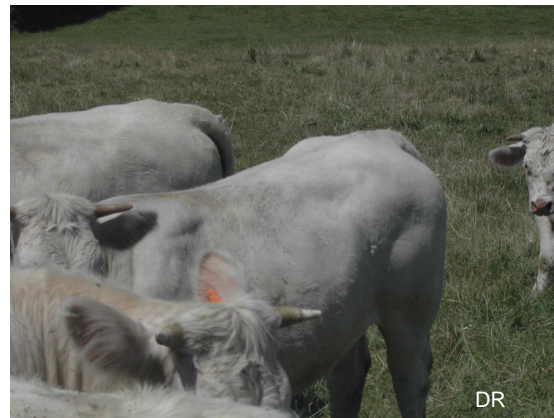
Animals grazing a few kilometres south of the site  
were covered with soot from the fire

The day after the fire, a nearby farmer informed inspection authorities of the presence of soot, greasy to the touch, covering vegetables in his garden; moreover, debris was strewn over his pastureland. Both the coat and mucosa of his cattle revealed an unfamiliar grey sheen.

On the same day, the local Prefect sent a memorandum to the mayors of all nine municipalities within the sector potentially affected, notifying them that investigations (soil, water, flora) were underway and emphasising the following recommendations: for residents to carefully wash and peel all fruits and vegetables before consumption; and for the area's cattle growers not to feed their animals with fouled plants and grass.

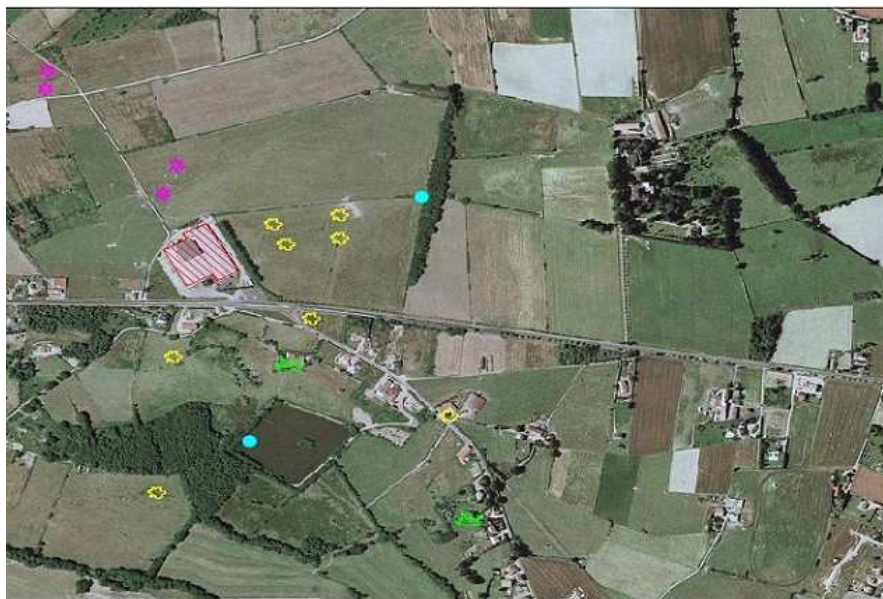
Map of sampling operations

This fallout of soot and debris, combined with the spill of fire-fighting water, raised fears of environmental contamination from dioxin, PCB (polychlorobiphenyl), PAHs (polycyclic aromatic hydrocarbons), hydrocarbons and heavy metals. At the request of the inspection authorities for classified facilities, a sampling campaign was undertaken on August 3, 2007 within a corridor 3 km wide by 6 km long along a south-easterly direction with respect to the site; this specific zone had been established on the basis of both meteorological data and onsite observations. This study provided an initial and approximate impact assessment of the fire outside the site: on soils and plants intended for beef cattle consumption, on the liquid effluents generated by fire-fighting actions (water used for extinction), and lastly on residents' vegetable gardens to determine whether consumption was safe. The results of analyses performed on soils and crops/plants

intended for human and animal consumption yielded values below the threshold; however, they also revealed areas of residual pollution due to the fire, namely on the canal used to discharge fire-fighting water.
