Degassing of a tanker truck containing waste

31 July 2007

Limay (Yvelines)
France

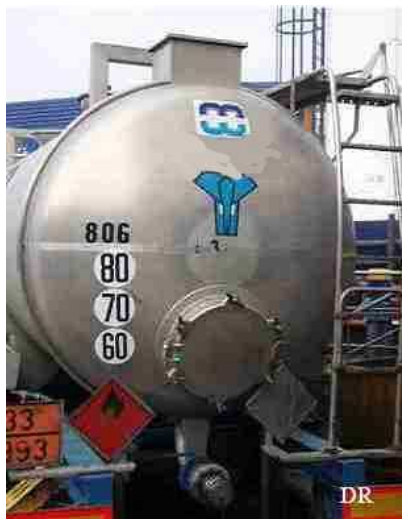
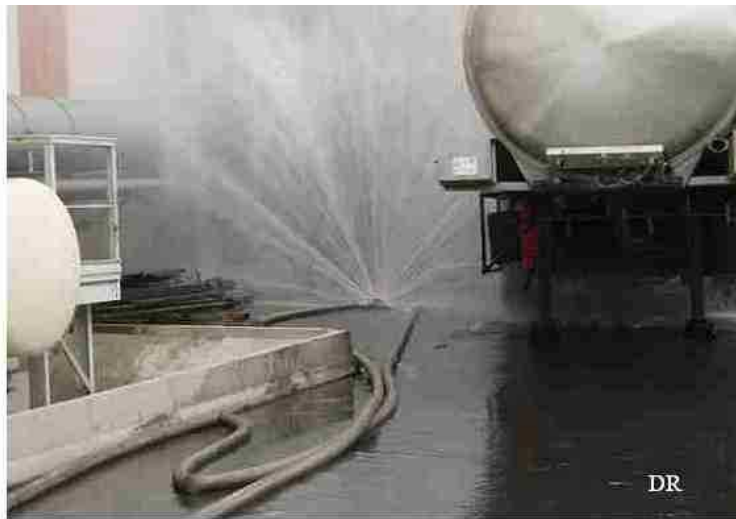
At 8:30 am, the temperature of the tanker truck sidewall was estimated at between 30° and 60°C. The vents were open and the truck was sprinkled by the spraying ramps located in the zone dedicated to direct processing operations.

By 12:00 noon, both the truck temperature and pressure were rising. The truck was moved outside the direct processing zone to install a "peacock fan"-shaped spraying device on each side of the truck. The valve on the site's industrial effluent and stormwater containment pond was then closed.

Around 1:30 pm, teams on the site's second shift arrived as a backup to continue spraying the tanker truck with fire hoses. In order to lower pressure, the truck was emptied of a few containers loaded with the mix, and these containers were placed adjacent to the truck. A safety perimeter was established.

Photographs of the tanker truck and the various spraying set-ups (reconstitution – Source: site operator)

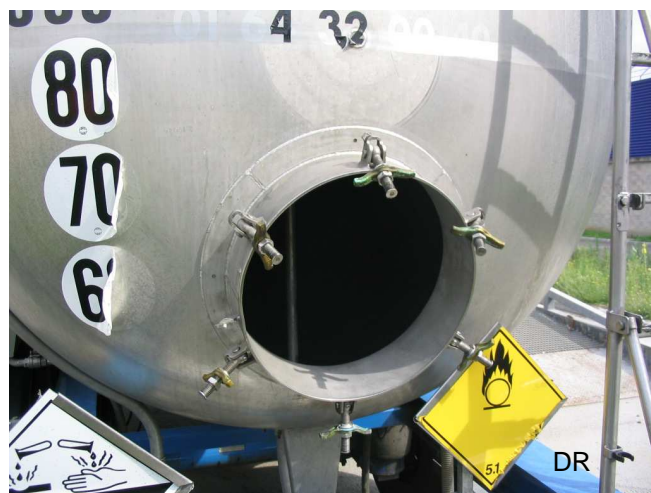
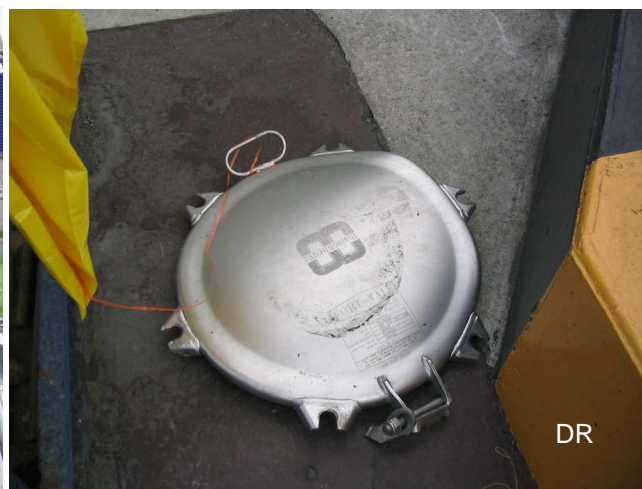
At the same time, 2:30 pm, the internal tanker truck pressure rose and the manhole located on the back face of the truck broke open. The truck degassed all at once; then, both the truck and tractor were propelled some fifteen metres due to the effect of this pressure burst and came to rest when reaching the edge of the track.

No major property damage was declared (deformation of some metal cladding), except for the tanker truck itself, whose braces and hood were bent.

Burst manhole cover (Photos courtesy of the site operator)

The decomposition of hydrogen peroxide led to a sudden degassing of the tanker truck. The H_2O_2 decomposition reaction is an exponential speed reaction. Defining with certainty the exact time when the product starts to react proves to be a difficult step, since inertia runs high in a tanker truck carrying 25 tonnes. This reaction was in fact able to begin prior to waste acceptance: before/during loading, at the same time as the transport?

- The selected unloading line was operated by either suction or nitrogen thrust; it lacks a specific relief valve system that could have allowed releasing the gas formed during the reaction;
- Only the tanker truck valves could have ensured proper aeration and the requisite evacuation of gas bubbles; these valves however proved inadequate for this particular waste within this particular volume.

- introduce the systematic verification of tanker truck temperature at the time of material acceptance (with all pertinent information recorded on the material transfer form);
- refuse the acceptance of wastes containing hydrogen peroxide in bulk packaging exclusively for concentrations below 5%, and require wastes containing higher concentrations to be shipped in barrels or containers.

- ⇒ Reinforcement of waste acceptance controls: a temperature control must be performed during sampling from the tanker truck. The result of this control step is to be formalised on the material transfer form;
